EXTERIOR MAINTENANCE REPAIR WORK FOR: VETERANS MEMORIAL HALL

WINNEBAGO COUNTY

BID # 21B-2226

ISSUED FOR: BIDDING

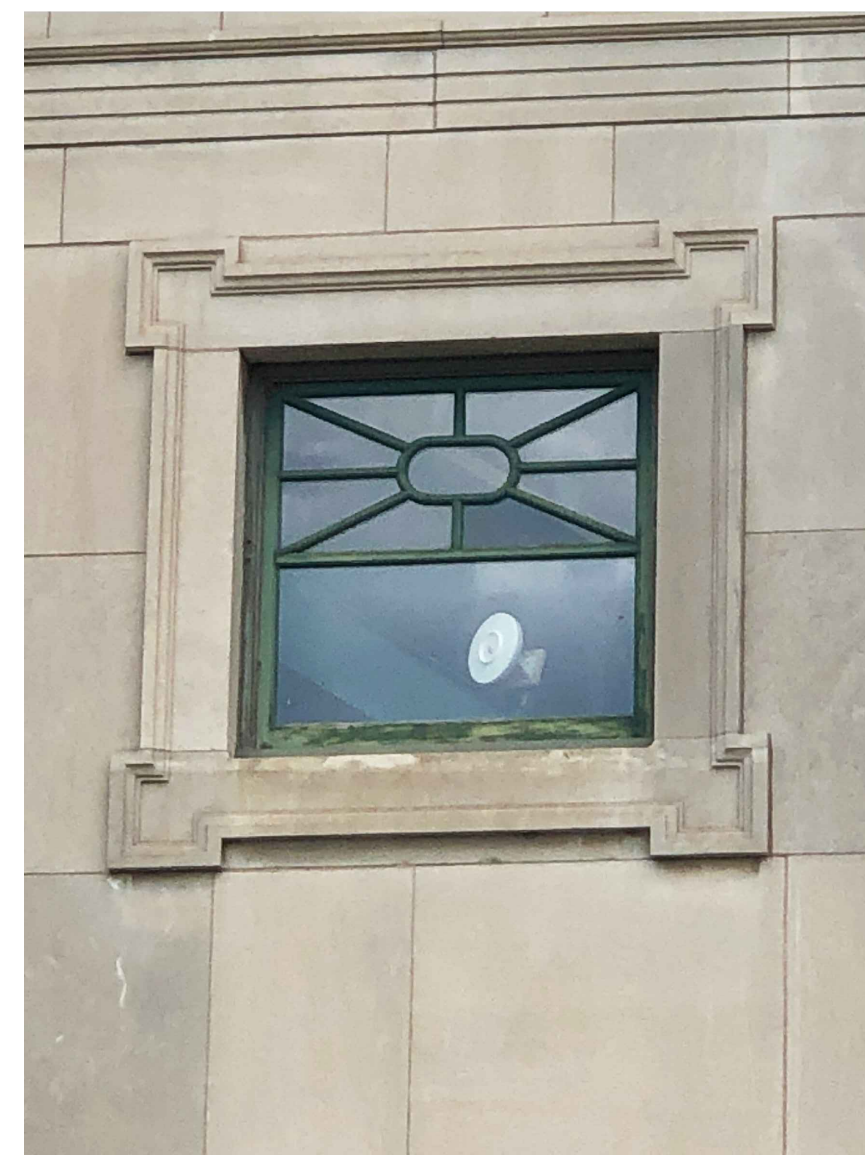
1
OBSERVATION:
BOTH GREEN & GRAY WINDOW PAINT ARE PEELING & FADING
RECOMMENDATION:
SURFACE PREPARATION FOR MPI DSD 2
REMOVE & REPLACE DETERIORATED PERIMETER SEALANT

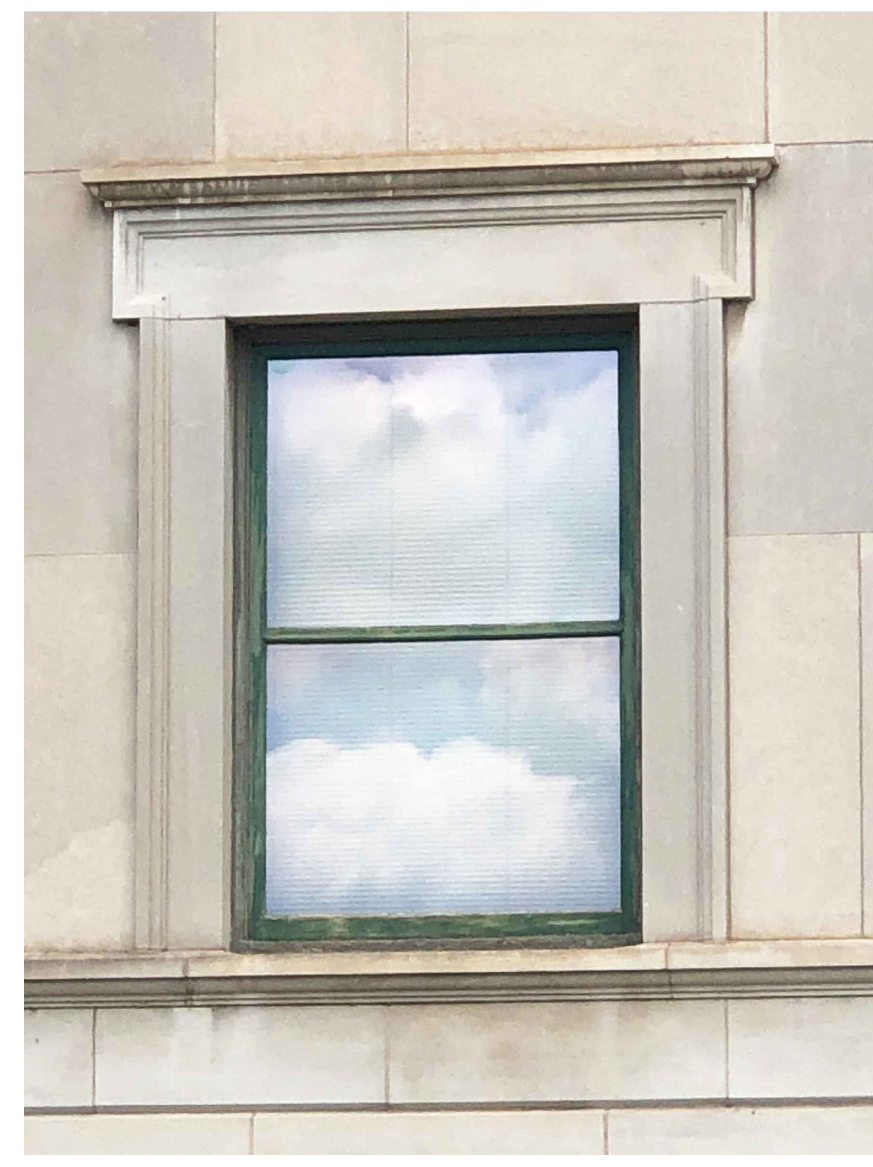
2
OBSERVATION:
BOTH GREEN & GRAY WINDOW PAINT ARE PEELING & FADING
RECOMMENDATION:
SURFACE PREPARATION FOR MPI DSD 2
REMOVE & REPLACE DETERIORATED PERIMETER SEALANT

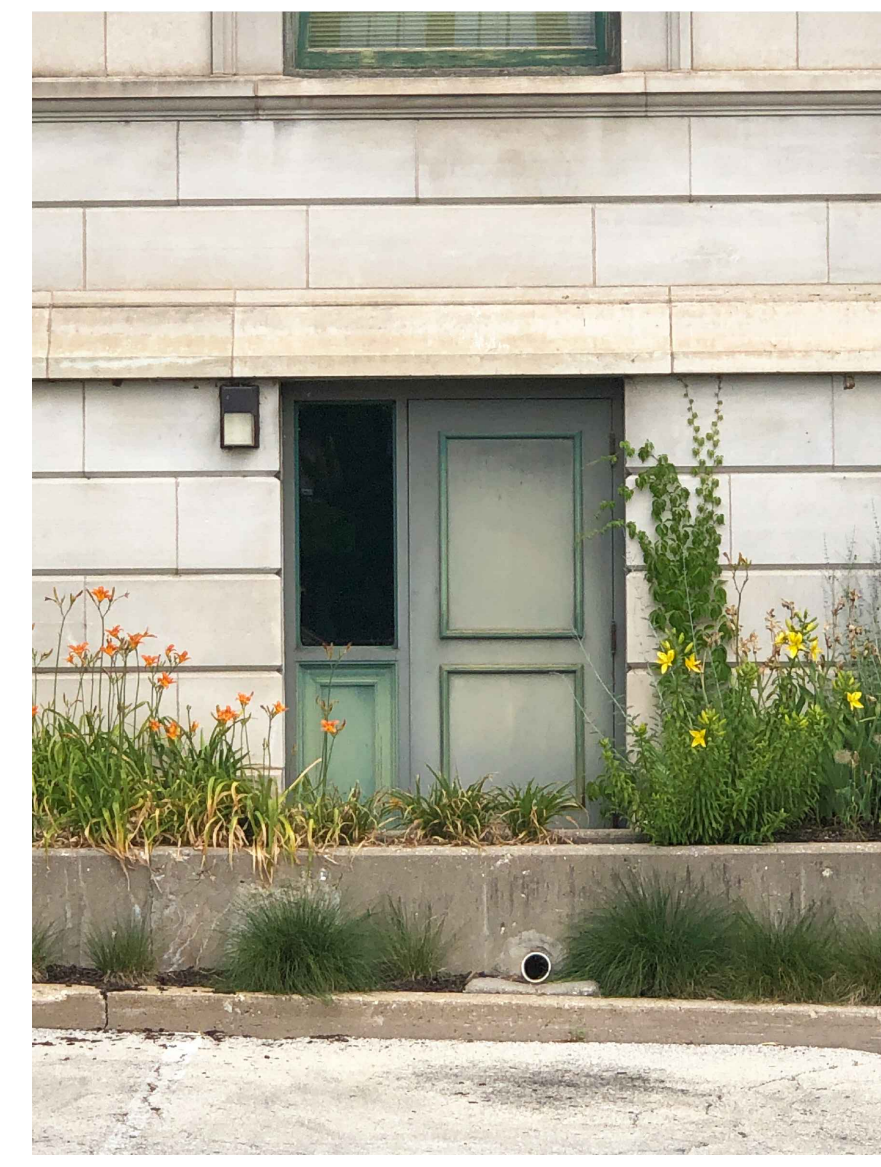
3
DOOR, FRAME & SIDELITE TO BE
REPAIRED AND FINISHED BY
OWNER
(NOT IN CONTRACT)

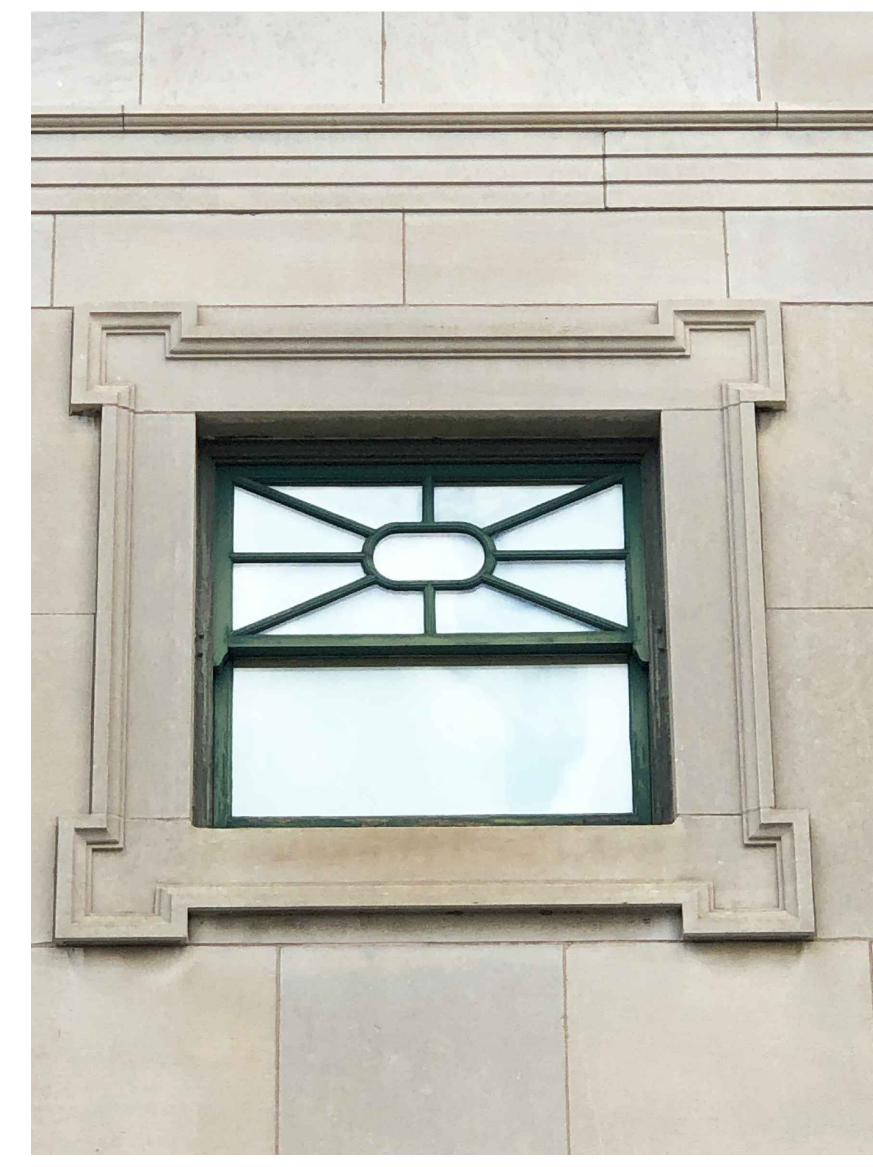
4
OBSERVATION:
BOTH GREEN & GRAY WINDOW PAINT ARE PEELING & FADING
RECOMMENDATION:
SURFACE PREPARATION FOR MPI DSD 2
REMOVE & REPLACE DETERIORATED PERIMETER SEALANT

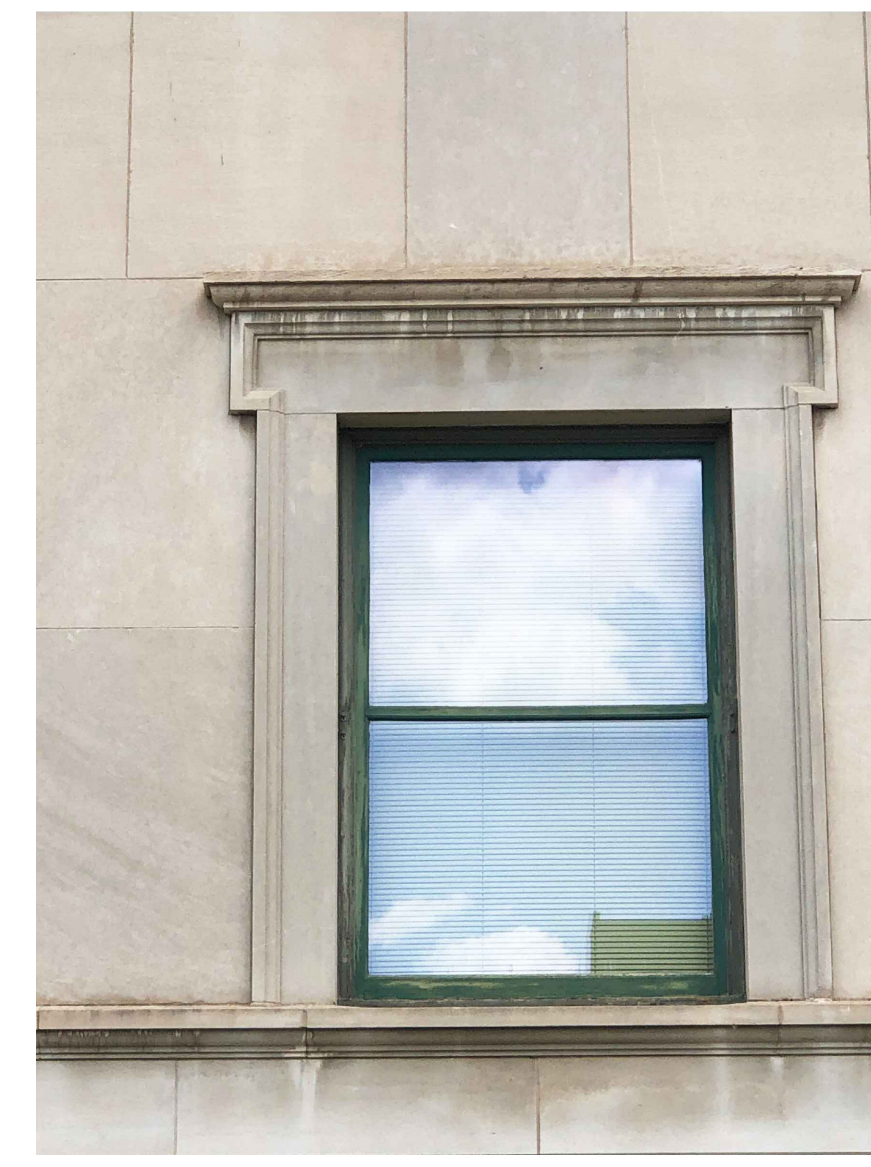
5
OBSERVATION:
BOTH GREEN & GRAY WINDOW PAINT ARE PEELING & FADING
RECOMMENDATION:
SURFACE PREPARATION FOR MPI DSD 2
REMOVE & REPLACE DETERIORATED PERIMETER SEALANT

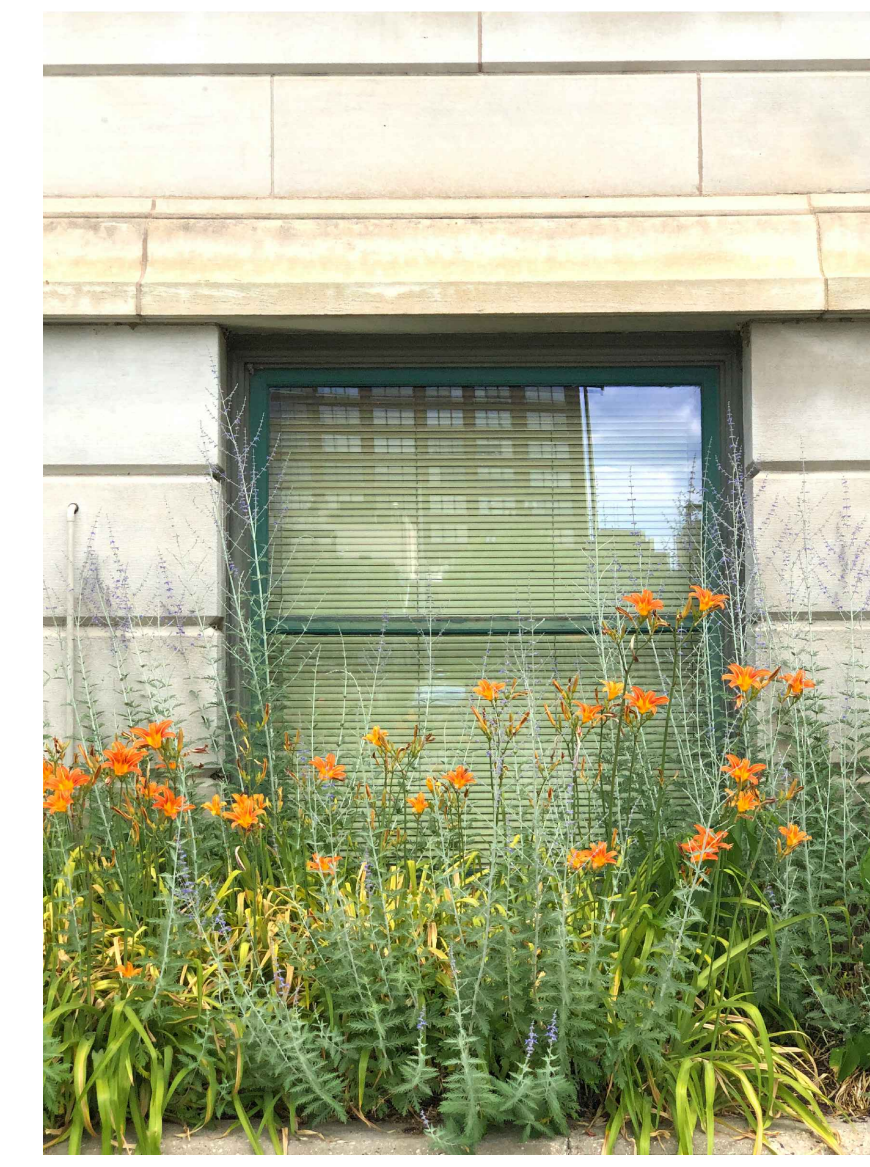
6
OBSERVATION:
BOTH GREEN & GRAY WINDOW PAINT ARE PEELING & FADING
RECOMMENDATION:
SURFACE PREPARATION FOR MPI DSD 3
REMOVE & REPLACE DETERIORATED PERIMETER SEALANT

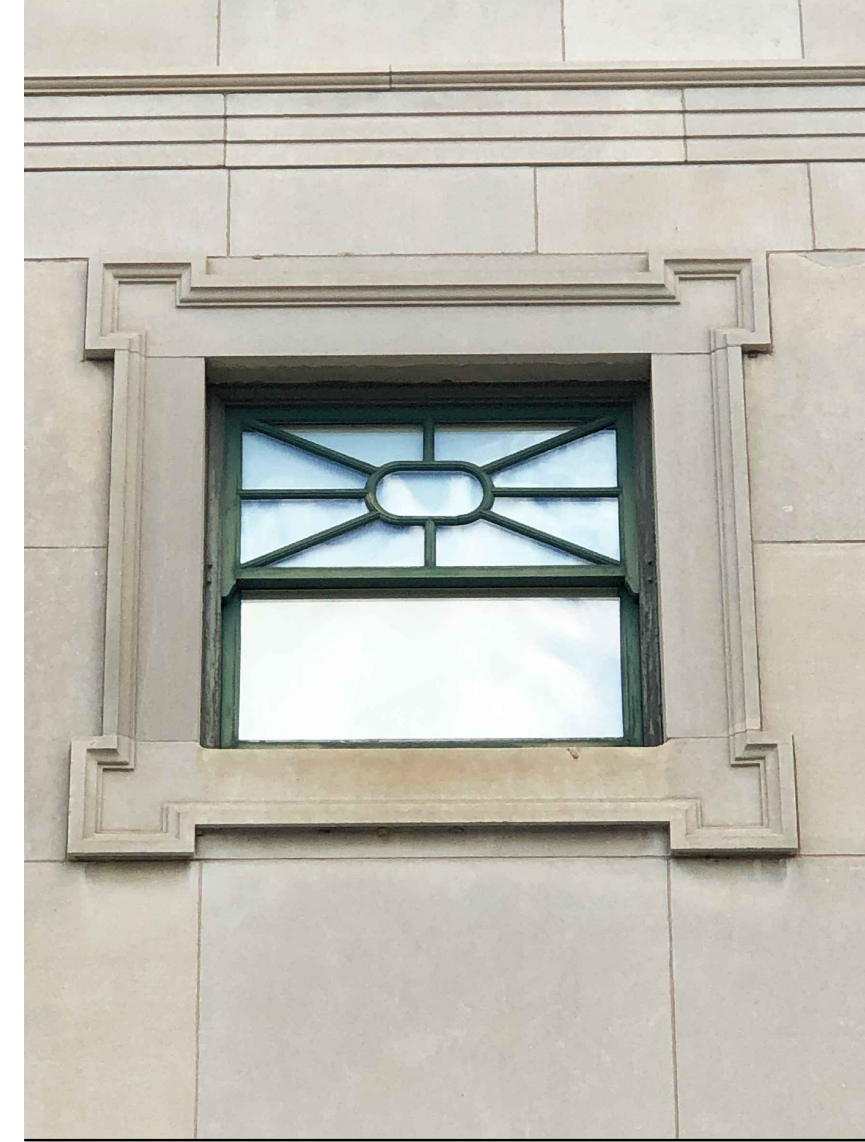
7
OBSERVATION:
BOTH GREEN & GRAY WINDOW PAINT ARE PEELING & FADING
RECOMMENDATION:
SURFACE PREPARATION FOR MPI DSD 2
REMOVE & REPLACE DETERIORATED PERIMETER SEALANT

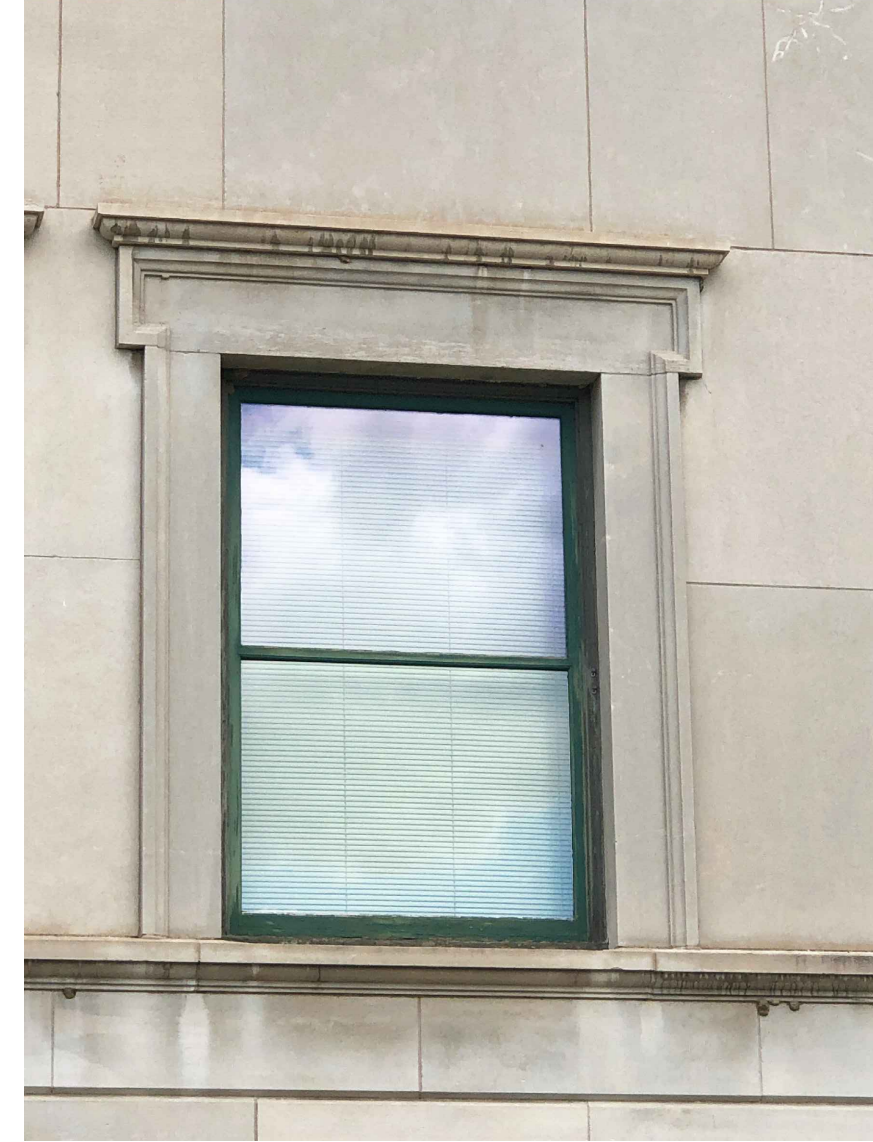
8
OBSERVATION:
BOTH GREEN & GRAY WINDOW PAINT ARE PEELING & FADING
RECOMMENDATION:
SURFACE PREPARATION FOR MPI DSD 2
REMOVE & REPLACE DETERIORATED PERIMETER SEALANT

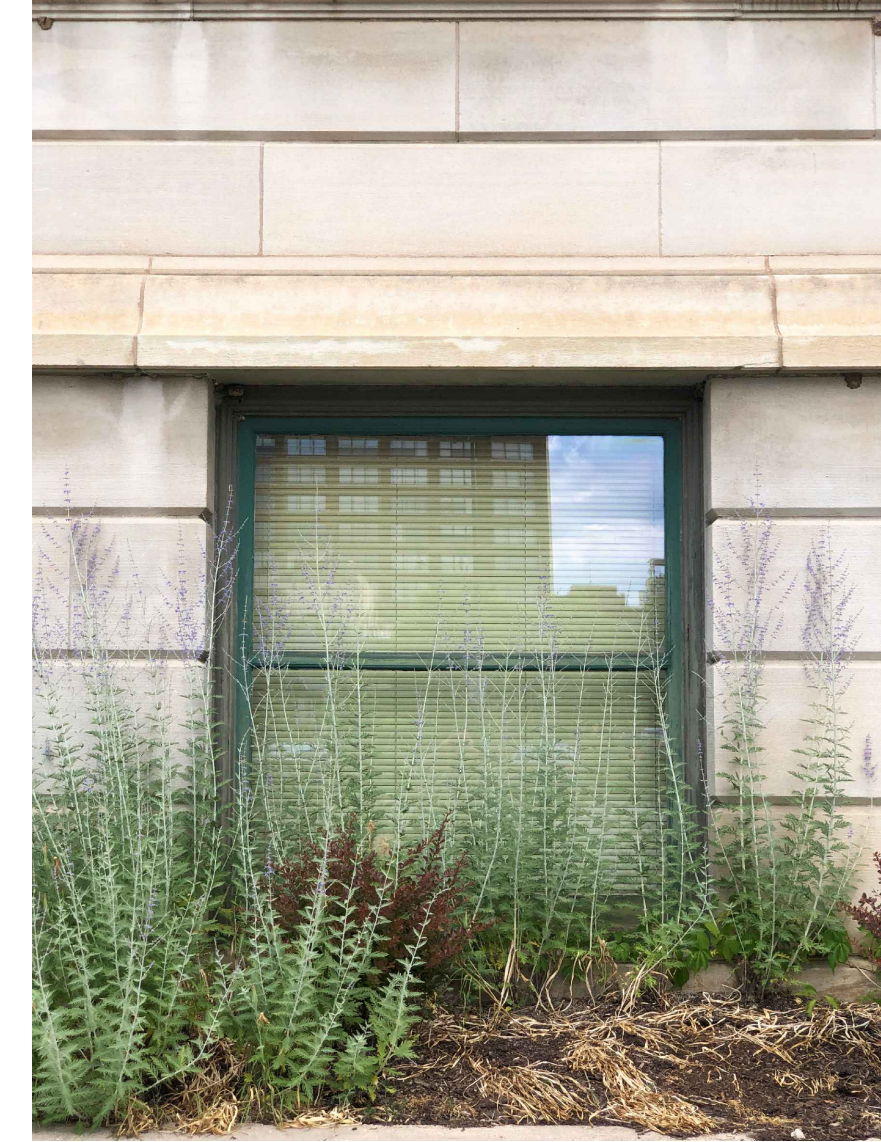
9
OBSERVATION:
BOTH GREEN & GRAY WINDOW PAINT ARE PEELING & FADING
RECOMMENDATION:
SURFACE PREPARATION FOR MPI DSD 3
REMOVE & REPLACE DETERIORATED PERIMETER SEALANT

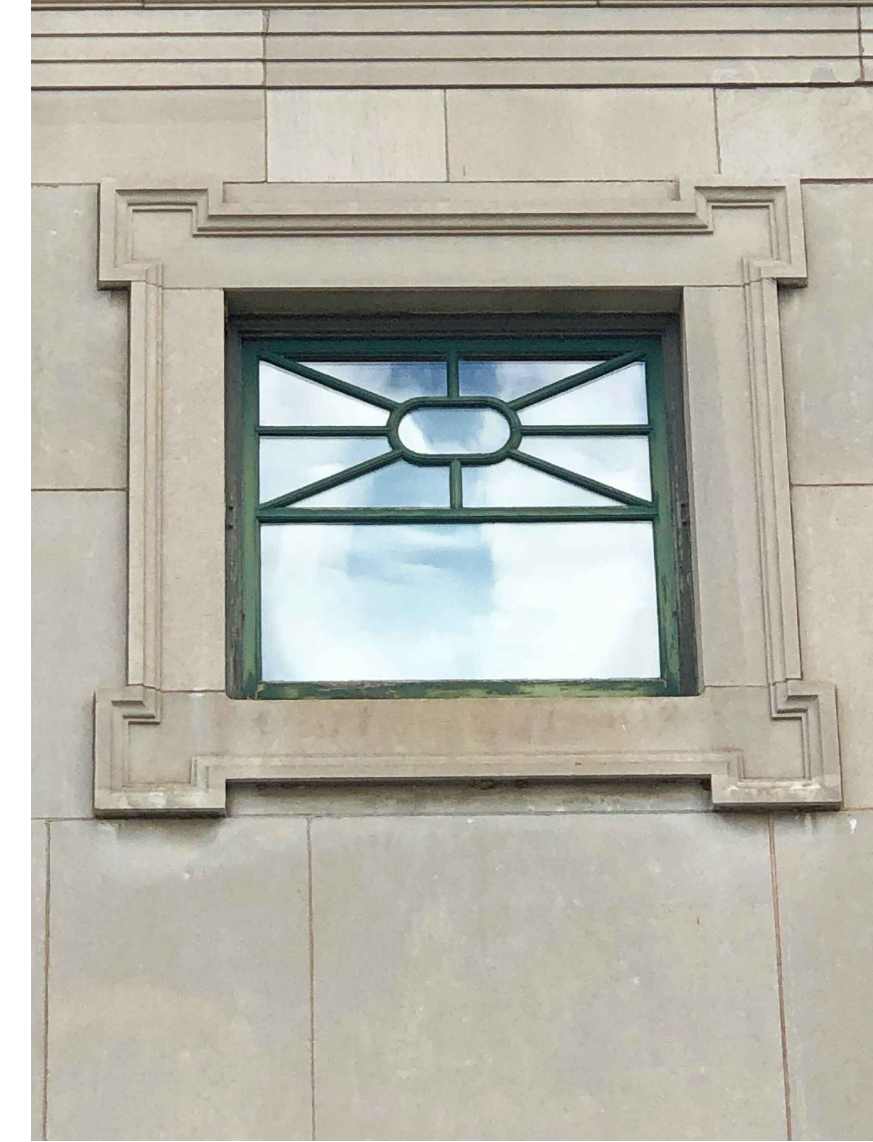
10
OBSERVATION:
BOTH GREEN & GRAY WINDOW PAINT ARE PEELING & FADING
RECOMMENDATION:
SURFACE PREPARATION FOR MPI DSD 2
REMOVE & REPLACE DETERIORATED PERIMETER SEALANT

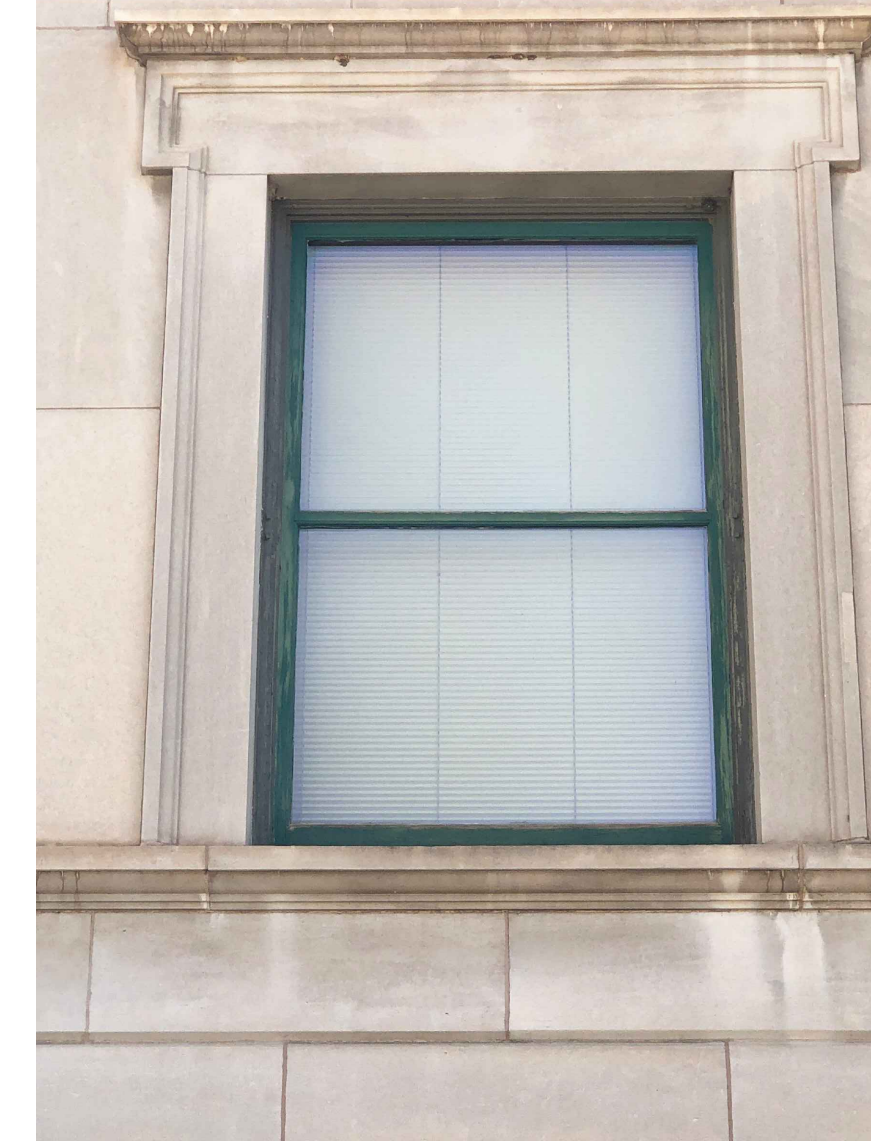
11
OBSERVATION:
BOTH GREEN & GRAY WINDOW PAINT ARE PEELING & FADING
RECOMMENDATION:
SURFACE PREPARATION FOR MPI DSD 2
REMOVE & REPLACE DETERIORATED PERIMETER SEALANT

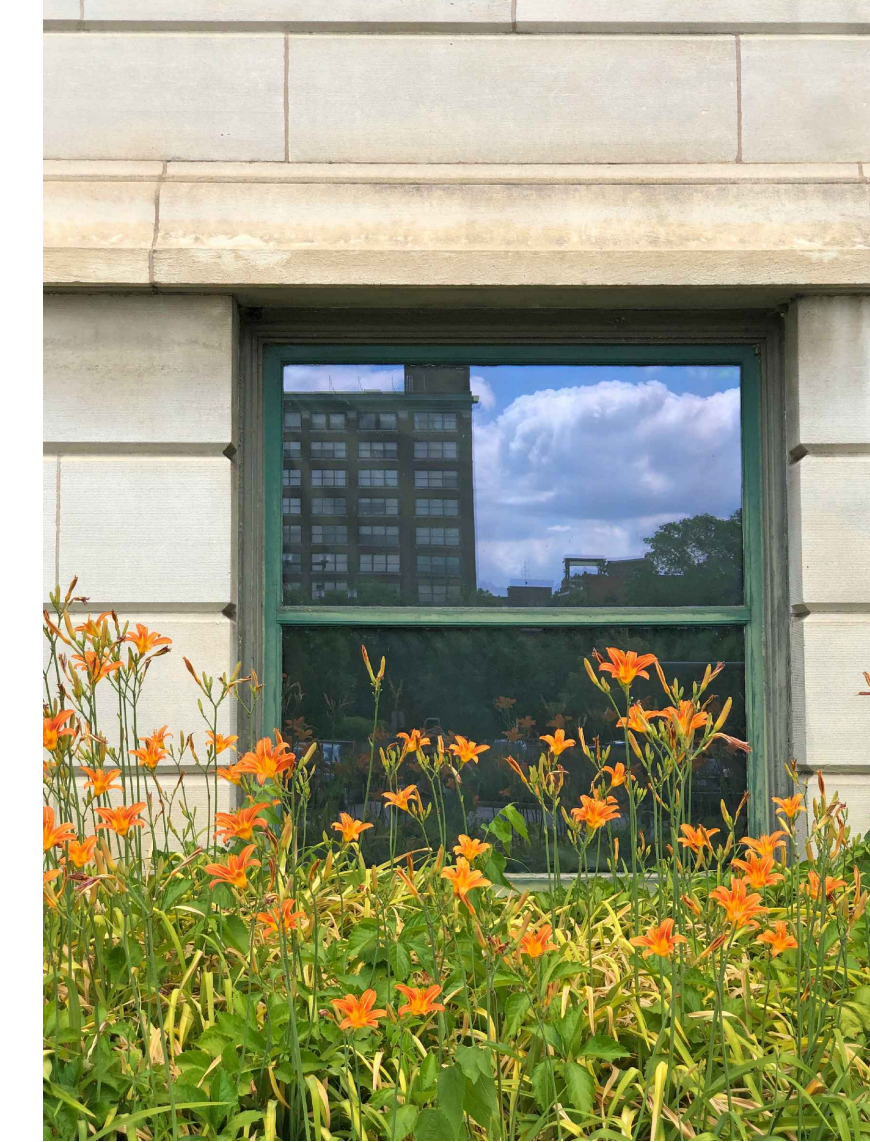
12
OBSERVATION:
BOTH GREEN & GRAY WINDOW PAINT ARE PEELING & FADING
RECOMMENDATION:
SURFACE PREPARATION FOR MPI DSD 3
REMOVE & REPLACE DETERIORATED PERIMETER SEALANT

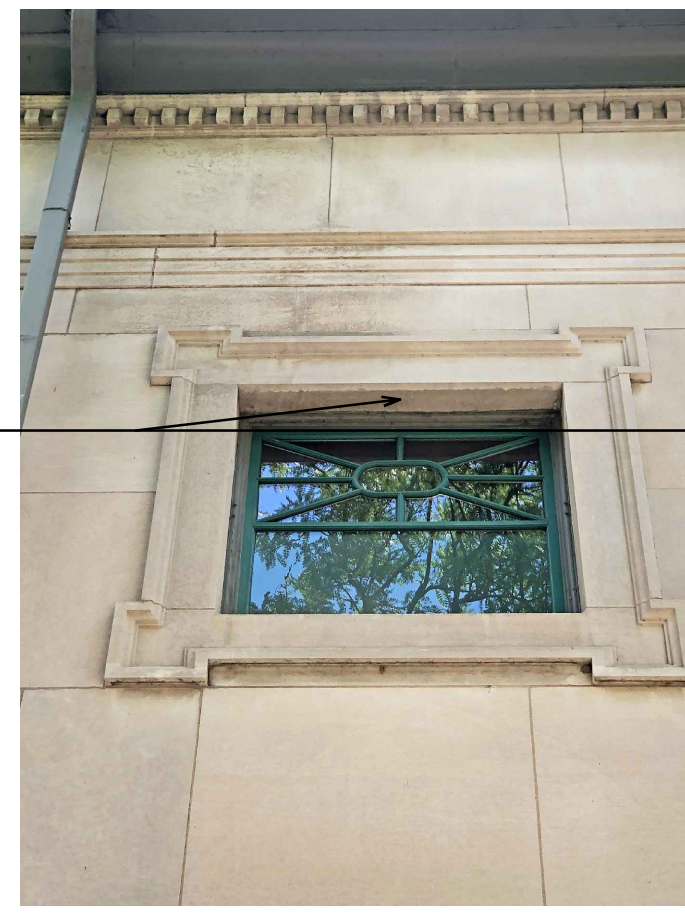
13
OBSERVATION:
BOTH GREEN & GRAY WINDOW PAINT ARE PEELING & FADING

RECOMMENDATION:
SURFACE PREPARATION FOR MPI DSD 2
REMOVE & REPLACE DETERIORATED PERIMETER SEALANT

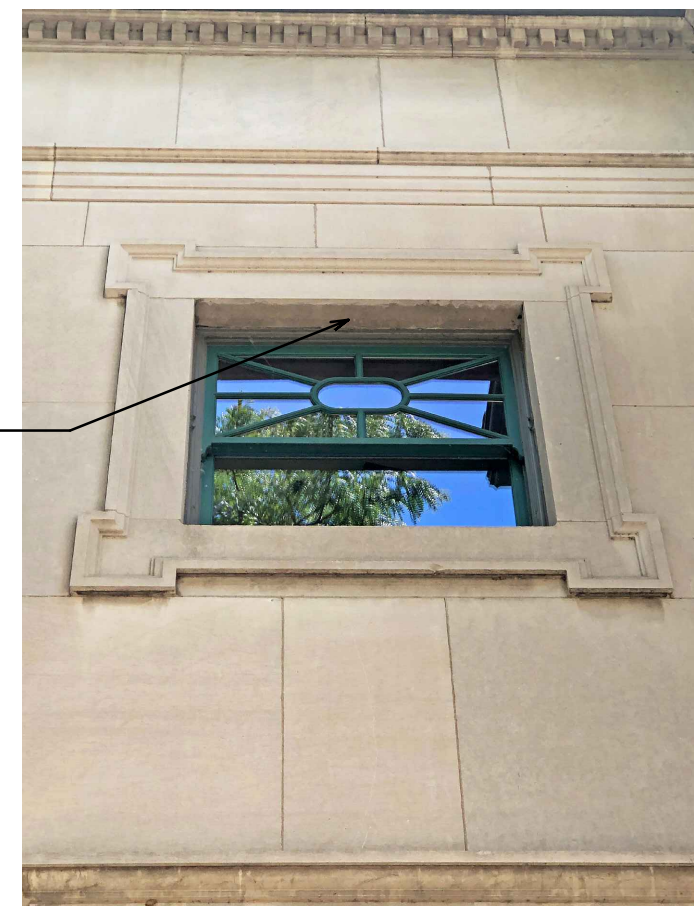
16
OBSERVATION:
BOTH GREEN & GRAY WINDOW PAINT ARE PEELING & FADING

RECOMMENDATION:
SURFACE PREPARATION FOR MPI DSD 2
REMOVE & REPLACE DETERIORATED PERIMETER SEALANT

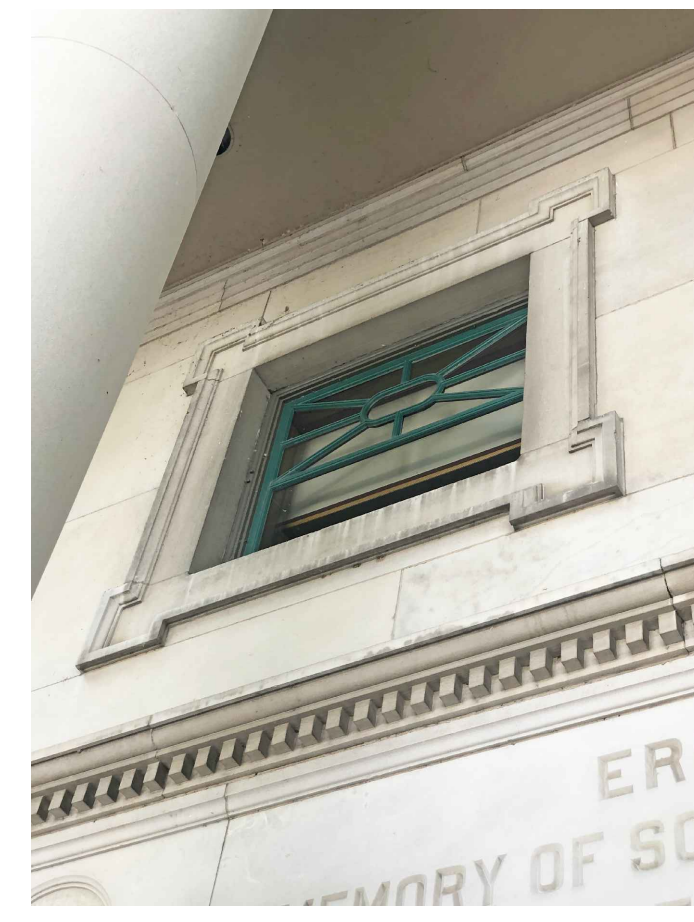
19
OBSERVATION:
BOTH GREEN & GRAY WINDOW PAINT ARE PEELING & FADING

RECOMMENDATION:
SURFACE PREPARATION FOR MPI DSD 2
REMOVE & REPLACE DETERIORATED PERIMETER SEALANT

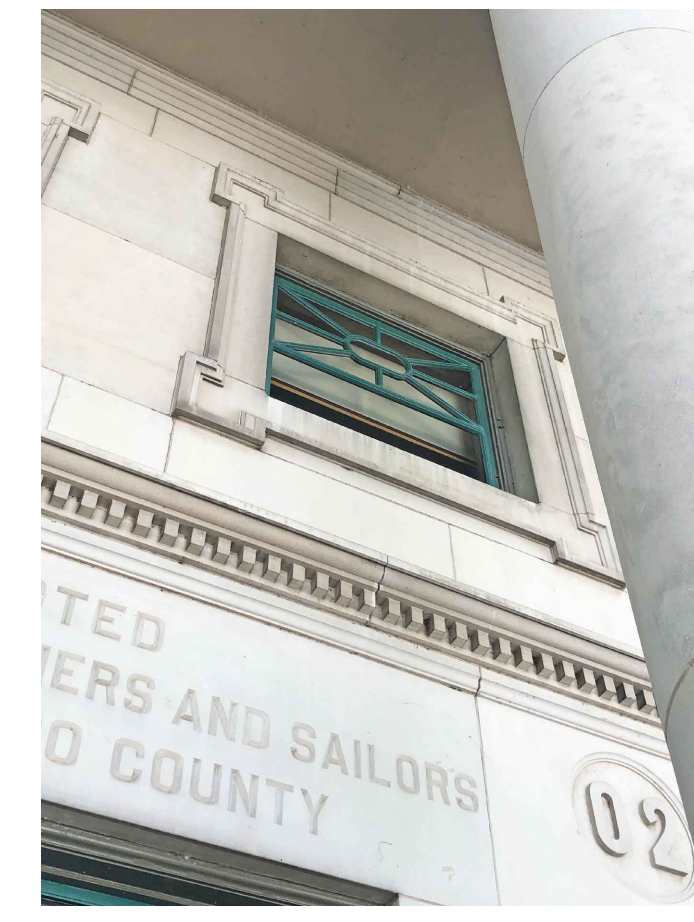
21
OBSERVATION:
BOTH GREEN & GRAY WINDOW PAINT ARE PEELING & FADING

RECOMMENDATION:
SURFACE PREPARATION FOR MPI DSD 2
REMOVE & REPLACE DETERIORATED PERIMETER SEALANT

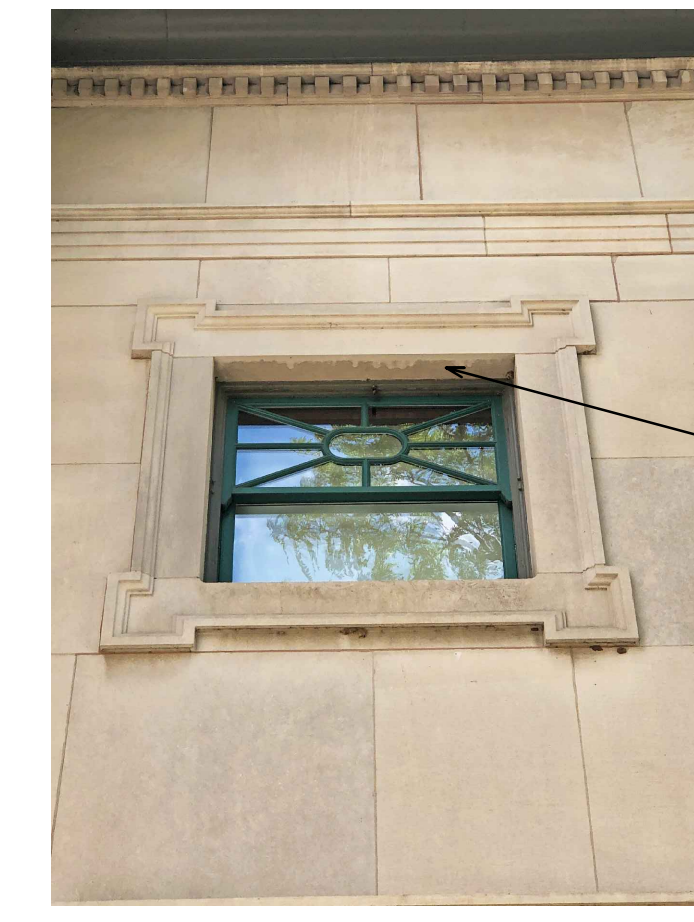
23
OBSERVATION:
BOTH GREEN & GRAY WINDOW PAINT ARE PEELING & FADING

RECOMMENDATION:
SURFACE PREPARATION FOR MPI DSD 2
REMOVE & REPLACE DETERIORATED PERIMETER SEALANT

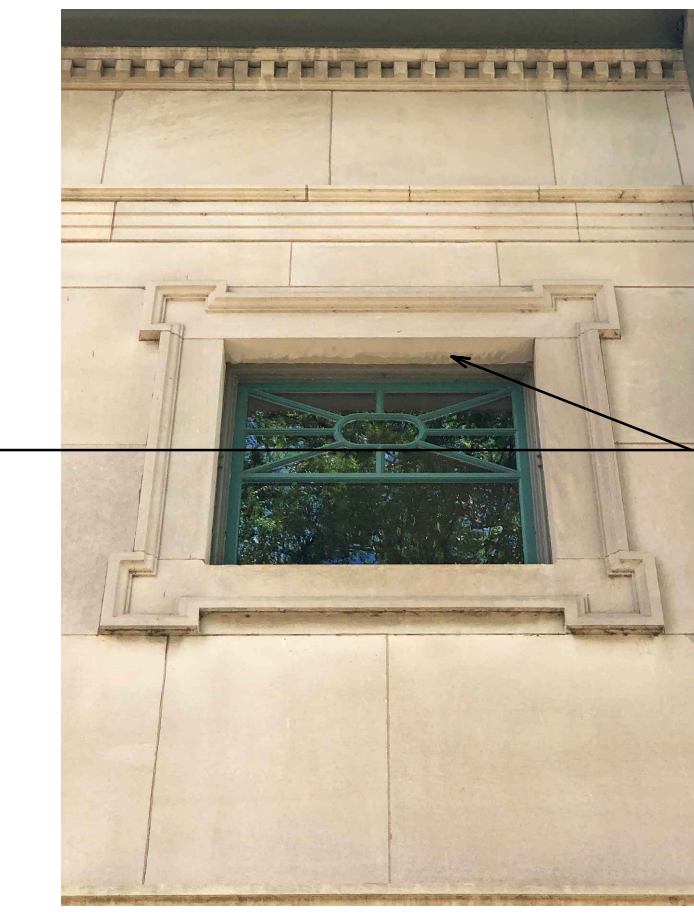
26
OBSERVATION:
BOTH GREEN & GRAY WINDOW PAINT ARE PEELING & FADING

RECOMMENDATION:
SURFACE PREPARATION FOR MPI DSD 2
REMOVE & REPLACE DETERIORATED PERIMETER SEALANT

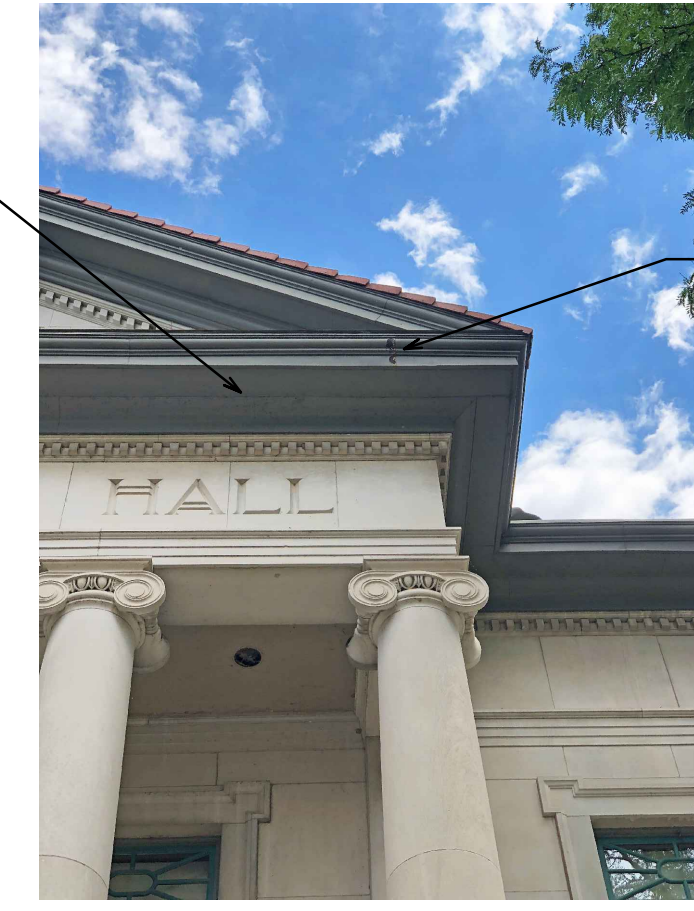
OBSERVATION:
RUST STAIN AND PEELING PAINT

RECOMMENDATION:
SURFACE PREPARATION FOR MPI DSD 3

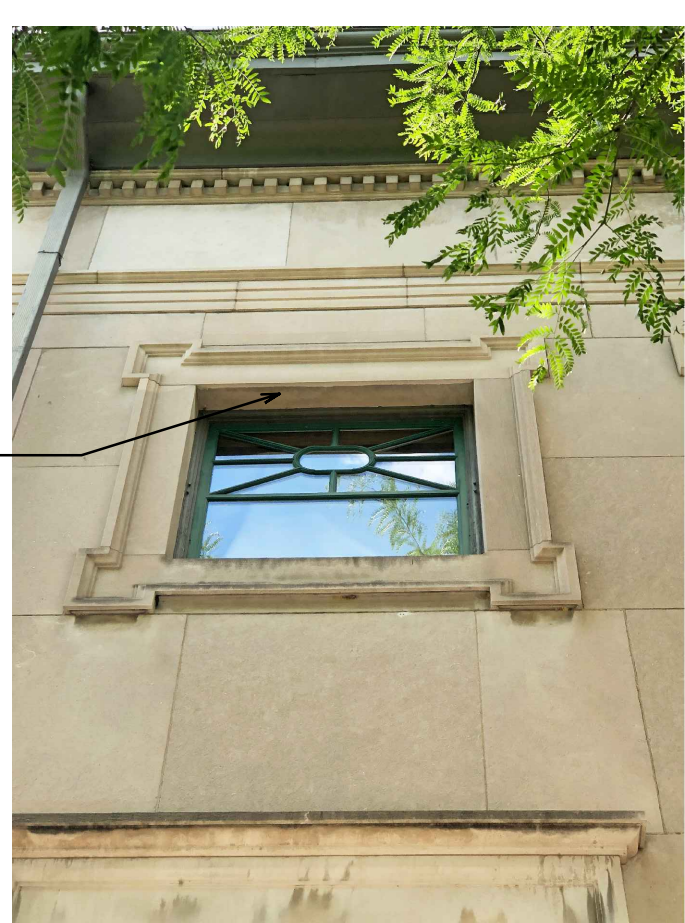
43 OBSERVATION: GREEN WINDOW PAINT IS OK GRAY WINDOW PAINT IS PEELING
RECOMMENDATION: SURFACE PREPARATION FOR MPI DSD 3 REMOVE & REPLACE DETERIORATED PERIMETER SEALANT

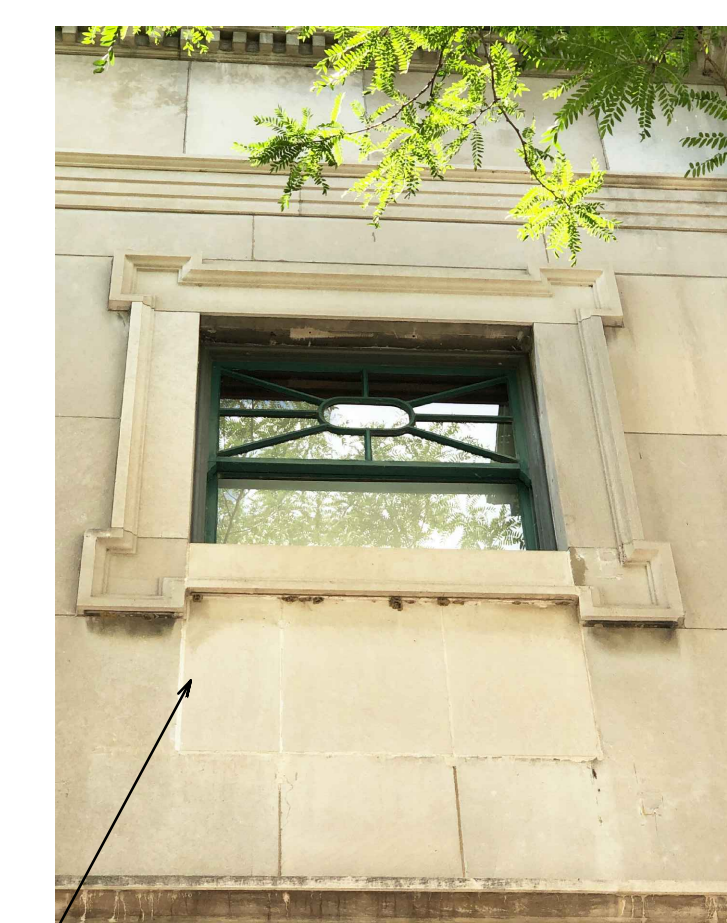
46 OBSERVATION: GREEN WINDOW PAINT IS OK GRAY WINDOW PAINT IS PEELING
RECOMMENDATION: SURFACE PREPARATION FOR MPI DSD 3 REMOVE & REPLACE DETERIORATED PERIMETER SEALANT

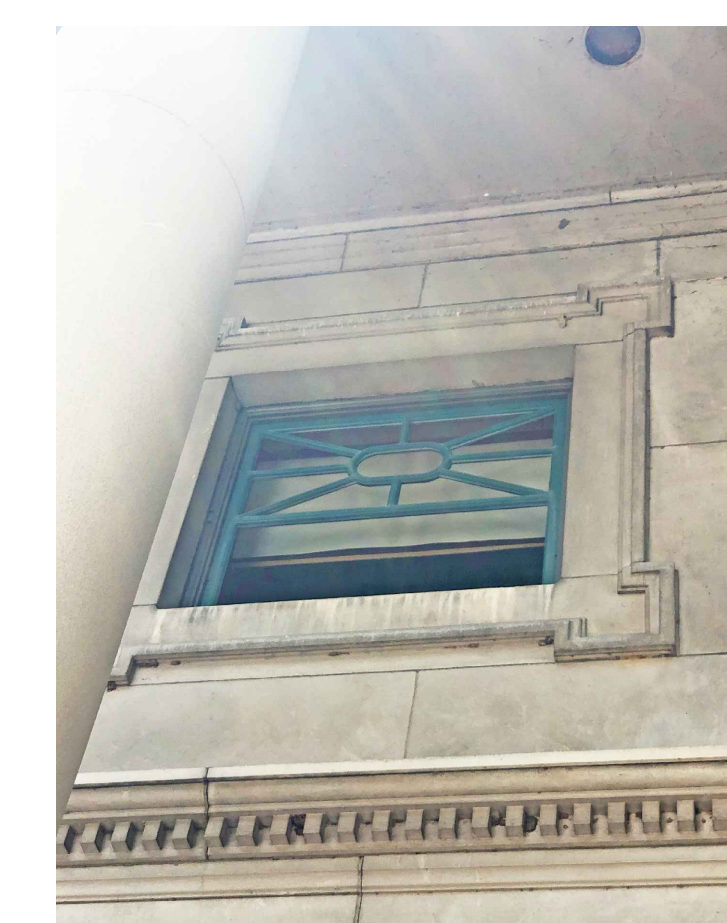
49 OBSERVATION: BOTH GREEN & GRAY WINDOW PAINT ARE PEELING & FADING. SOME WOOD DAMAGE OBSERVED.
RECOMMENDATION: SURFACE PREPARATION FOR MPI DSD 4 REMOVE & REPLACE DETERIORATED PERIMETER SEALANT

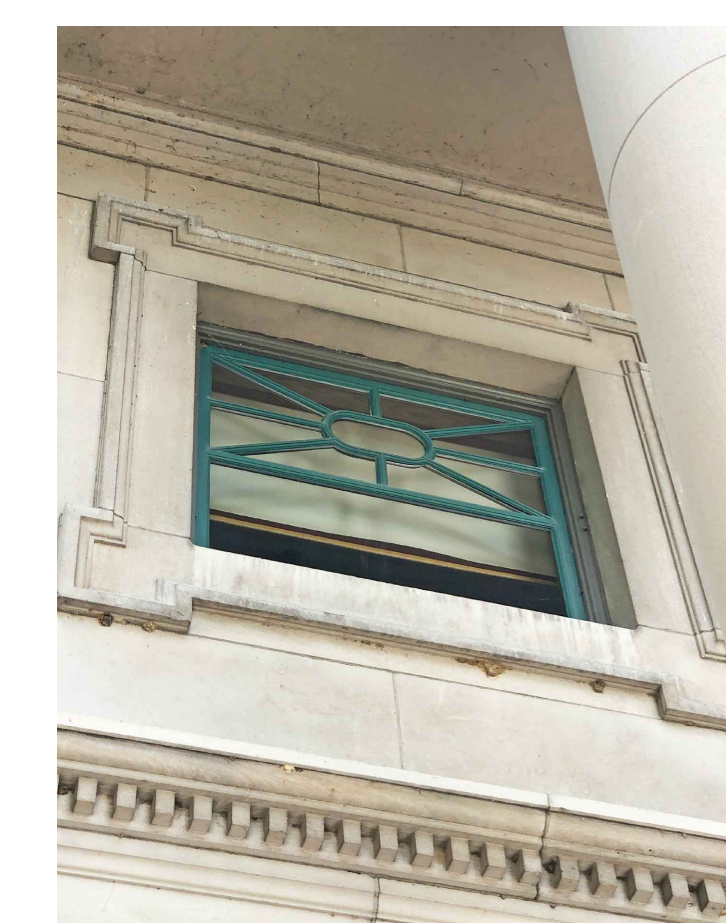
51 OBSERVATION: BOTH GREEN & GRAY WINDOW PAINT ARE PEELING & FADING
RECOMMENDATION: SURFACE PREPARATION FOR MPI DSD 2 REMOVE & REPLACE DETERIORATED PERIMETER SEALANT

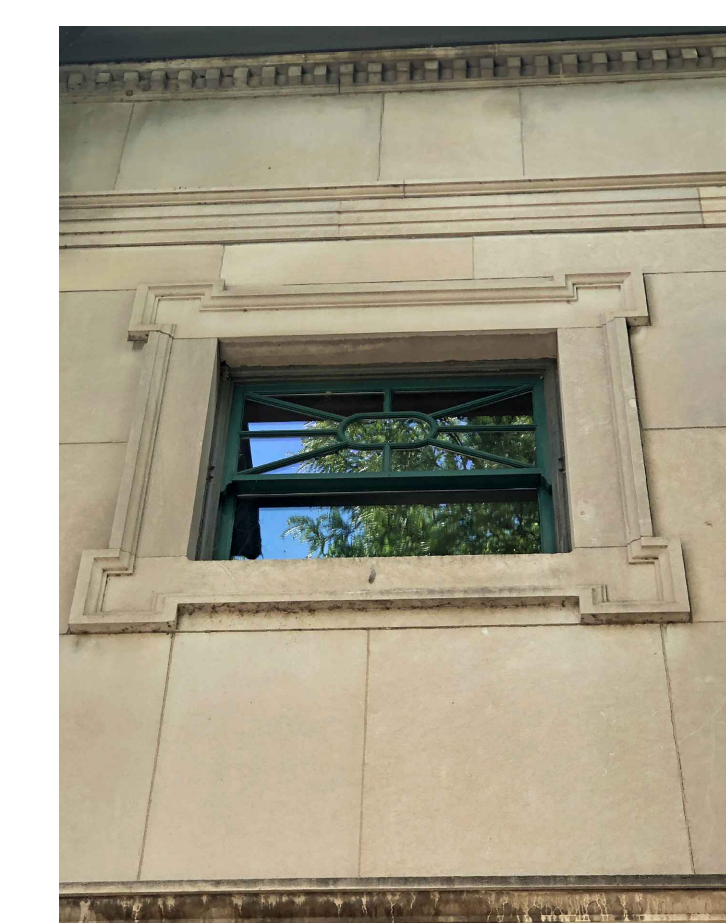
53 OBSERVATION: GREEN WINDOW PAINT IS OK GRAY WINDOW PAINT IS PEELING
RECOMMENDATION: SURFACE PREPARATION FOR MPI DSD 3 REMOVE & REPLACE DETERIORATED PERIMETER SEALANT

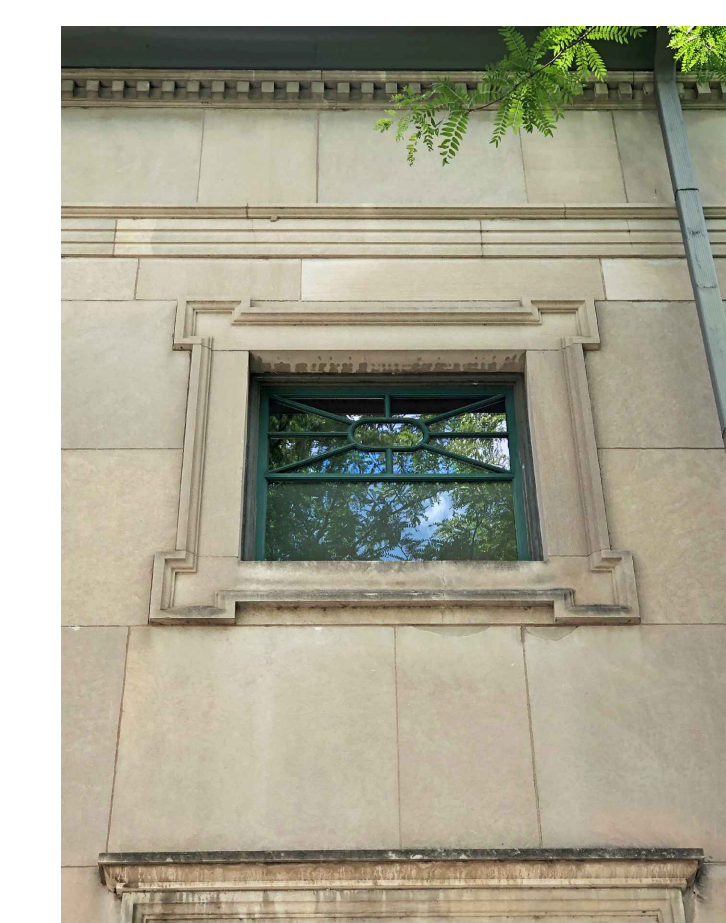
56 OBSERVATION: GREEN WINDOW PAINT IS OK GRAY WINDOW PAINT IS PEELING
RECOMMENDATION: SURFACE PREPARATION FOR MPI DSD 3 REMOVE & REPLACE DETERIORATED PERIMETER SEALANT

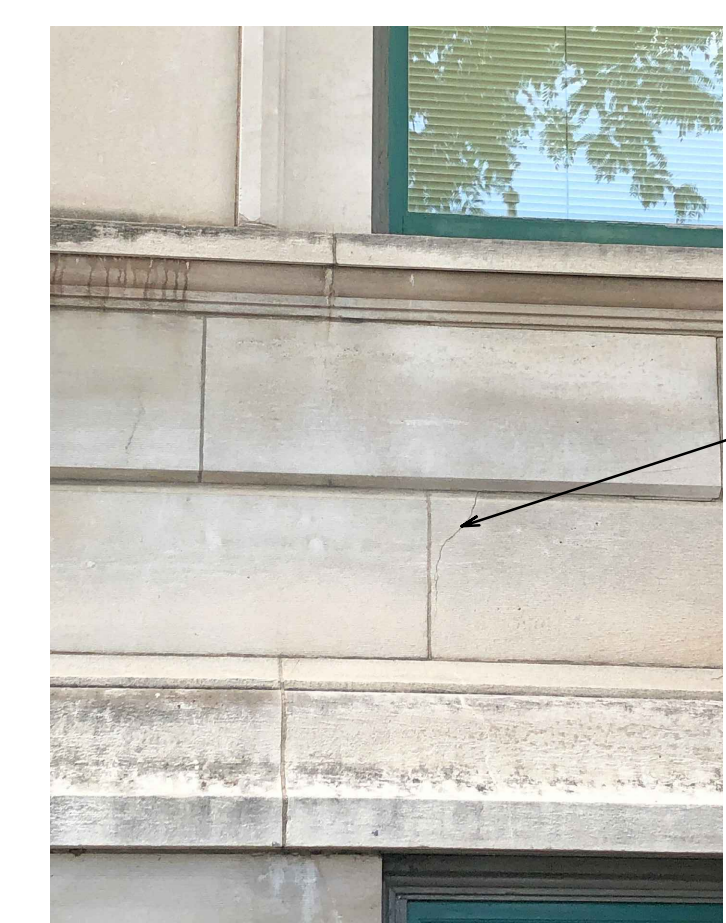
OBSERVATION: STONE UNIT IS CRACKED WITH NO APPARENT DISPLACEMENT.
RECOMMENDATION: DETERMINE IF STONE IS LOOSE. IF CRACKED PIECE IS LOOSE, REPAIR BY SURFACE PATCHING. IF CRACKED PORTION IS SOUND, REPAIR CRACK.

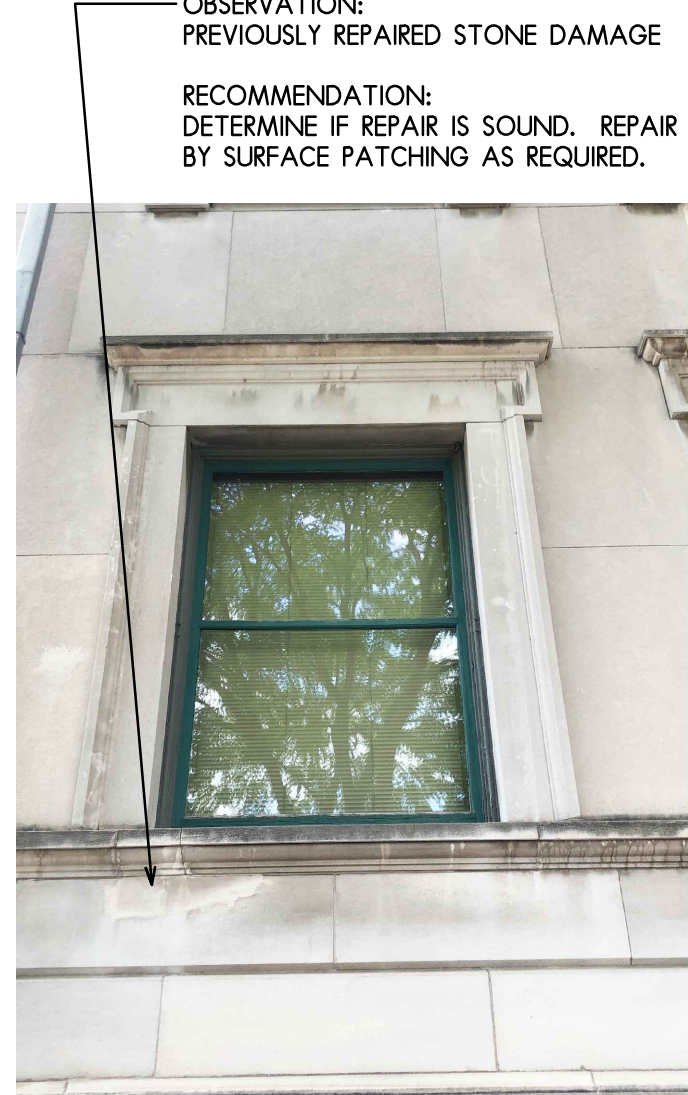
OBSERVATION: PREVIOUSLY REPAIRED STONE DAMAGE
RECOMMENDATION: DETERMINE IF REPAIR IS SOUND. REPAIR BY SURFACE PATCHING AS REQUIRED.
