EXTERIOR MAINTENANCE REPAIR WORK FOR: VETERANS MEMORIAL HALL

WINNEBAGO COUNTY

BID # 21B-2226

ISSUED FOR: BIDDING

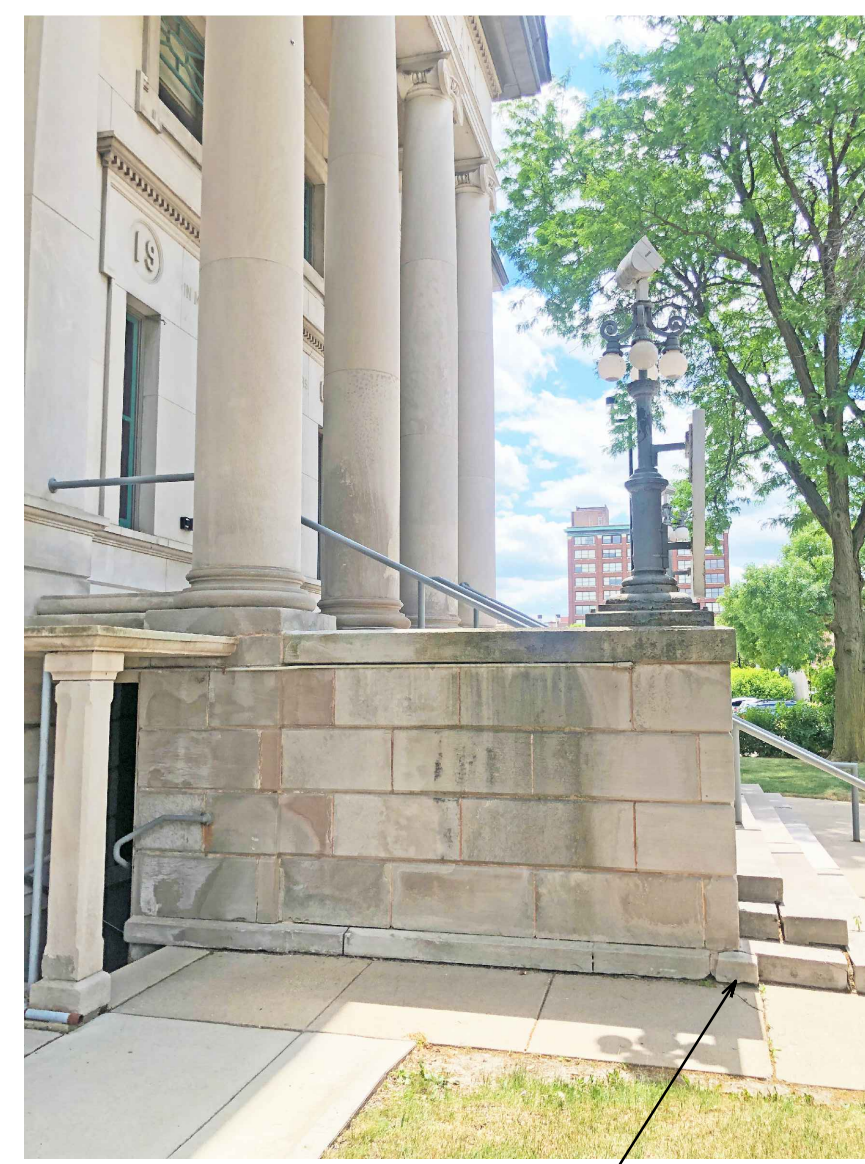
1
OBSERVATION:
STONE CORNER IS SEVERELY DAMAGED AND DISPLACED
RECOMMENDATION:
SEE STAIR WORK NOTES THIS SHEET

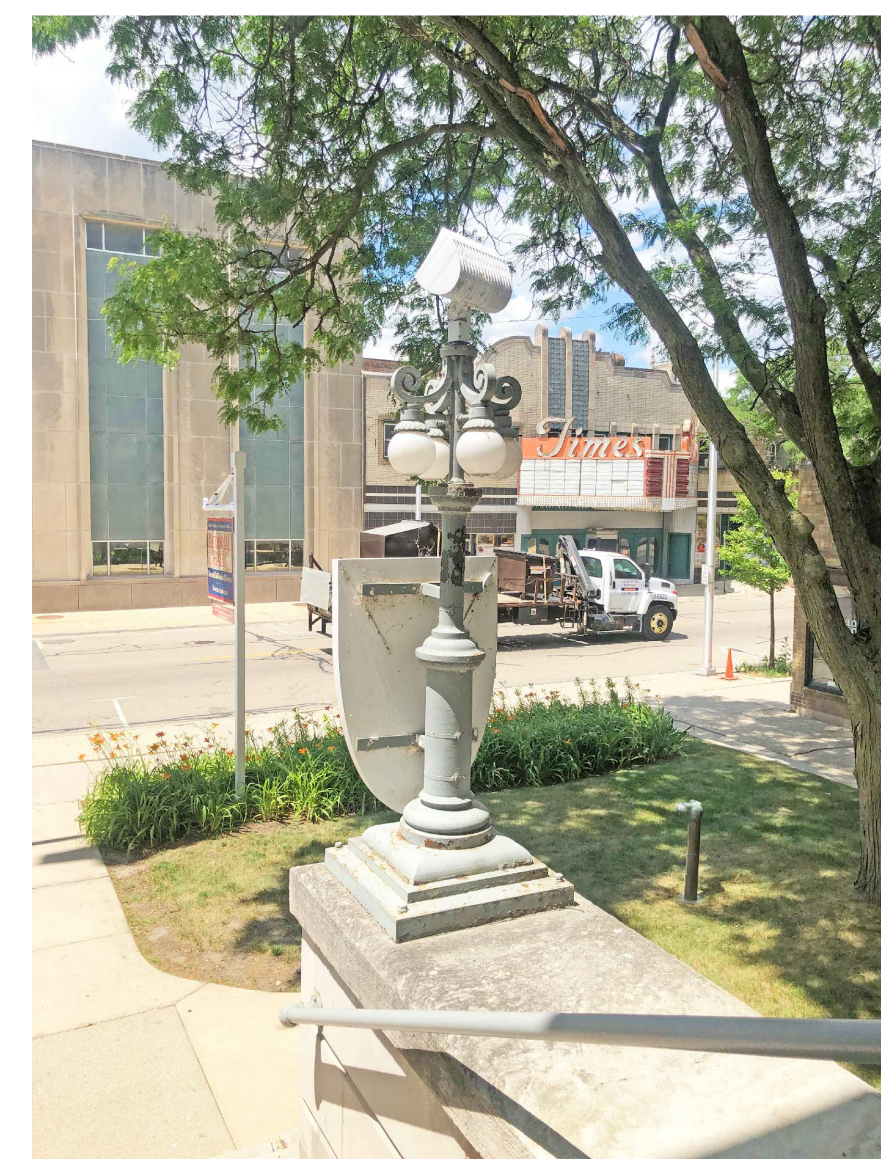
3
OBSERVATION:
EXTERIOR STAIR LIGHT POSTS ARE SEVERELY RUSTED
AND THE PAINT IS PEELING
RECOMMENDATION:
SURFACE PREPARATION FOR MPI DSD 3

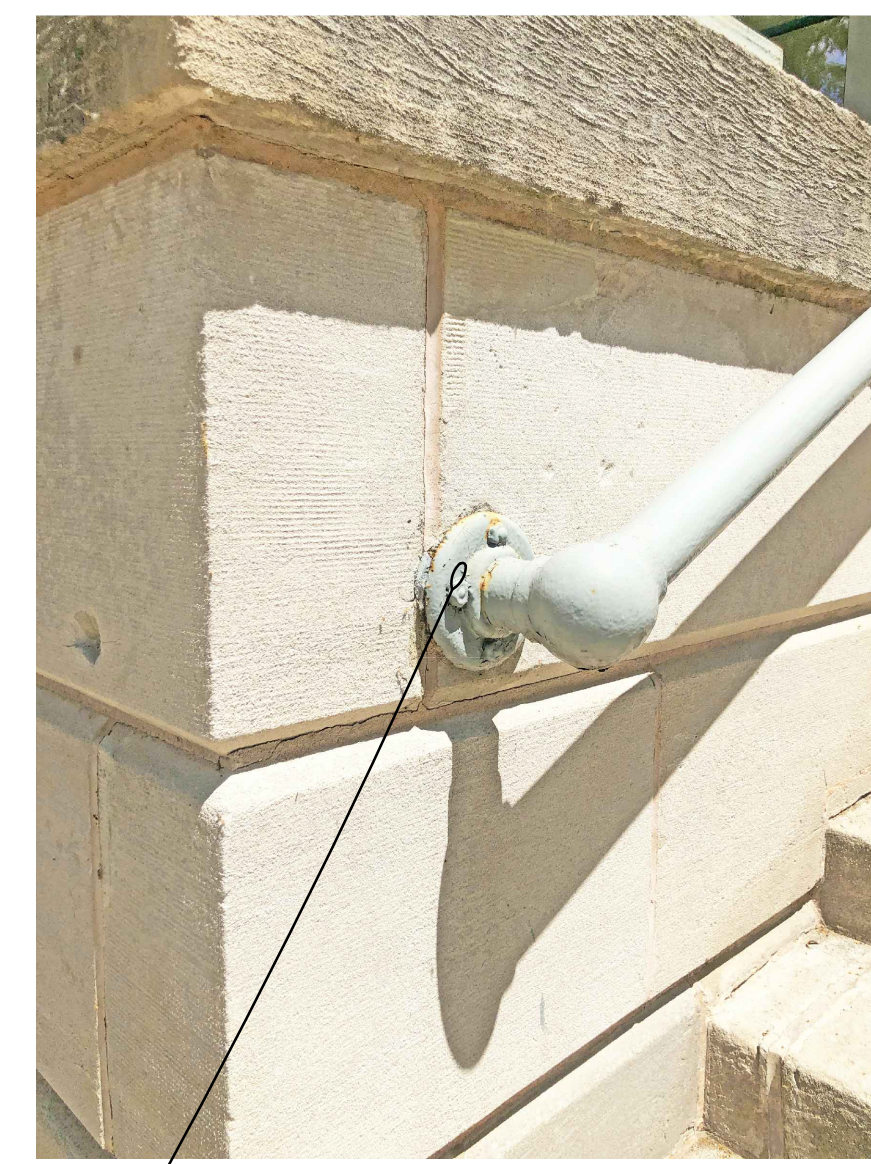
5
OBSERVATION:
EXTERIOR STAIR HANDRAIL IS SEVERELY RUSTED AND
THE PAINT IS PEELING
RECOMMENDATION:
SCRAPE AND REMOVE ALL LOOSE PAINT AND RUST,
TREAT SOLID RUST, SAND OTHER SURFACES TO
BLEND SURFACE FINISHES, CLEAN PRIME AND APPLY
MIN 2 COATS FINISH PAINT.

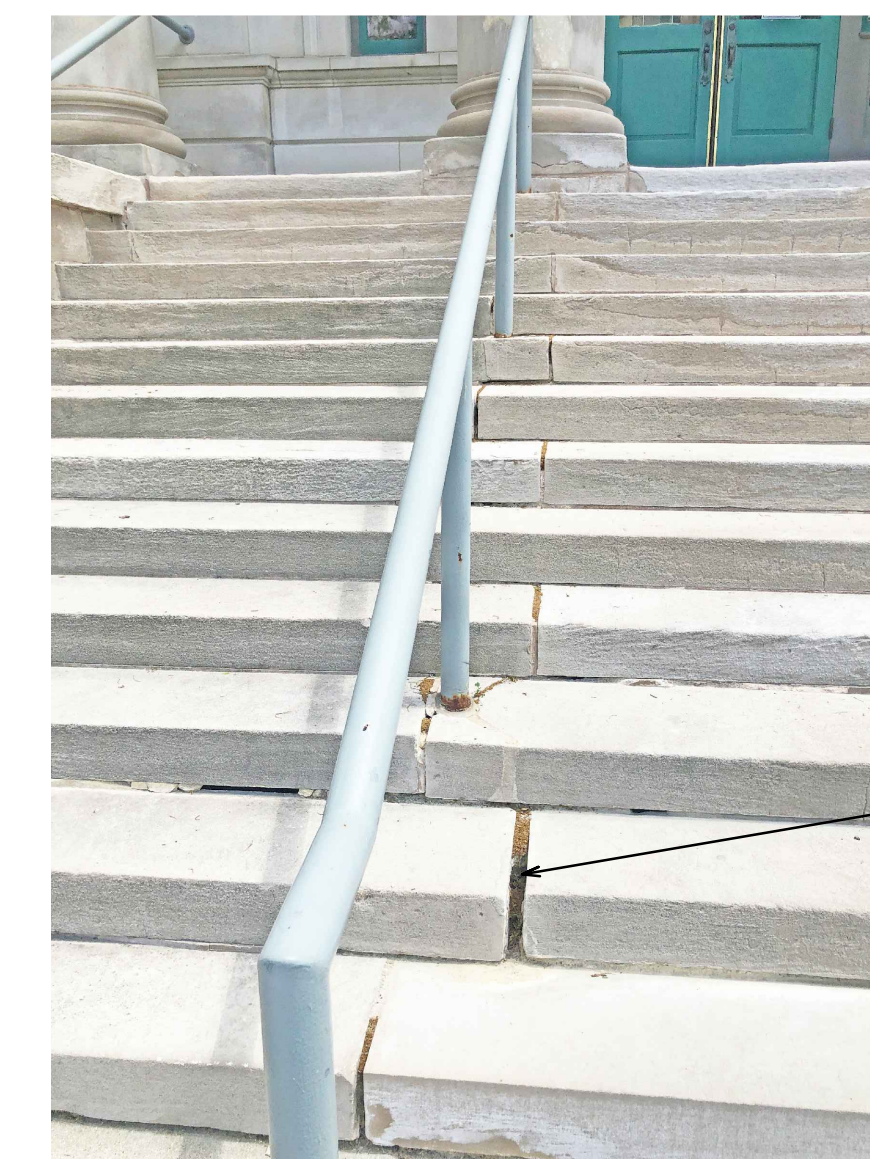
6
OBSERVATION:
EXTERIOR STAIR HANDRAIL IS SEVERELY RUSTED AND
THE PAINT IS PEELING
RECOMMENDATION:
SCRAPE AND REMOVE ALL LOOSE PAINT AND RUST,
TREAT SOLID RUST, SAND OTHER SURFACES TO
BLEND SURFACE FINISHES, CLEAN PRIME AND APPLY
MIN 2 COATS FINISH PAINT.

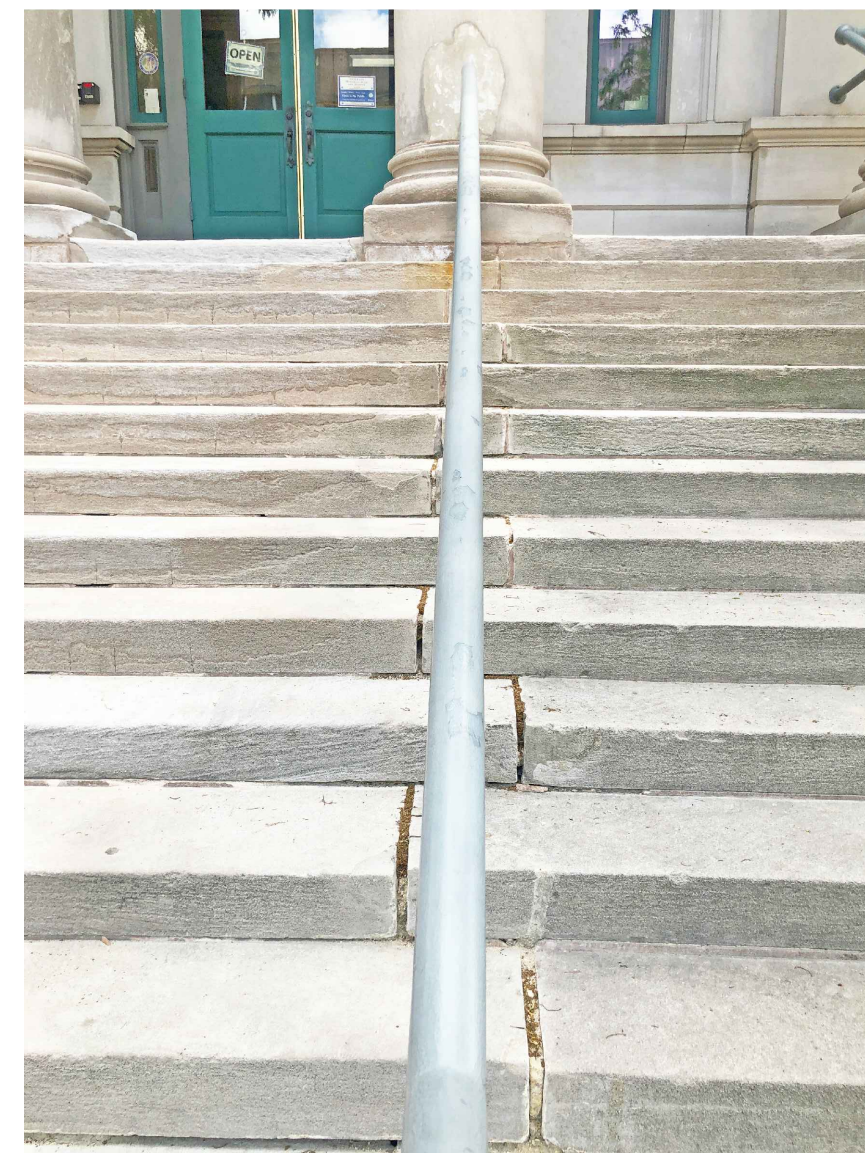
7
OBSERVATION:
EXTERIOR STAIR HANDRAIL IS SEVERELY RUSTED AND
THE PAINT IS PEELING
RECOMMENDATION:
SCRAPE AND REMOVE ALL LOOSE PAINT AND RUST,
TREAT SOLID RUST, SAND OTHER SURFACES TO
BLEND SURFACE FINISHES, CLEAN PRIME AND APPLY
MIN 2 COATS FINISH PAINT.

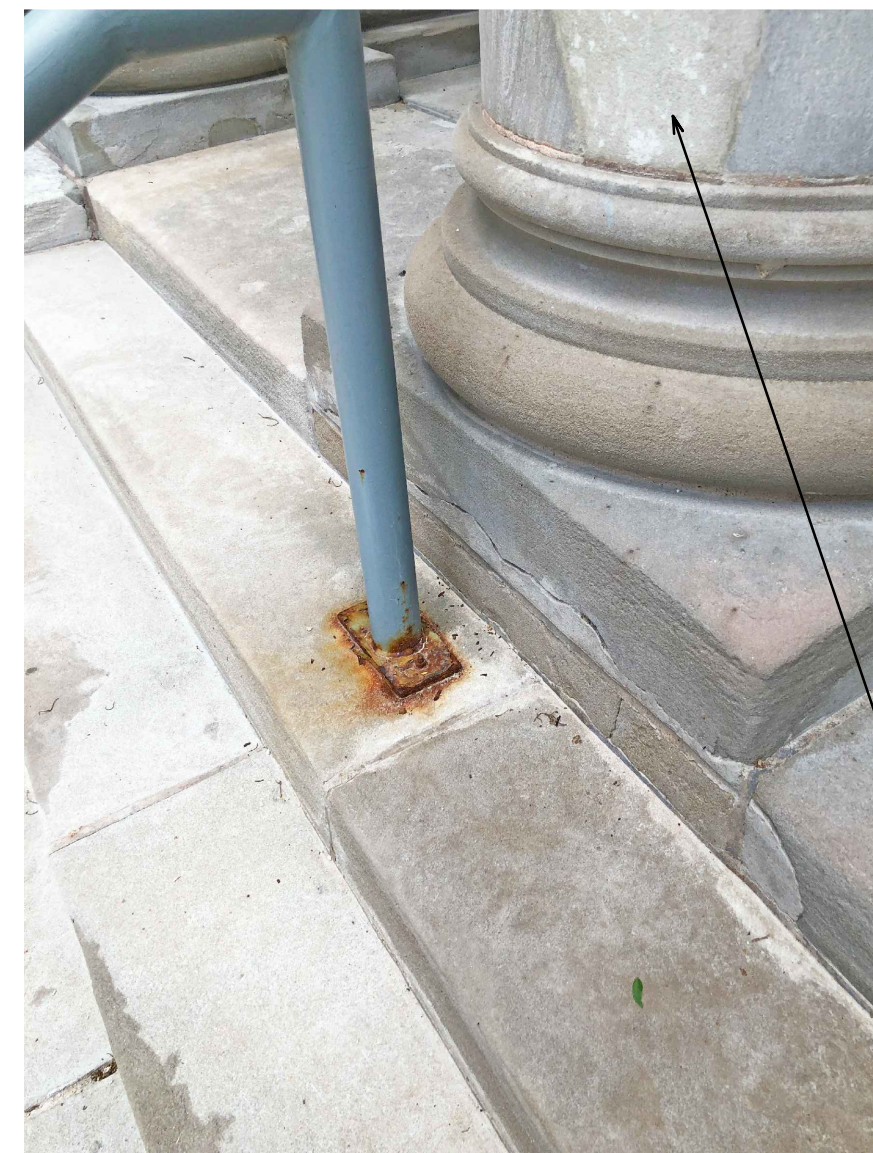
8
OBSERVATION:
EXTERIOR STAIR HANDRAIL IS SEVERELY RUSTED AND
THE PAINT IS PEELING
RECOMMENDATION:
SCRAPE AND REMOVE ALL LOOSE PAINT AND RUST,
TREAT SOLID RUST, SAND OTHER SURFACES TO
BLEND SURFACE FINISHES, CLEAN PRIME AND APPLY
MIN 2 COATS FINISH PAINT.

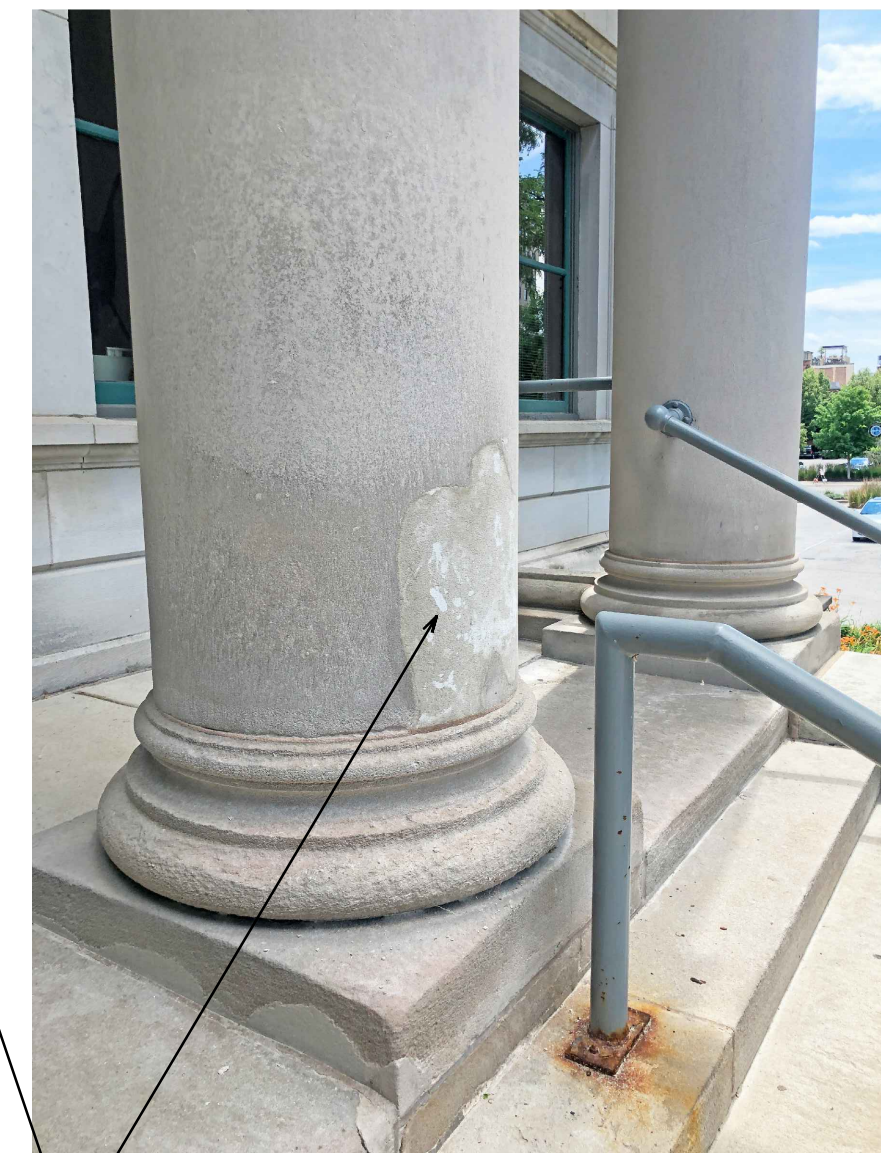
9
OBSERVATION:
EXISTING STONE REPAIRS ON COLUMNS DON'T
MATCH THE ORIGINAL STONE COLOR WELL
RECOMMENDATION:
CLEAN AND STAIN EXISTING REPAIR TO BETTER
BLEND WITH THE ORIGINAL STONE

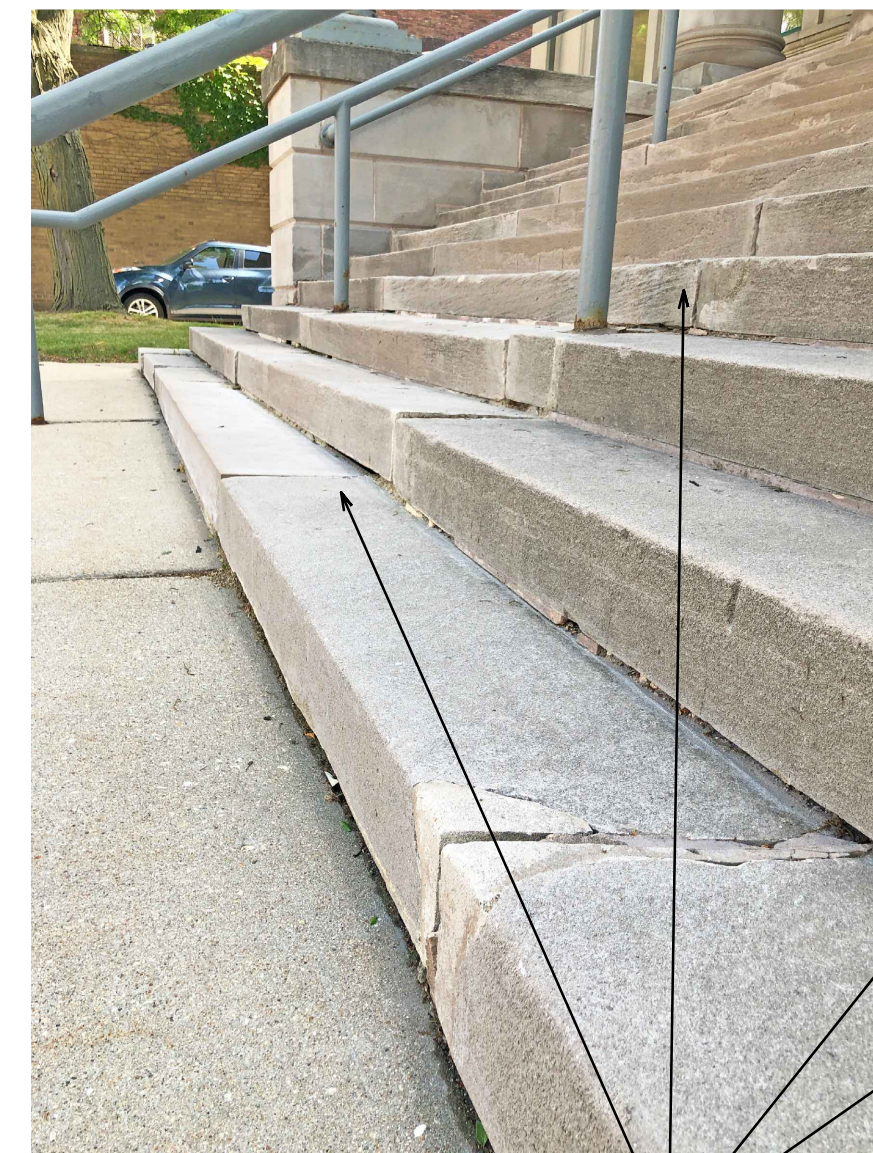
10
OBSERVATION:
STONE STEPS ARE CRACKED AND SEVERELY DISPLACED
RECOMMENDATION:
SEE STAIR WORK NOTES THIS SHEET

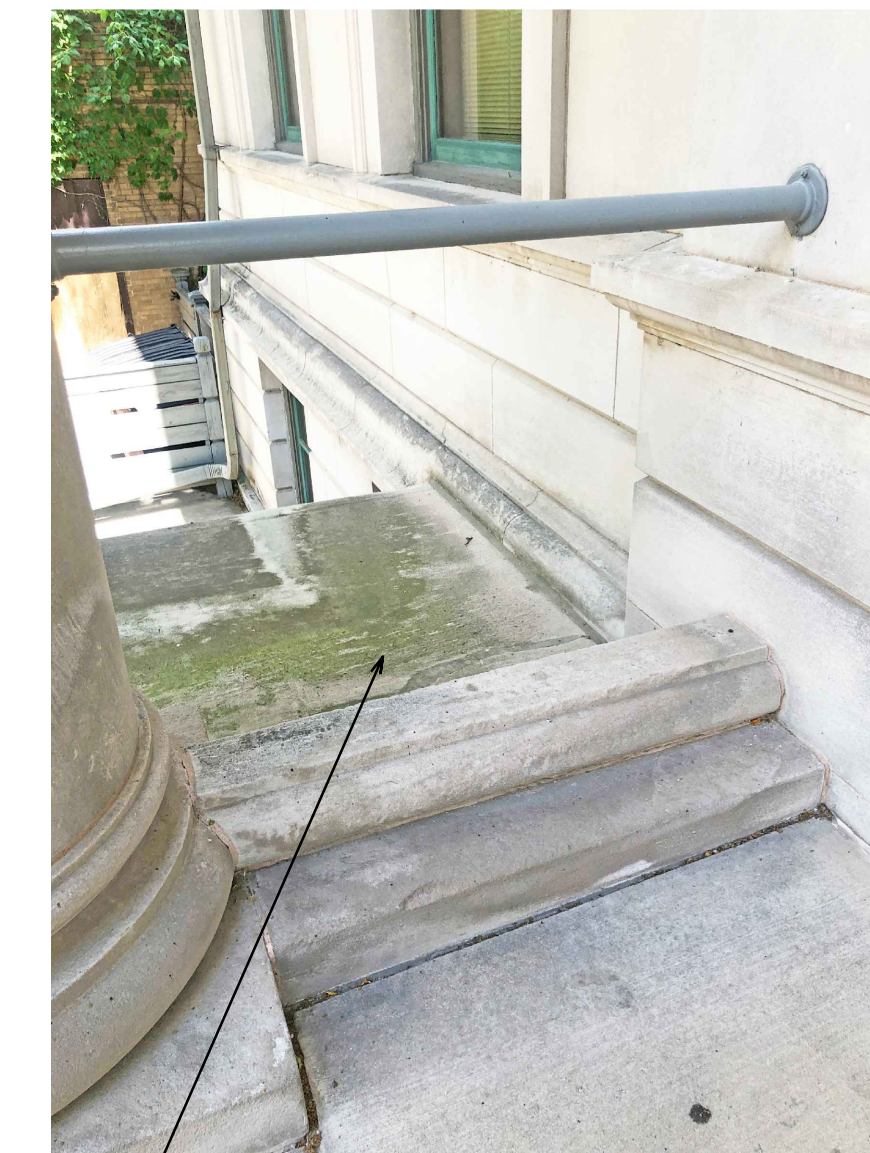
12
OBSERVATION:
EXISTING STONE "ROOF SLAB OVER LOWER ENTRY IS
STAINED
RECOMMENDATION:
CLEAN BY POWER WASHING

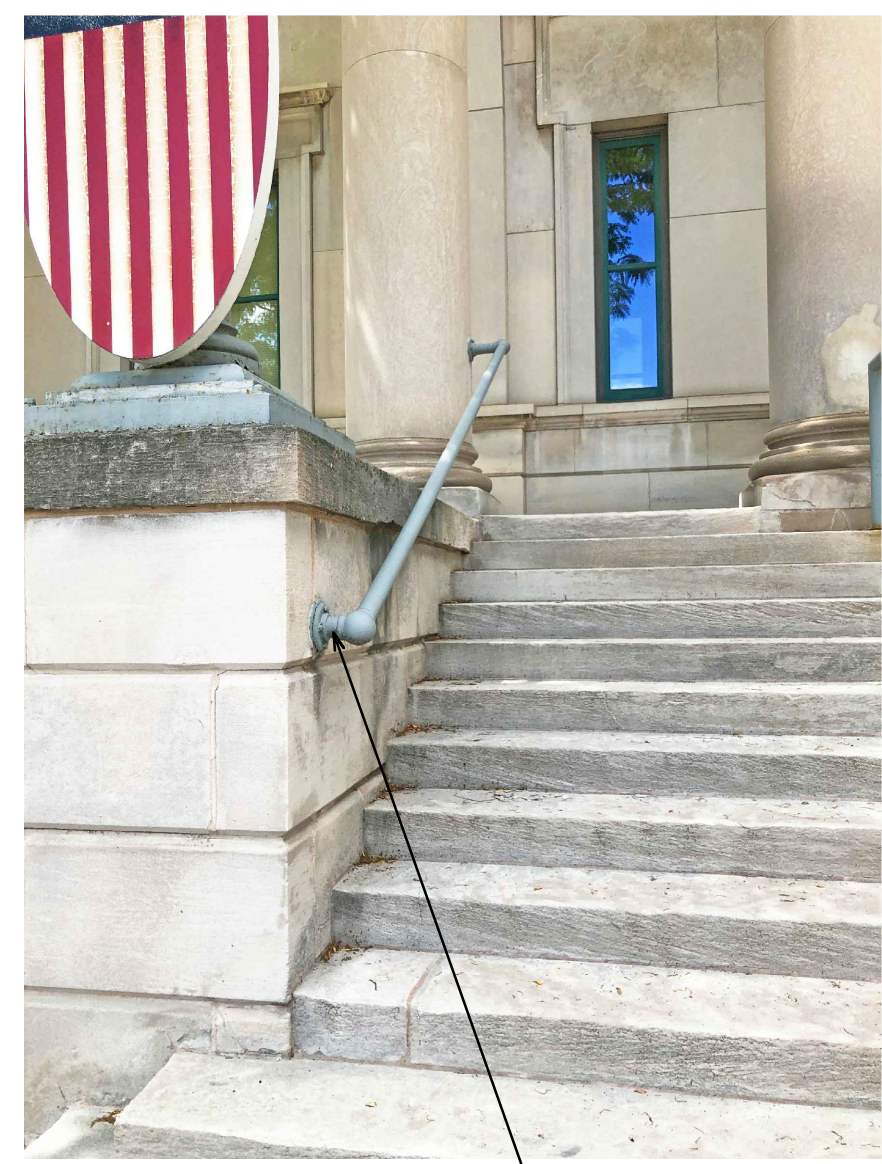
3 OBSERVATION:
EXTERIOR STAIR HANDRAIL IS SEVERELY RUSTED AND
THE PAINT IS PEELING

RECOMMENDATION:
SCRAPE AND REMOVE ALL LOOSE PAINT AND RUST,
TREAT SOLID RUST, SAND OTHER SURFACES TO
BLEND SURFACE FINISHES, CLEAN PRIME AND APPLY
MINI 2 COATS FINISH PAINT. SEAL JOINT BETWEEN
HANDRAIL BRACKET AND STONE WALL

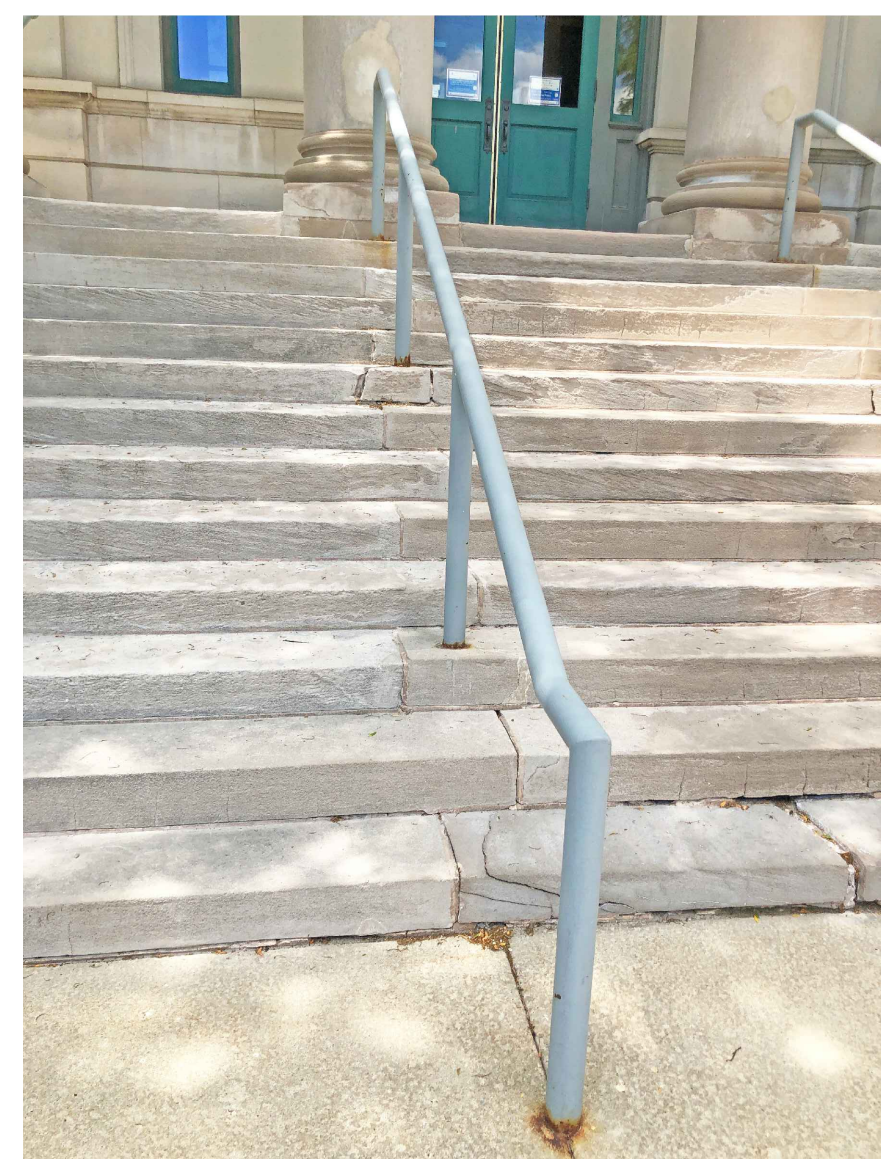
4 OBSERVATION:
EXTERIOR STAIR HANDRAIL IS SEVERELY RUSTED AND
THE PAINT IS PEELING

RECOMMENDATION:
SCRAPE AND REMOVE ALL LOOSE PAINT AND RUST,
TREAT SOLID RUST, SAND OTHER SURFACES TO
BLEND SURFACE FINISHES, CLEAN PRIME AND APPLY
MINI 2 COATS FINISH PAINT.

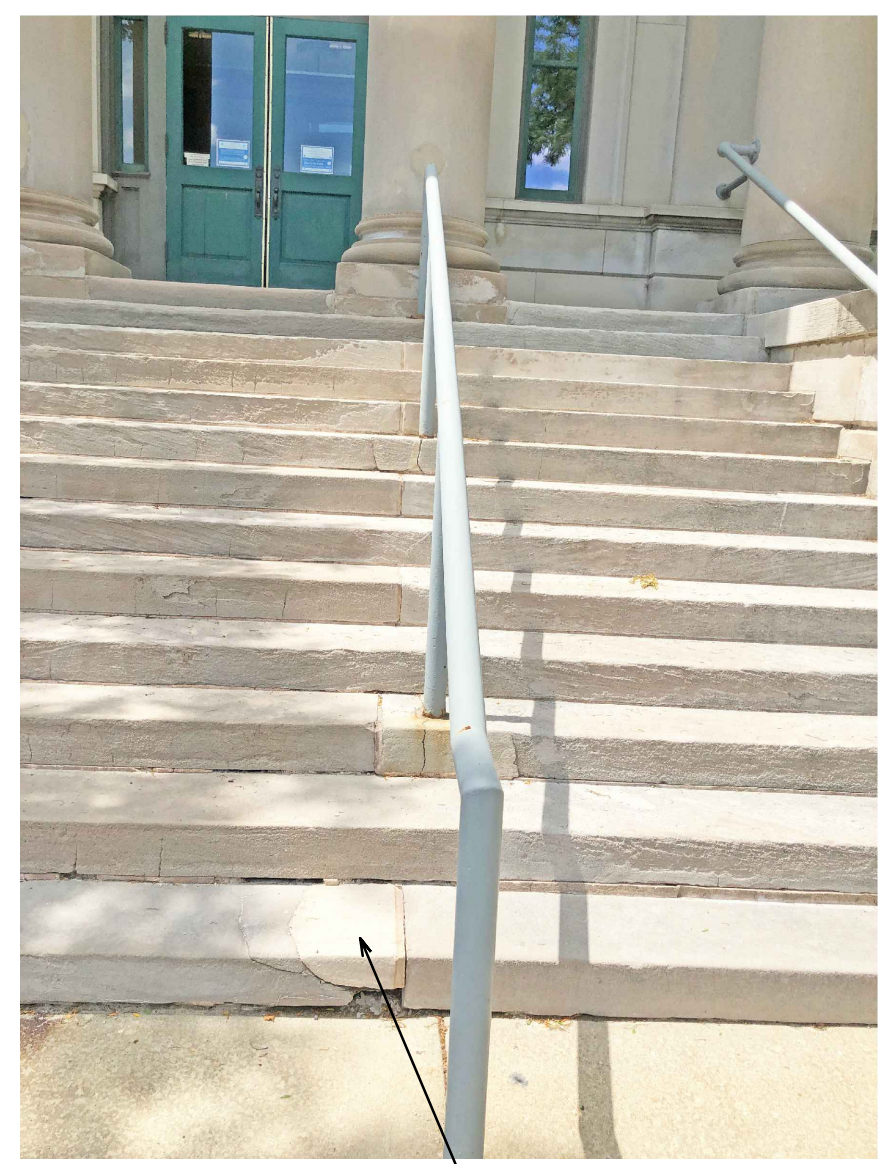
5 OBSERVATION:
STONE STEPS ARE DAMAGED AND DISPLACED

RECOMMENDATION:
SEE STAIR WORK NOTES THIS SHEET

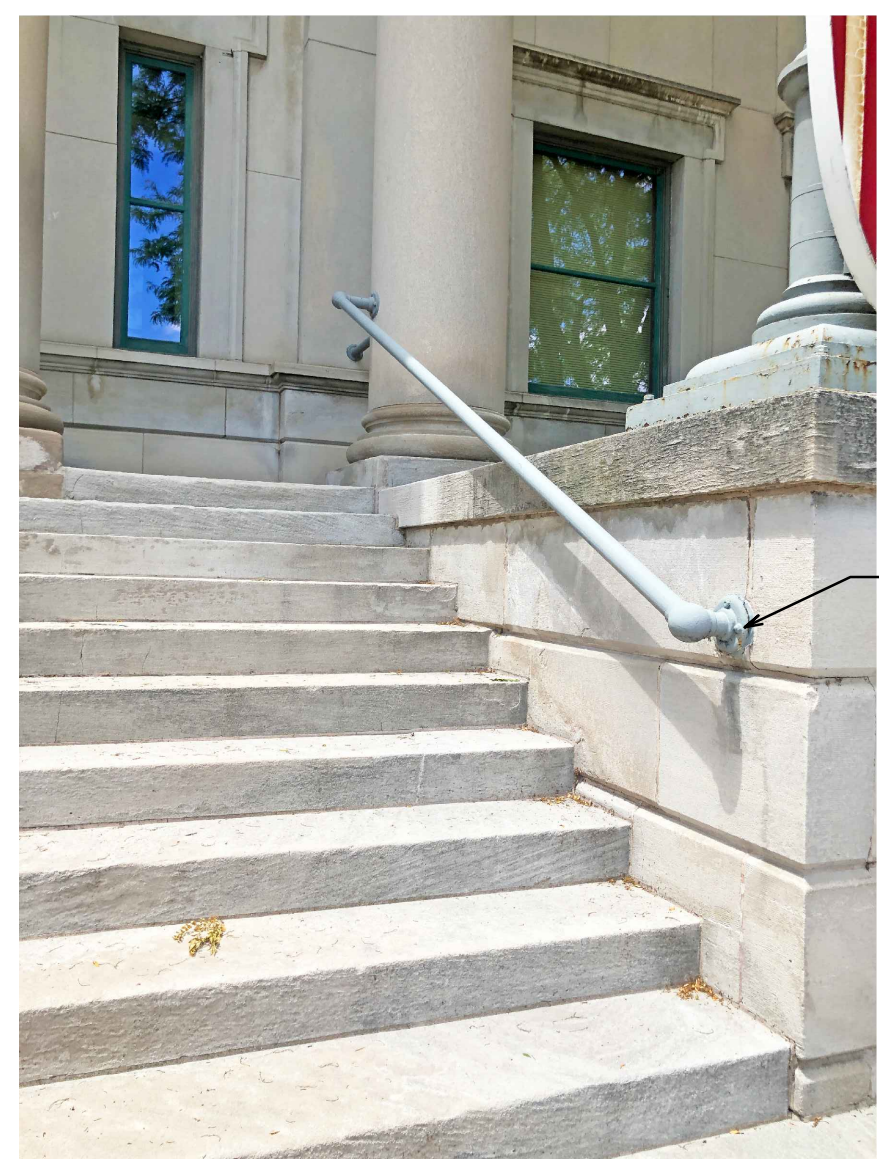
OBSERVATION:
EXTERIOR STAIR HANDRAIL IS SEVERELY RUSTED AND
THE PAINT IS PEELING

RECOMMENDATION:
SCRAPE AND REMOVE ALL LOOSE PAINT AND RUST,
TREAT SOLID RUST, SAND OTHER SURFACES TO
BLEND SURFACE FINISHES, CLEAN PRIME AND APPLY
MINI 2 COATS FINISH PAINT. SEAL JOINT BETWEEN
HANDRAIL BRACKET AND STONE WALL

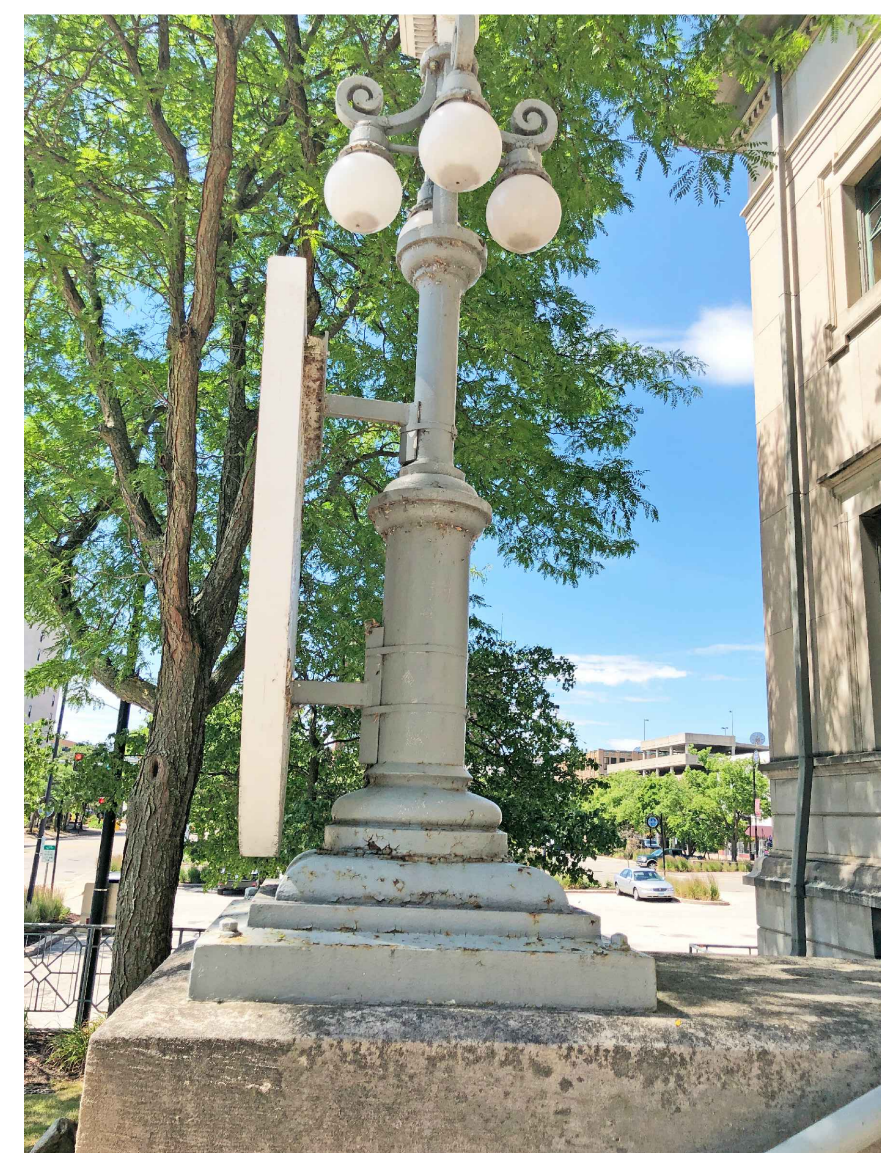
7 OBSERVATION:
EXTERIOR STAIR LIGHT POSTS ARE SEVERELY RUSTED
AND THE PAINT IS PEELING

RECOMMENDATION:
SURFACE PREPARATION FOR MPI DSD 3

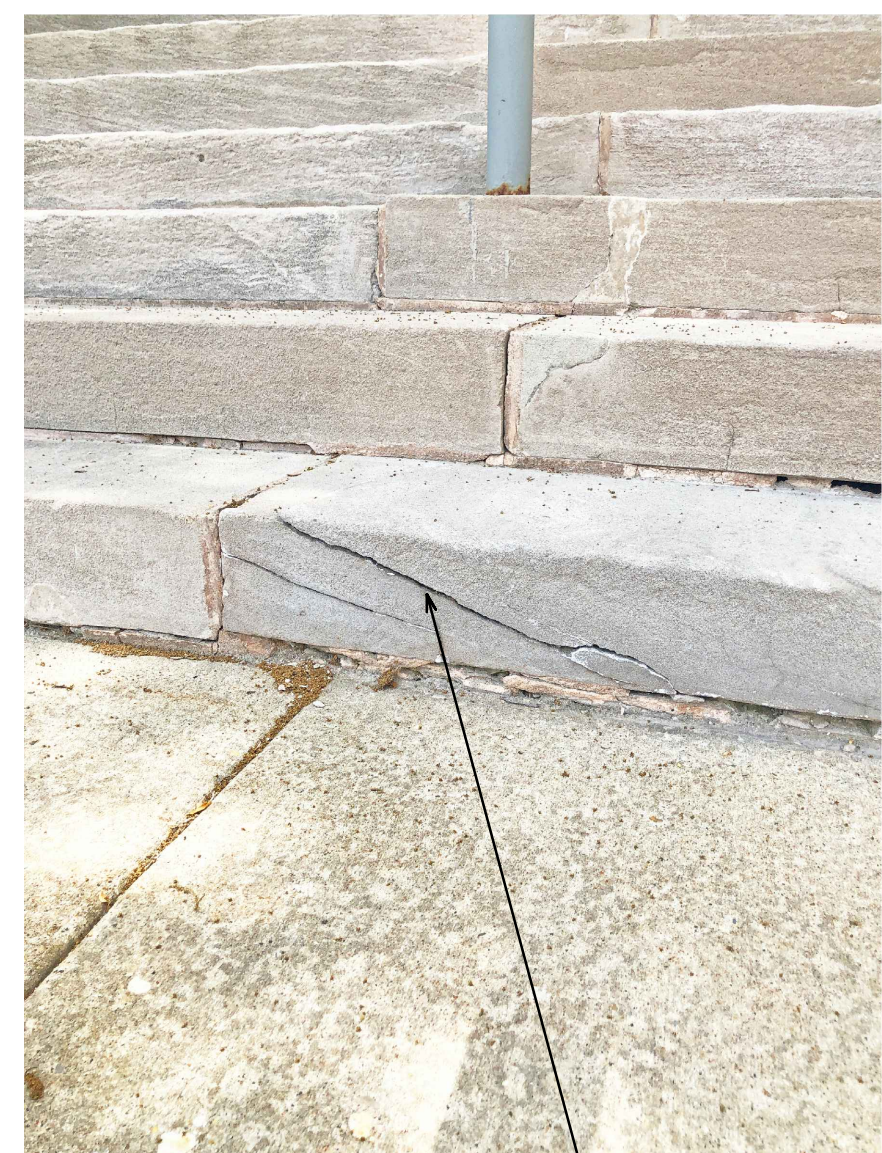
9 OBSERVATION:
STONE STEPS ARE DAMAGED AND DISPLACED

RECOMMENDATION:
SEE STAIR WORK NOTES THIS SHEET

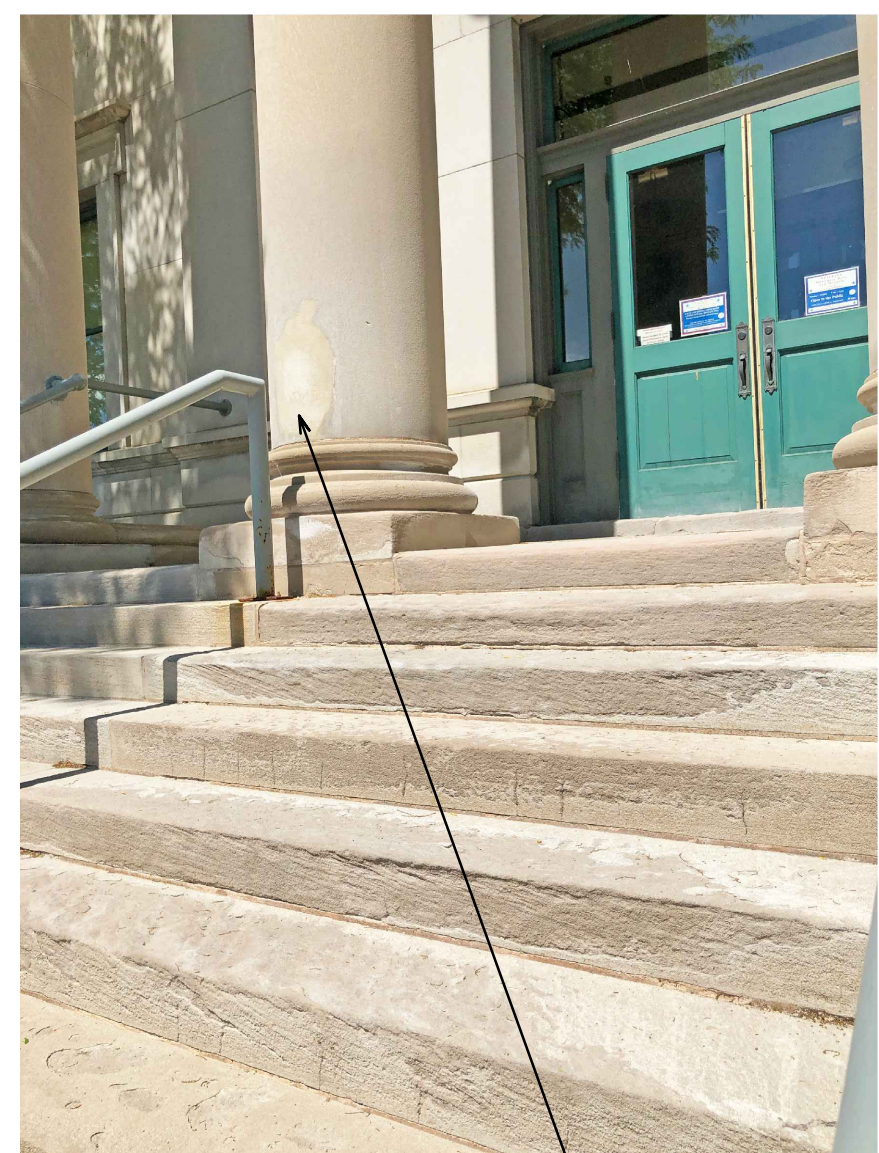
11 OBSERVATION:
EXISTING STONE REPAIRS ON COLUMNS DON'T
MATCH THE ORIGINAL STONE COLOR WELL

RECOMMENDATION:
CLEAN AND STAIN EXISTING REPAIR TO BETTER
BLEND WITH THE ORIGINAL STONE
