EXTERIOR MAINTENANCE REPAIR WORK FOR: VETERANS MEMORIAL HALL

WINNEBAGO COUNTY

BID # 21B-2226

ISSUED FOR: BIDDING

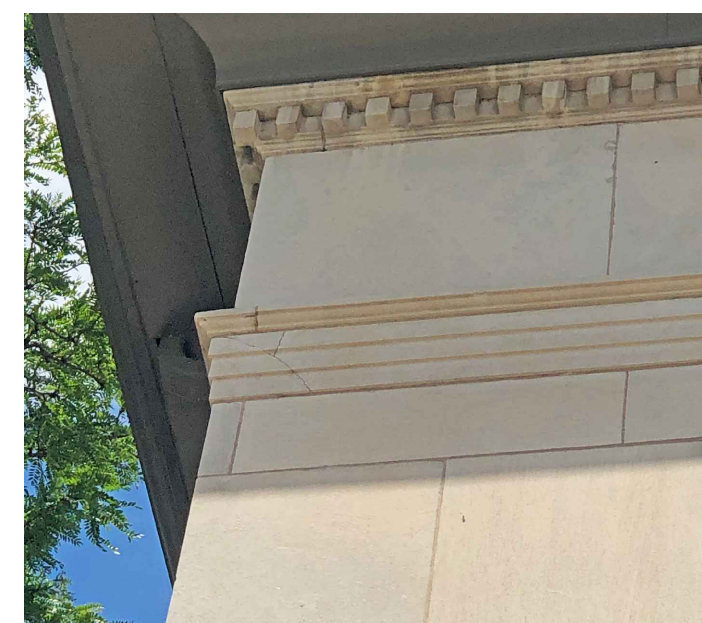
OBSERVATION:
STONE UNIT IS CRACKED WITH SOME DISPLACEMENT.
RECOMMENDATION:
DETERMINE IF PIECE OF STONE IS LOOSE AND IN DANGER OF
FALLING OUT. IF CRACKED PIECE IS LOOSE, REPAIR BY SURFACE
PATCHING. IF CRACKED PORTION IS SOUND, REPAIR CRACK.

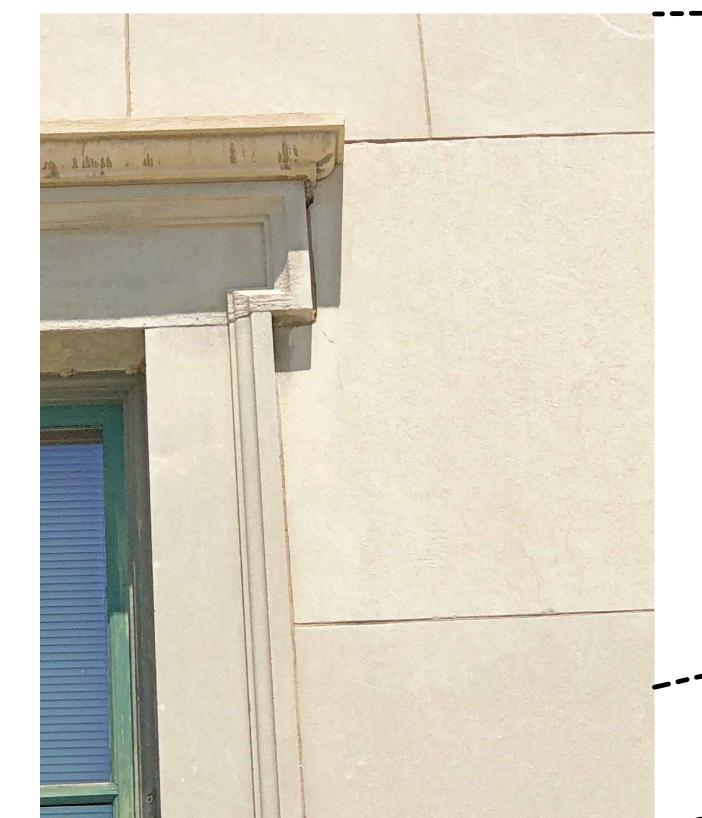
OBSERVATION:
STONE UNIT IS CRACKED WITH NO APPARENT
DISPLACEMENT.
RECOMMENDATION:
REPAIR CRACK.

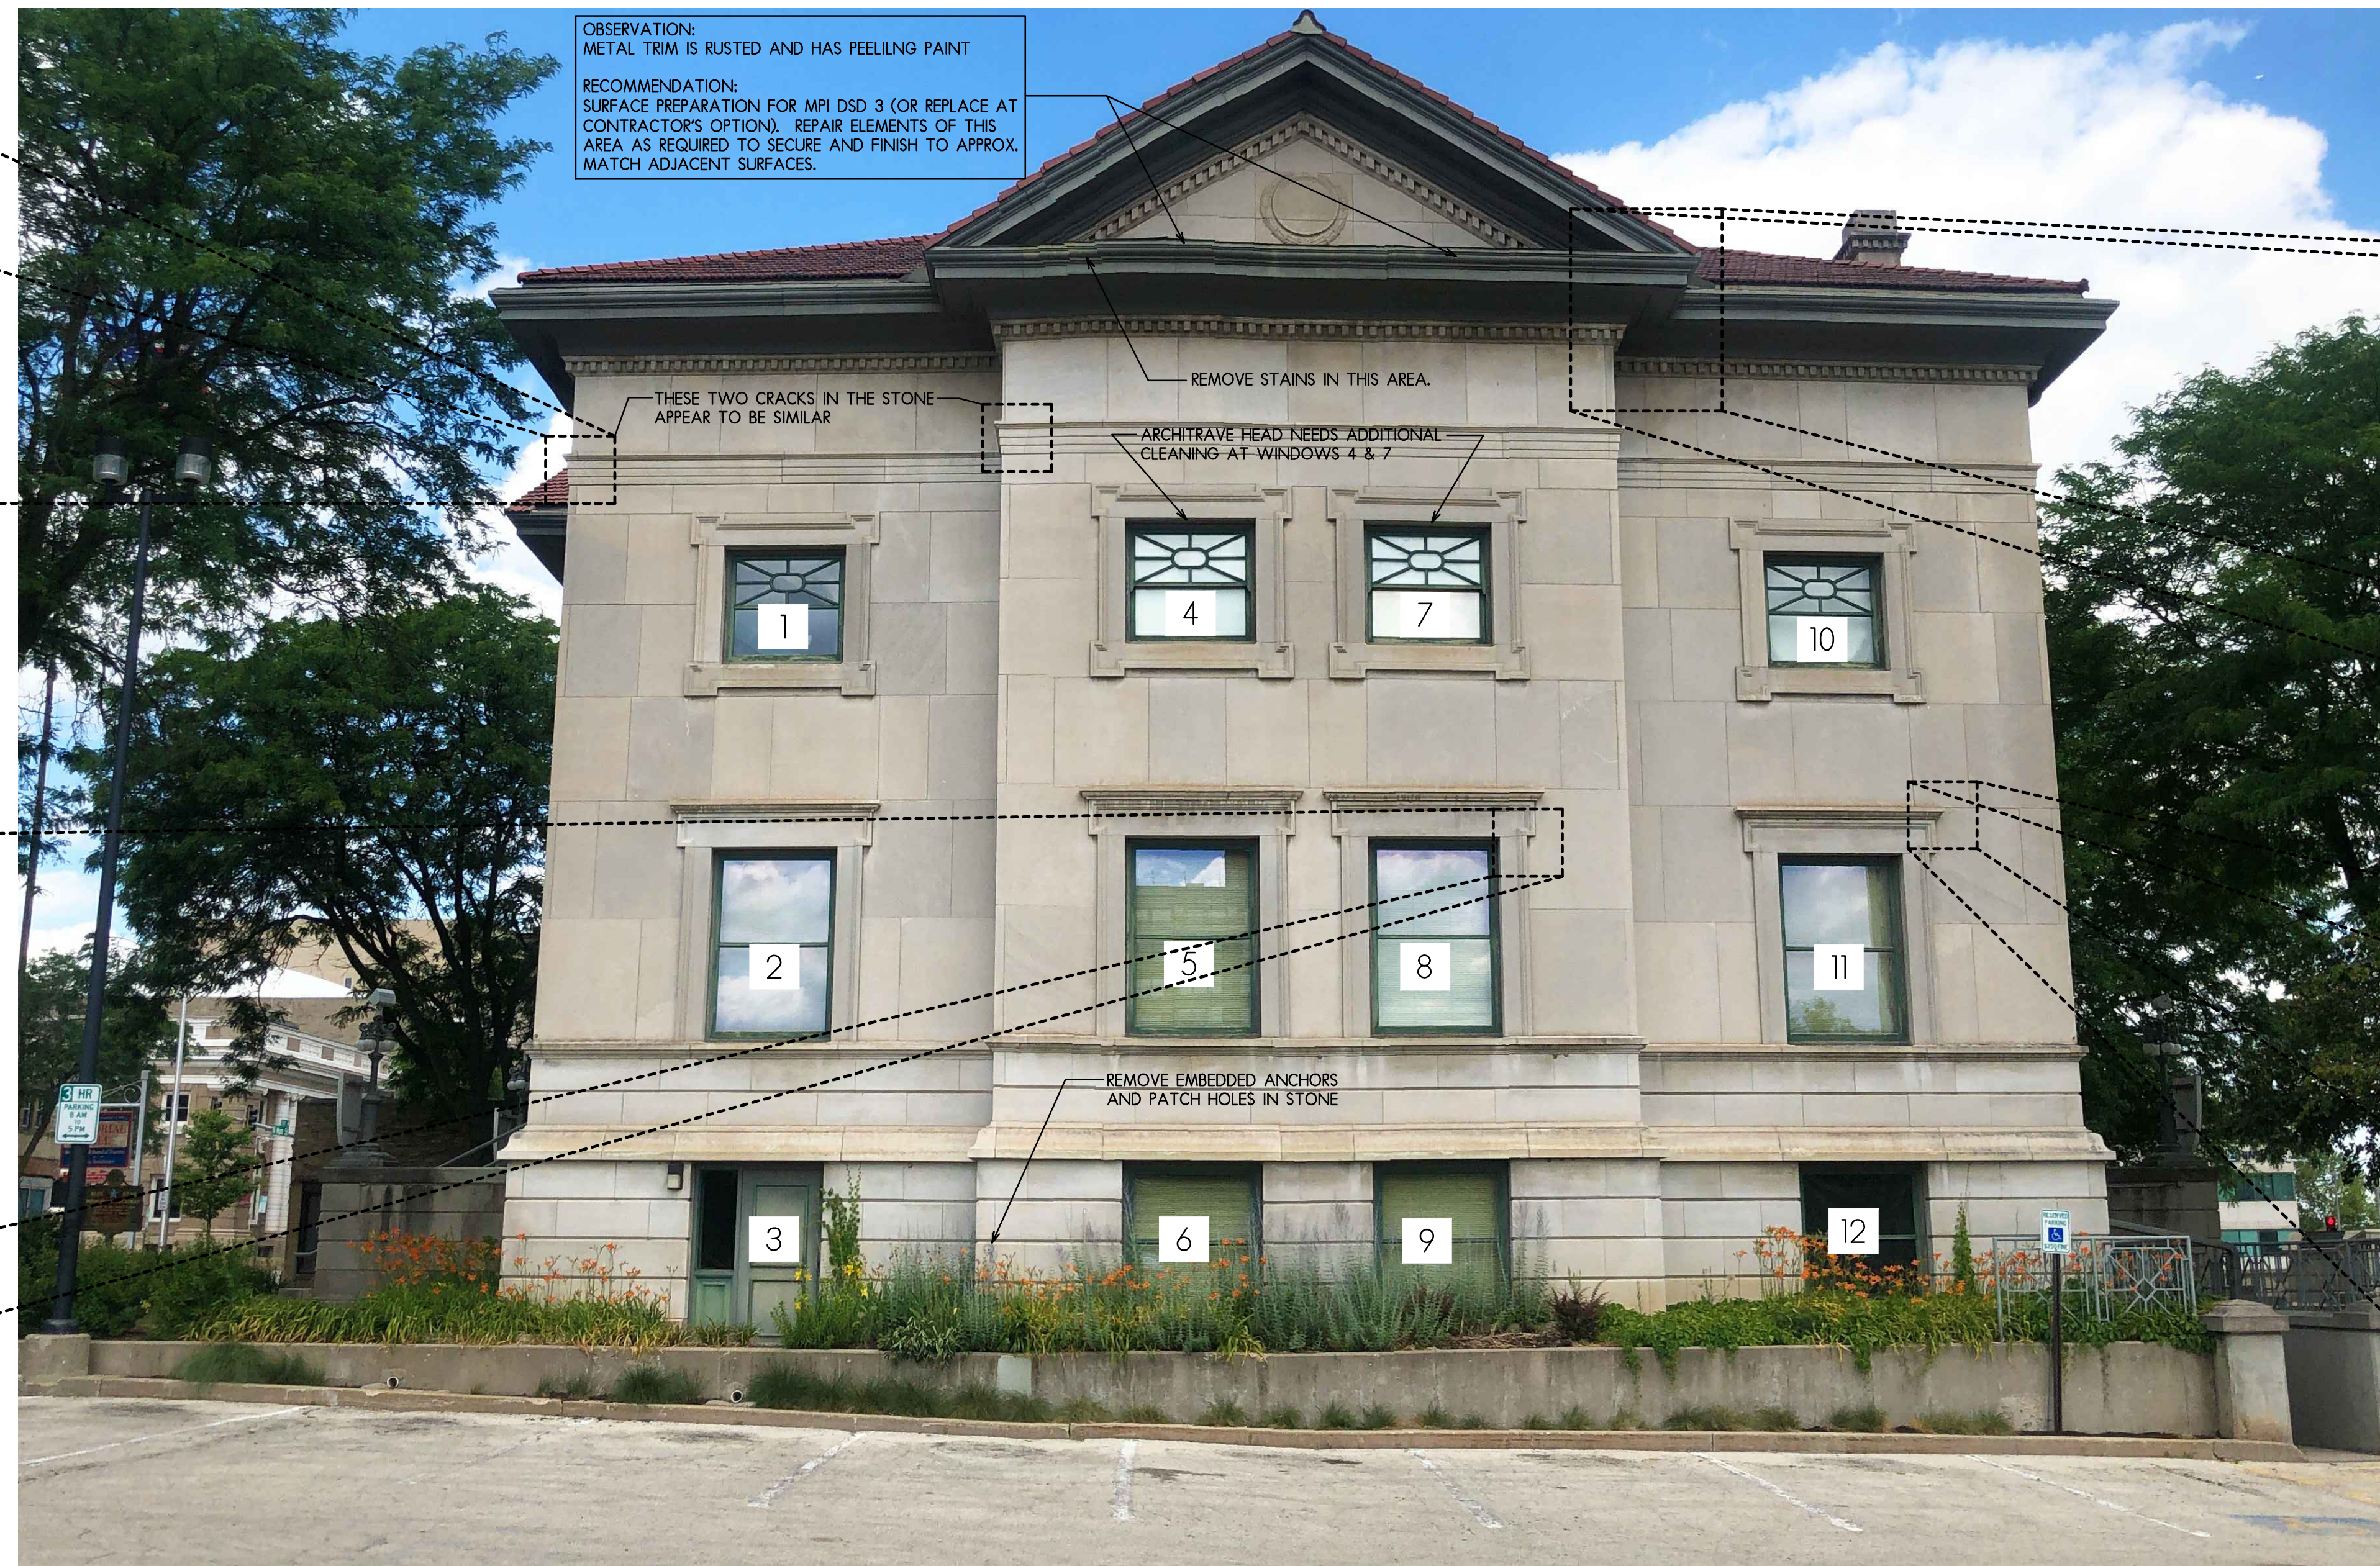
OBSERVATION:
METAL TRIM IS RUSTED AND HAS PEELING PAINT
RECOMMENDATION:
SURFACE PREPARATION FOR MPI DSD 3 (OR REPLACE AT
CONTRACTOR'S OPTION). REPAIR ELEMENTS OF THIS
AREA AS REQUIRED TO SECURE AND FINISH TO APPROX.
MATCH ADJACENT SURFACES.

THESE TWO CRACKS IN THE STONE
APPEAR TO BE SIMILAR

REMOVE STAINS IN THIS AREA.

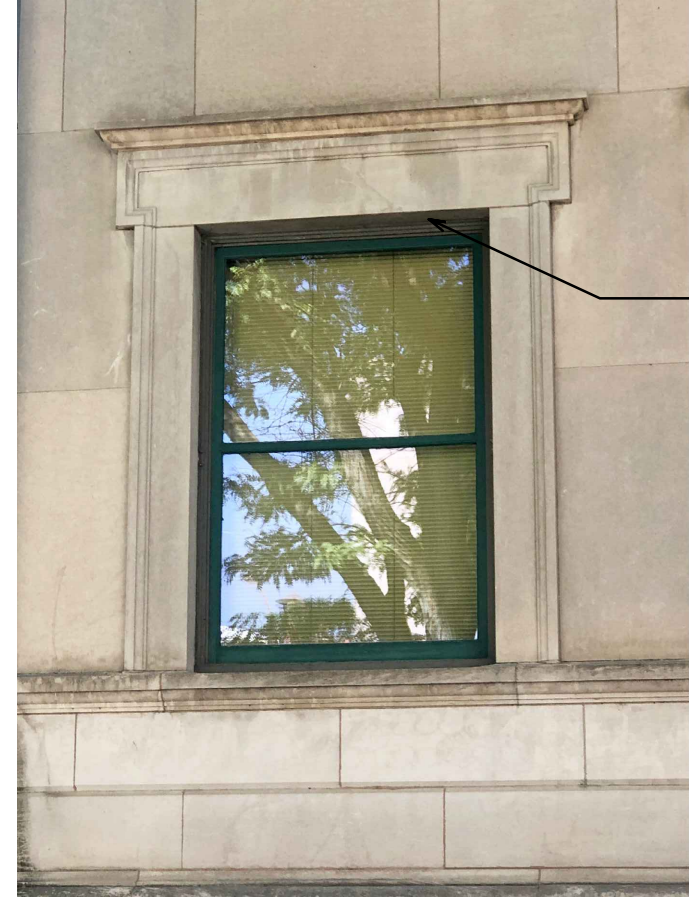
14

ARCHITRAVE HEAD NEEDS ADDITIONAL CLEANING

OBSERVATION:
BOTH GREEN & GRAY WINDOW PAINT ARE PEELING & FADING

RECOMMENDATION:
SURFACE PREPARATION FOR MPI DSD 2
REMOVE & REPLACE DETERIORATED PERIMETER SEALANT

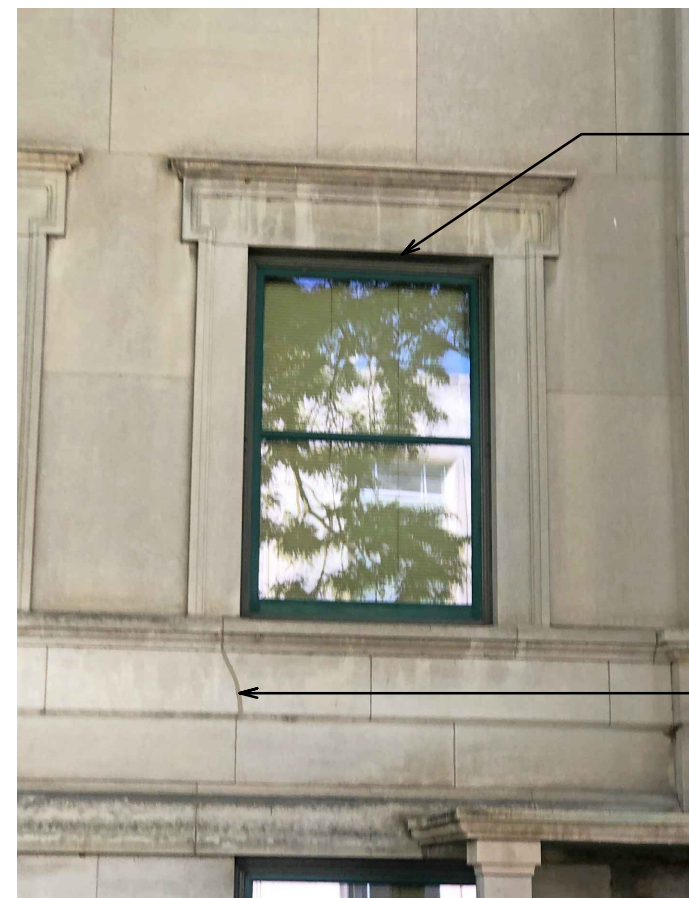
17

ARCHITRAVE HEAD NEEDS ADDITIONAL CLEANING

OBSERVATION:
BOTH GREEN & GRAY WINDOW PAINT ARE PEELING & FADING

OBSERVATION:
PREVIOUSLY REPAIRED STONE DAMAGE

RECOMMENDATION:
SURFACE PREPARATION FOR MPI DSD 2
REMOVE & REPLACE DETERIORATED PERIMETER SEALANT

RECOMMENDATION:
NO REPAIR REQUIRED

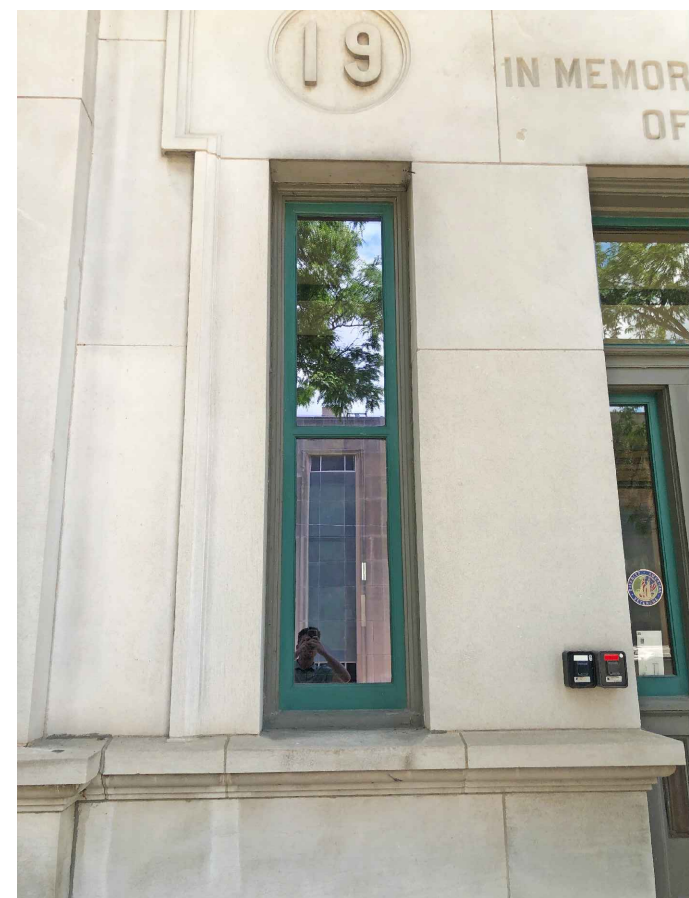
OBSERVATION:
GREEN WINDOW PAINT IS OK
GRAY WINDOW PAINT IS PEELING

RECOMMENDATION:
SURFACE PREPARATION FOR MPI DSD 2
REMOVE & REPLACE DETERIORATED PERIMETER SEALANT

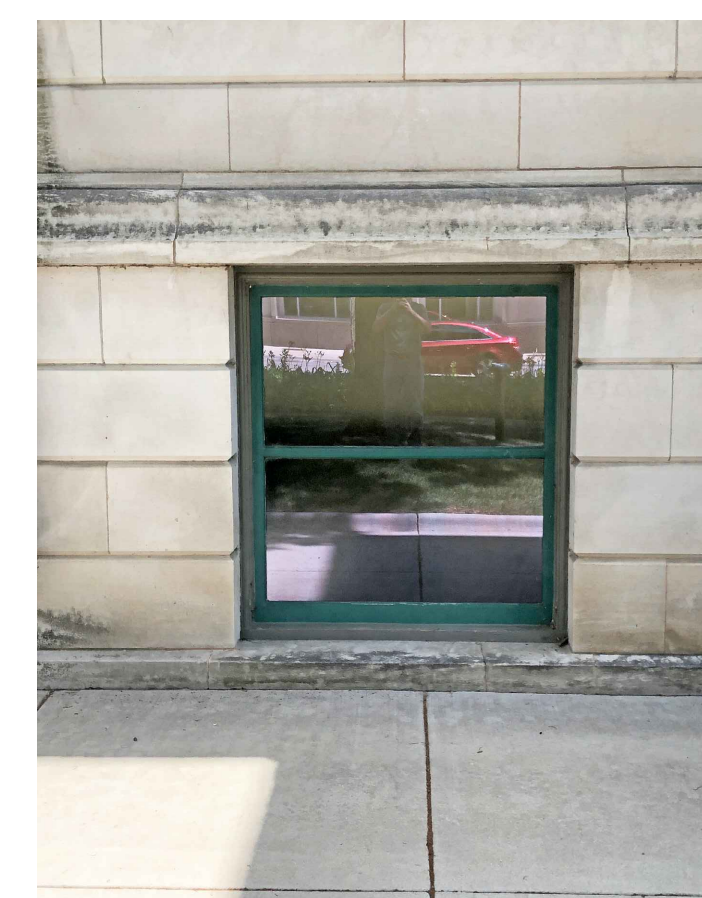
15

OBSERVATION:
BOTH GREEN & GRAY WINDOW PAINT ARE PEELING & FADING

RECOMMENDATION:
SURFACE PREPARATION FOR MPI DSD 3
REMOVE & REPLACE DETERIORATED PERIMETER SEALANT

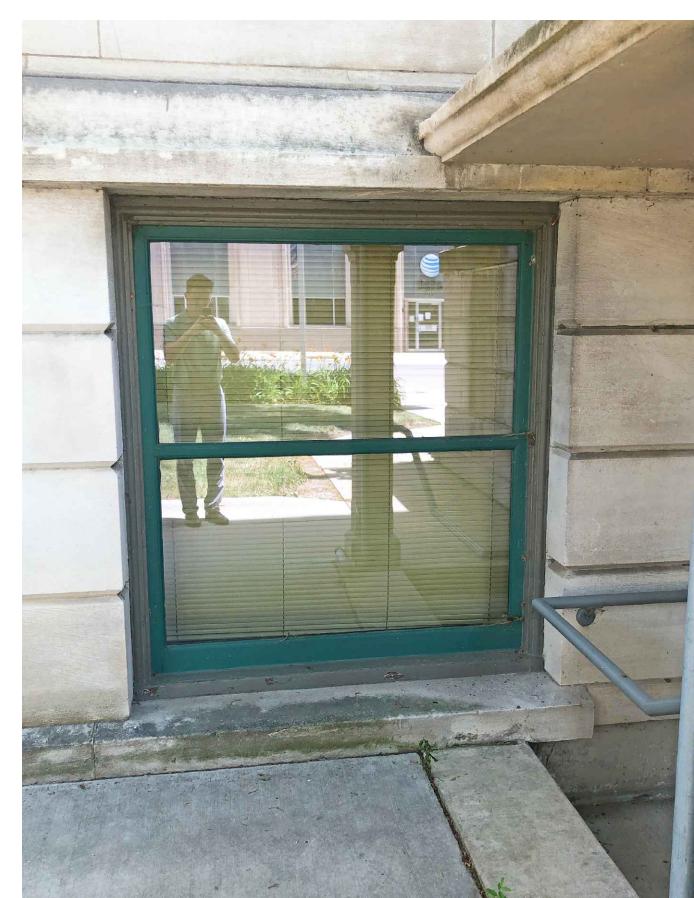
18

OBSERVATION:
GREEN WINDOW PAINT IS OK
GRAY WINDOW PAINT IS PEELING

RECOMMENDATION:
SURFACE PREPARATION FOR MPI DSD 2
REMOVE & REPLACE DETERIORATED PERIMETER SEALANT

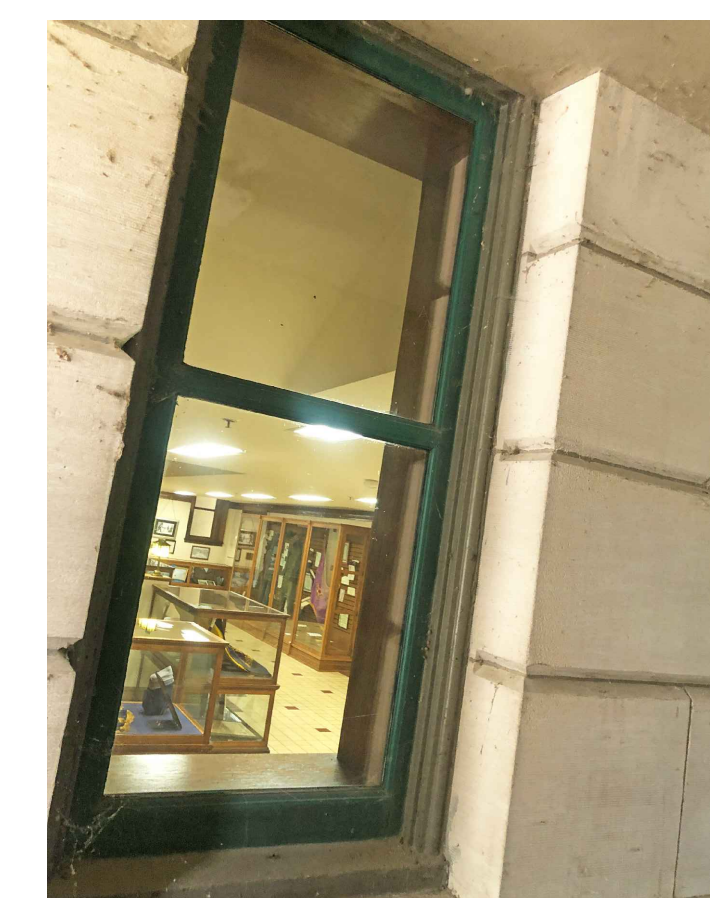
29

OBSERVATION:
BOTH GREEN & GRAY WINDOW PAINT ARE PEELING

RECOMMENDATION:
SURFACE PREPARATION FOR MPI DSD 2
REMOVE & REPLACE DETERIORATED PERIMETER SEALANT

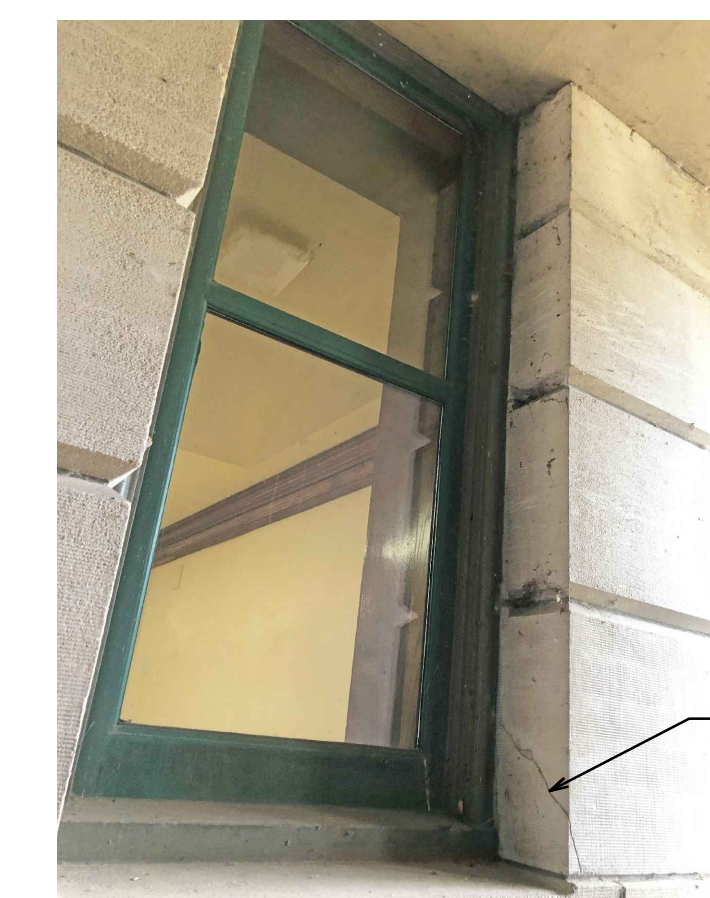
30

OBSERVATION:
BOTH GREEN & GRAY WINDOW PAINT ARE PEELING & FADING

RECOMMENDATION:
SURFACE PREPARATION FOR MPI DSD 3
REMOVE & REPLACE DETERIORATED PERIMETER SEALANT

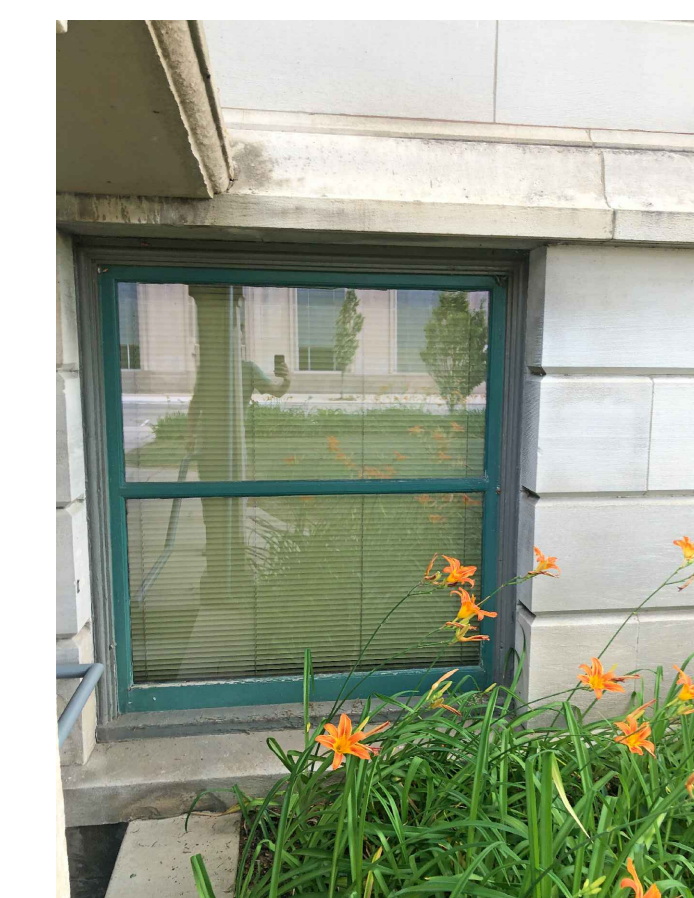
25

OBSERVATION:
BOTH GREEN & GRAY WINDOW PAINT ARE PEELING & FADING

RECOMMENDATION:
SURFACE PREPARATION FOR MPI DSD 3
REMOVE & REPLACE DETERIORATED PERIMETER SEALANT

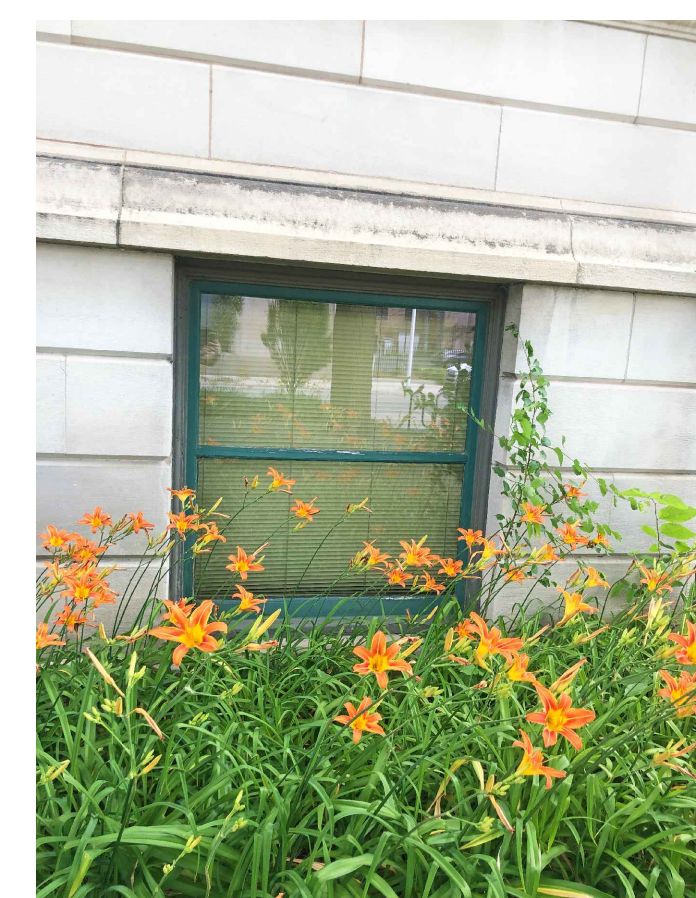
28

OBSERVATION:
GREEN WINDOW PAINT IS OK
GRAY WINDOW PAINT IS PEELING

RECOMMENDATION:
SURFACE PREPARATION FOR MPI DSD 2
REMOVE & REPLACE DETERIORATED PERIMETER SEALANT

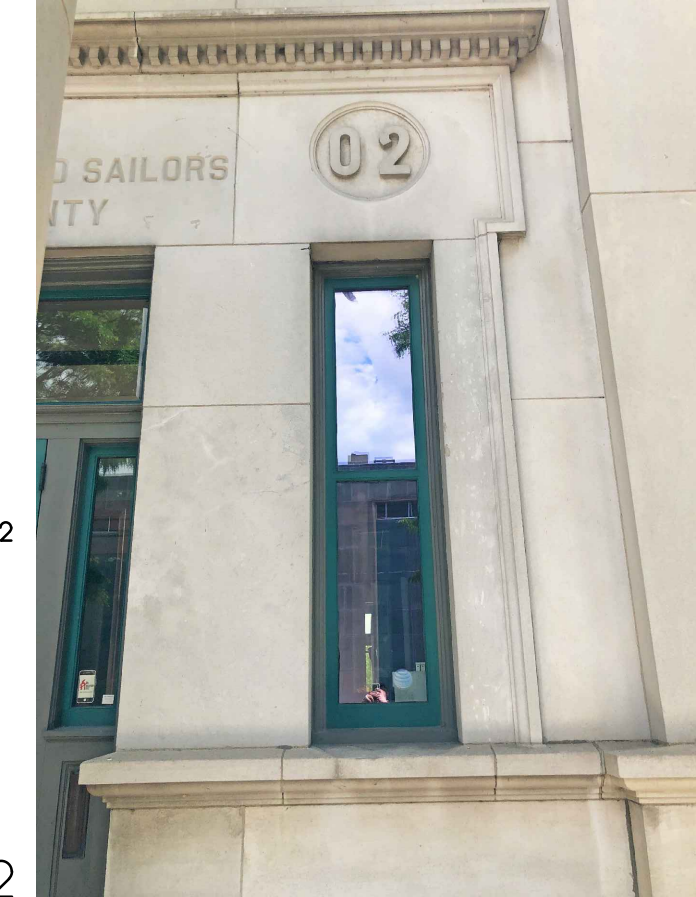
22

OBSERVATION:
GREEN WINDOW PAINT IS OK
GRAY WINDOW PAINT IS PEELING

RECOMMENDATION:
SURFACE PREPARATION FOR MPI DSD 2
REMOVE & REPLACE DETERIORATED PERIMETER SEALANT

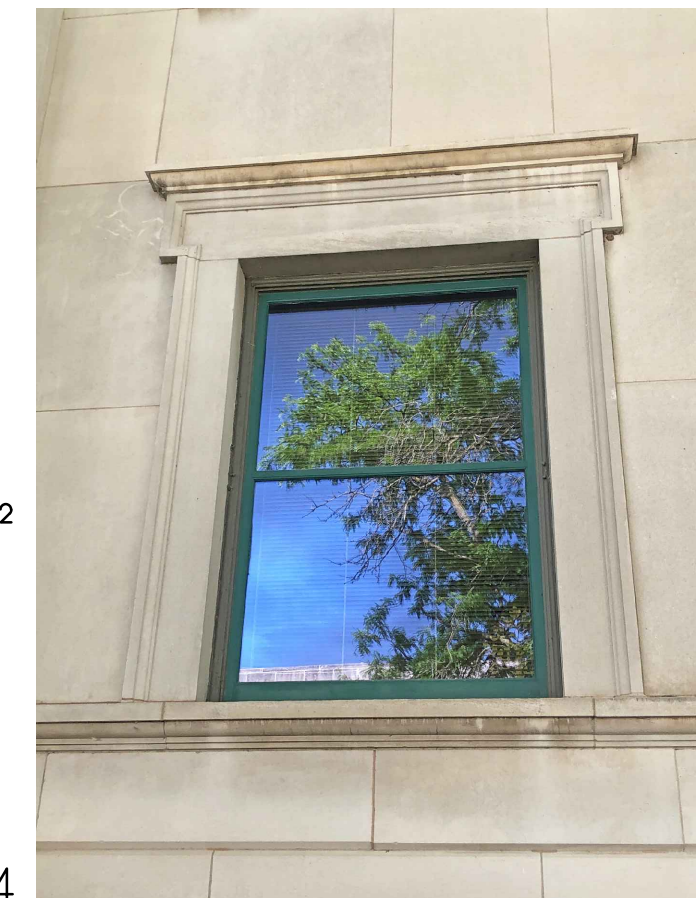
24

OBSERVATION:
GREEN WINDOW PAINT IS OK
GRAY WINDOW PAINT IS PEELING

RECOMMENDATION:
SURFACE PREPARATION FOR MPI DSD 2
REMOVE & REPLACE DETERIORATED PERIMETER SEALANT

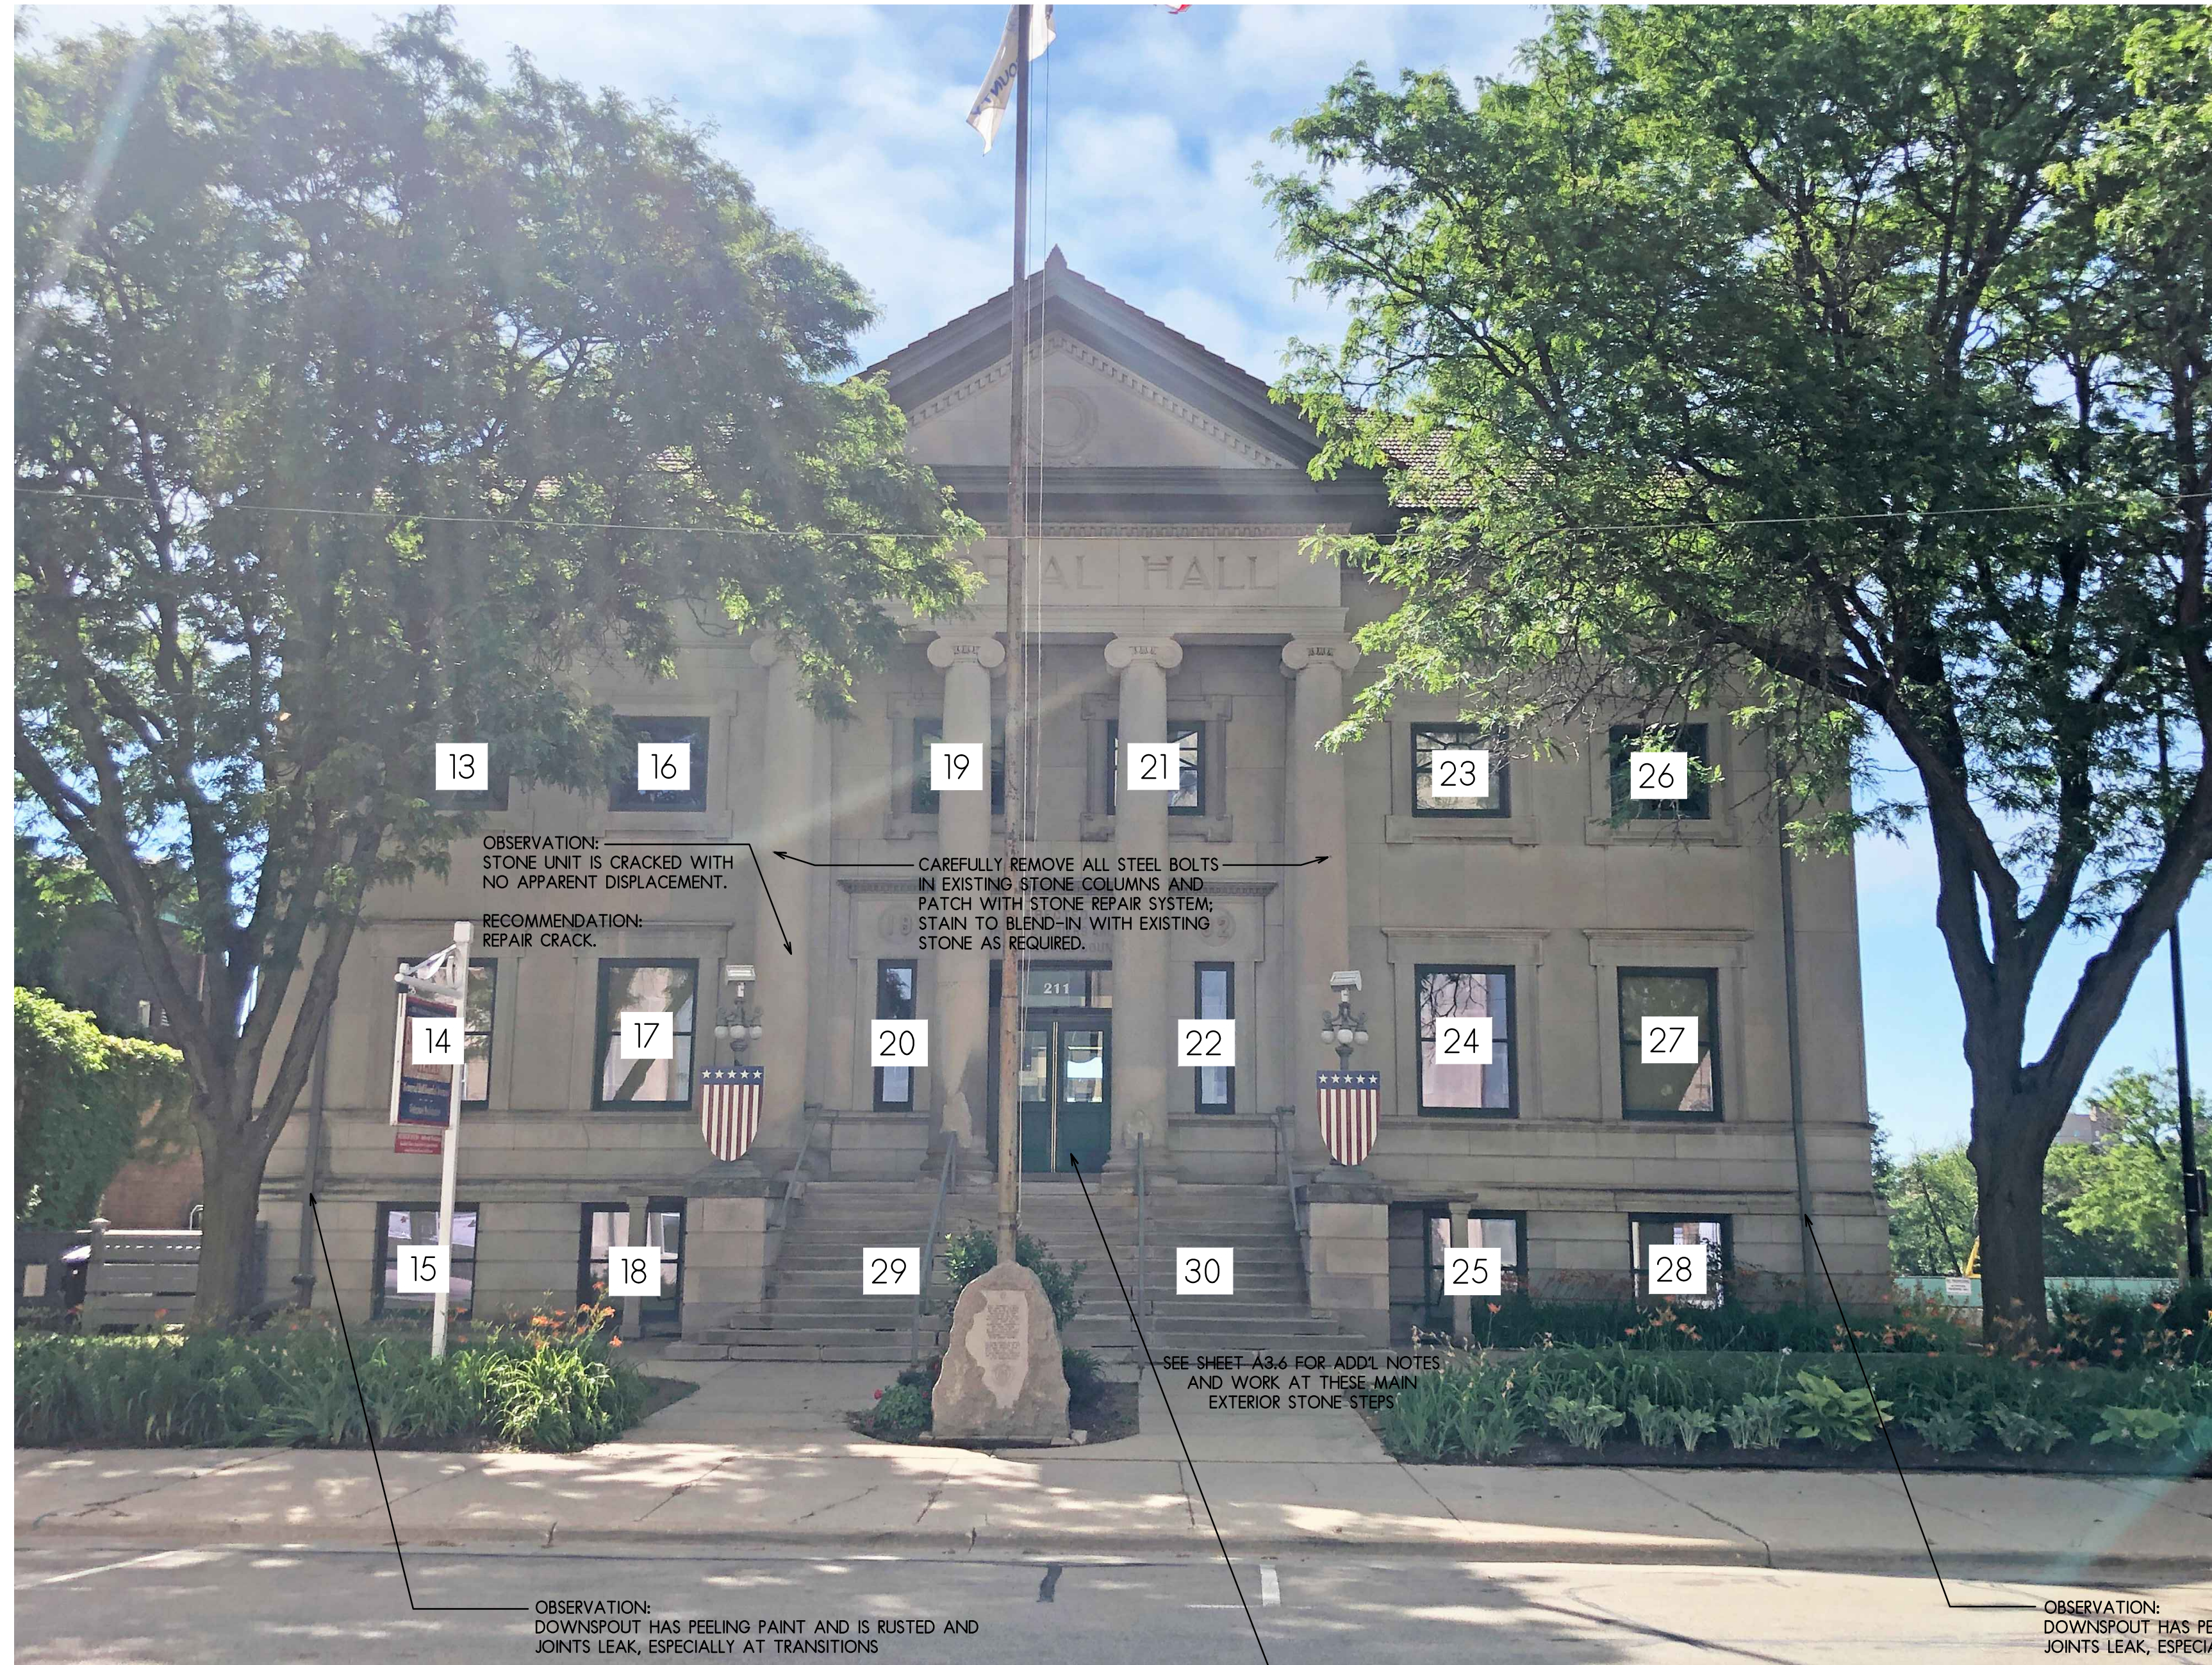
13
OBSERVATION:
STONE UNIT IS CRACKED WITH NO APPARENT DISPLACEMENT.

RECOMMENDATION:
REPAIR CRACK.

CAREFULLY REMOVE ALL STEEL BOLTS IN EXISTING STONE COLUMNS AND PATCH WITH STONE REPAIR SYSTEM; STAIN TO BLEND-IN WITH EXISTING STONE AS REQUIRED.

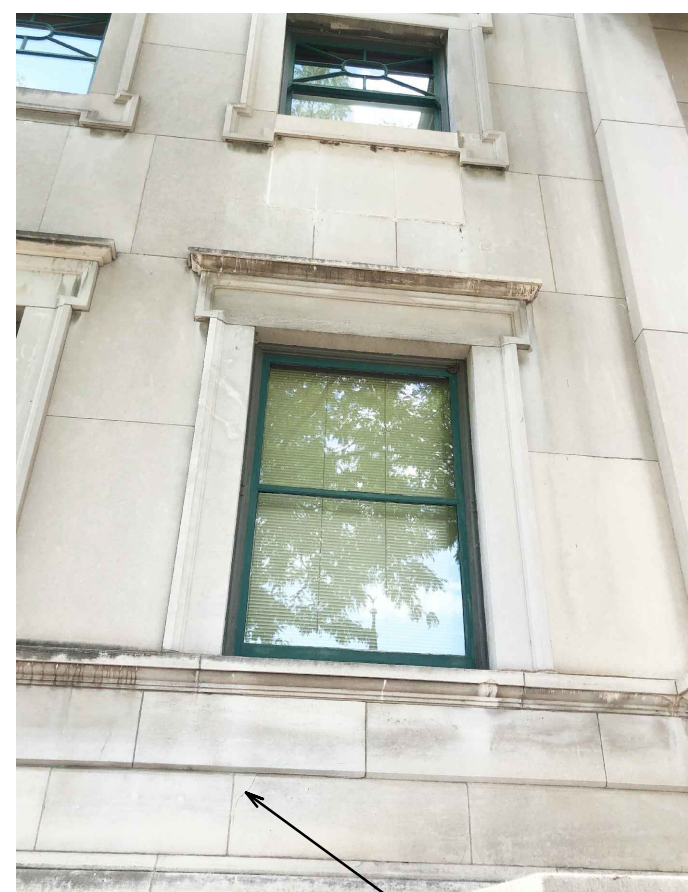
44

OBSERVATION: BOTH GREEN & GRAY WINDOW PAINT ARE PEELING & FADING
RECOMMENDATION: SURFACE PREPARATION FOR MPI DSD 3 REMOVE & REPLACE DETERIORATED PERIMETER SEALANT

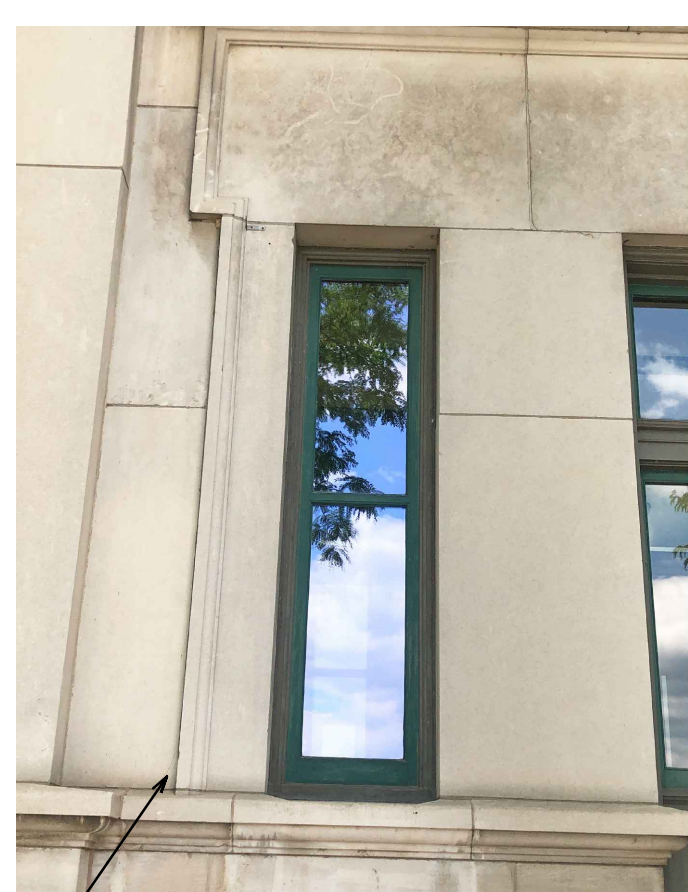
47

OBSERVATION: BOTH GREEN & GRAY WINDOW PAINT ARE PEELING & FADING
RECOMMENDATION: SURFACE PREPARATION FOR MPI DSD 2 REMOVE & REPLACE DETERIORATED PERIMETER SEALANT

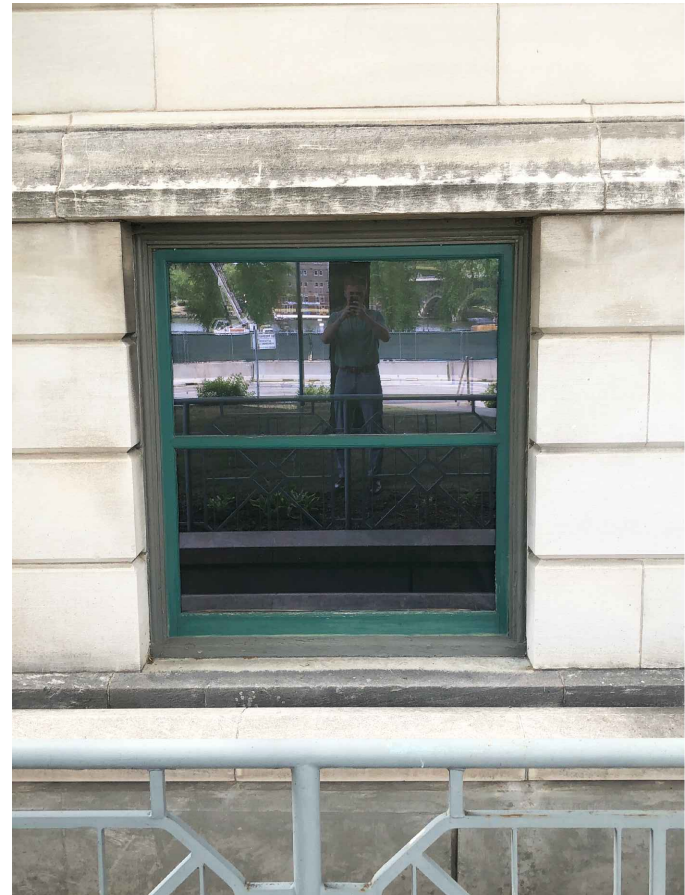
45

OBSERVATION: BOTH GREEN & GRAY WINDOW PAINT IS PEELING
RECOMMENDATIONS: SURFACE PREPARATION FOR MPI DSD 2 REMOVE & REPLACE DETERIORATED PERIMETER SEALANT

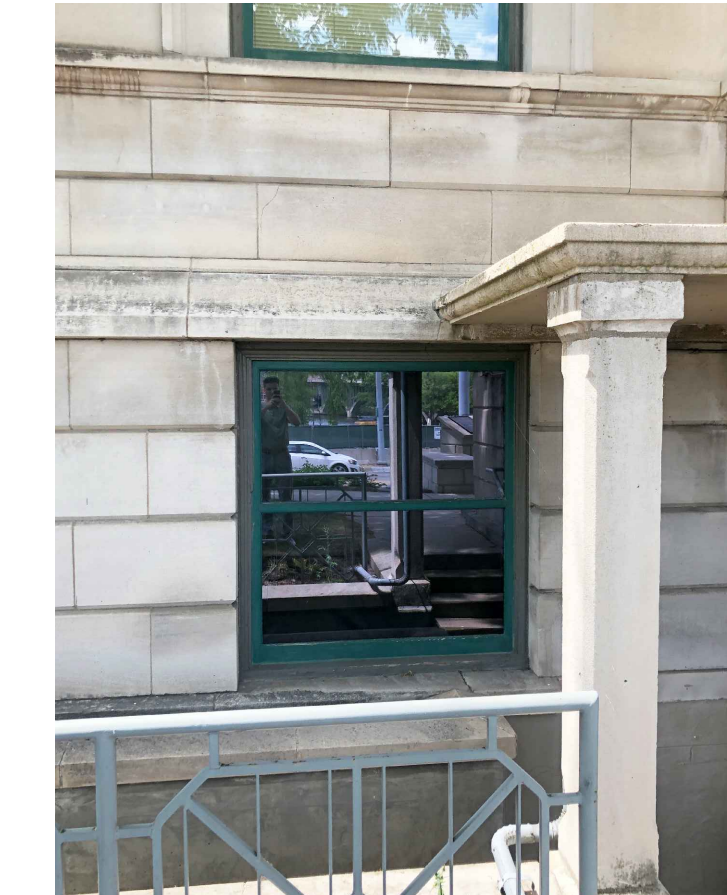
48

OBSERVATION: BOTH GREEN & GRAY WINDOW PAINT ARE PEELING & FADING
RECOMMENDATIONS: SURFACE PREPARATION FOR MPI DSD 2 REMOVE & REPLACE DETERIORATED PERIMETER SEALANT

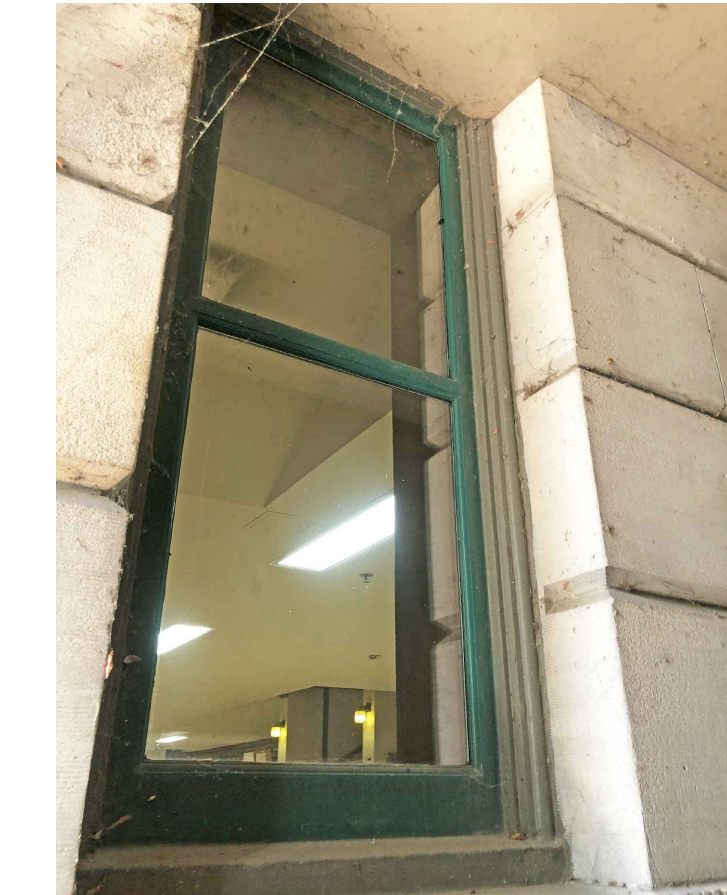
59

OBSERVATION: BOTH GREEN & GRAY WINDOW PAINT ARE PEELING & FADING
RECOMMENDATIONS: SURFACE PREPARATION FOR MPI DSD 2 REMOVE & REPLACE DETERIORATED PERIMETER SEALANT

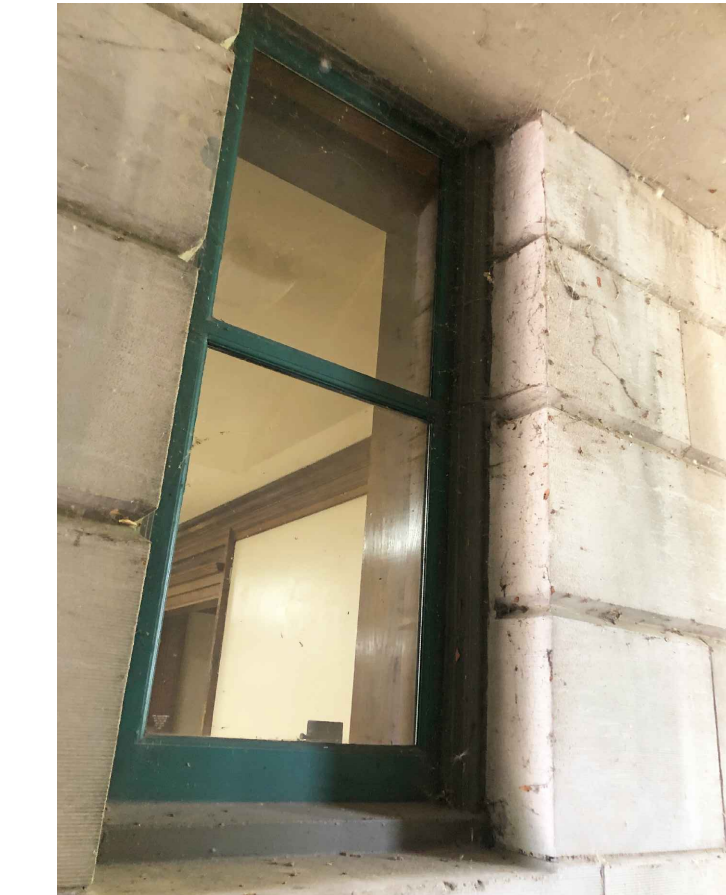
60

OBSERVATION: BOTH GREEN & GRAY WINDOW PAINT ARE PEELING & FADING
RECOMMENDATION: SURFACE PREPARATION FOR MPI DSD 2 REMOVE & REPLACE DETERIORATED PERIMETER SEALANT

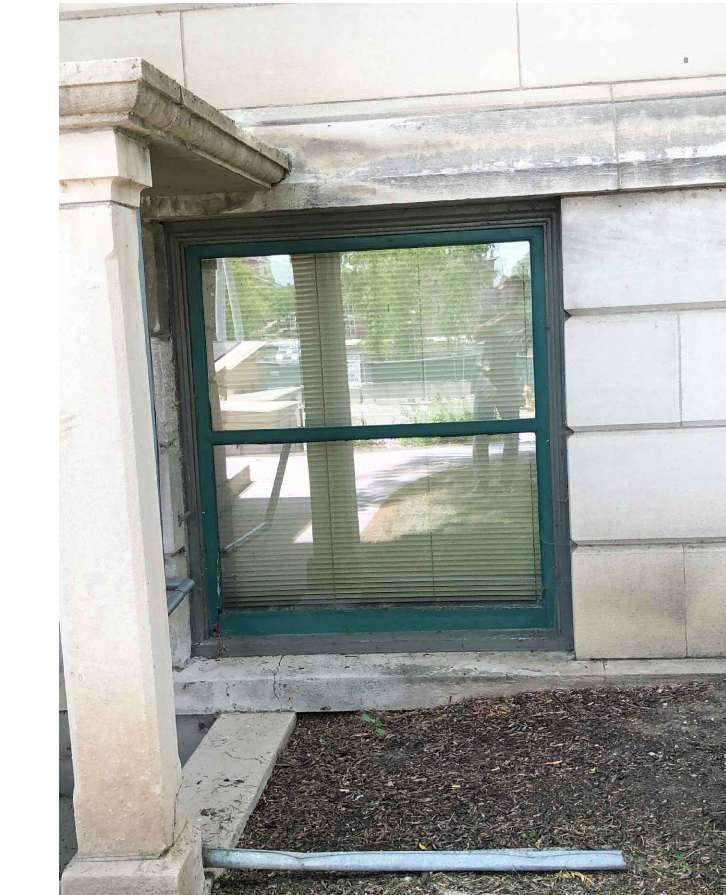
55

OBSERVATION: BOTH GREEN & GRAY WINDOW PAINT ARE PEELING & FADING
RECOMMENDATION: SURFACE PREPARATION FOR MPI DSD 2 REMOVE & REPLACE DETERIORATED PERIMETER SEALANT

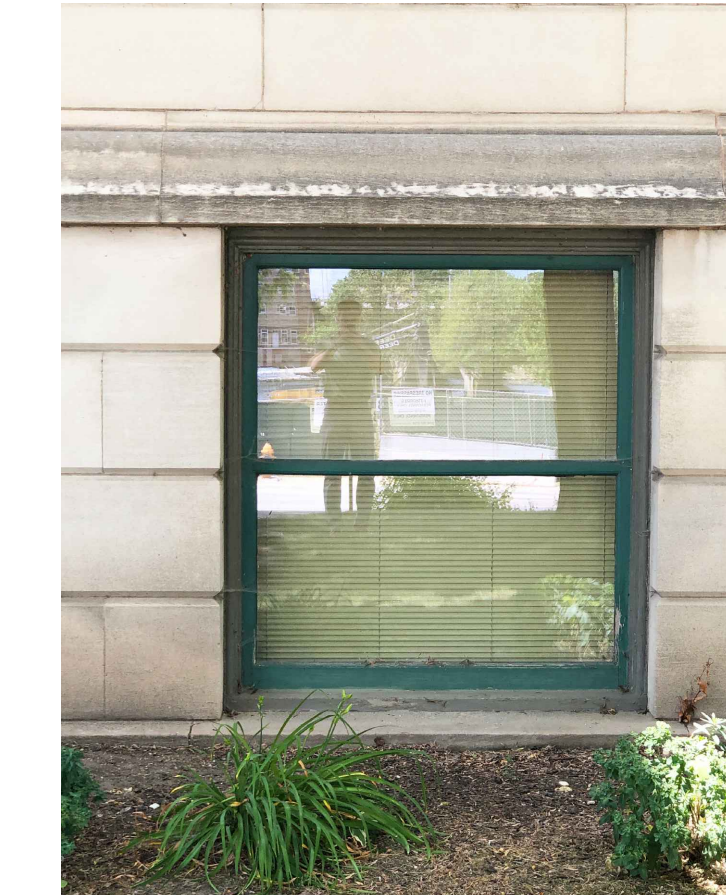
58

OBSERVATION: BOTH GREEN & GRAY WINDOW PAINT ARE PEELING & FADING. SOME WOOD DAMAGE OBSERVED.
RECOMMENDATION: SURFACE PREPARATION FOR MPI DSD 4 REMOVE & REPLACE DETERIORATED PERIMETER SEALANT

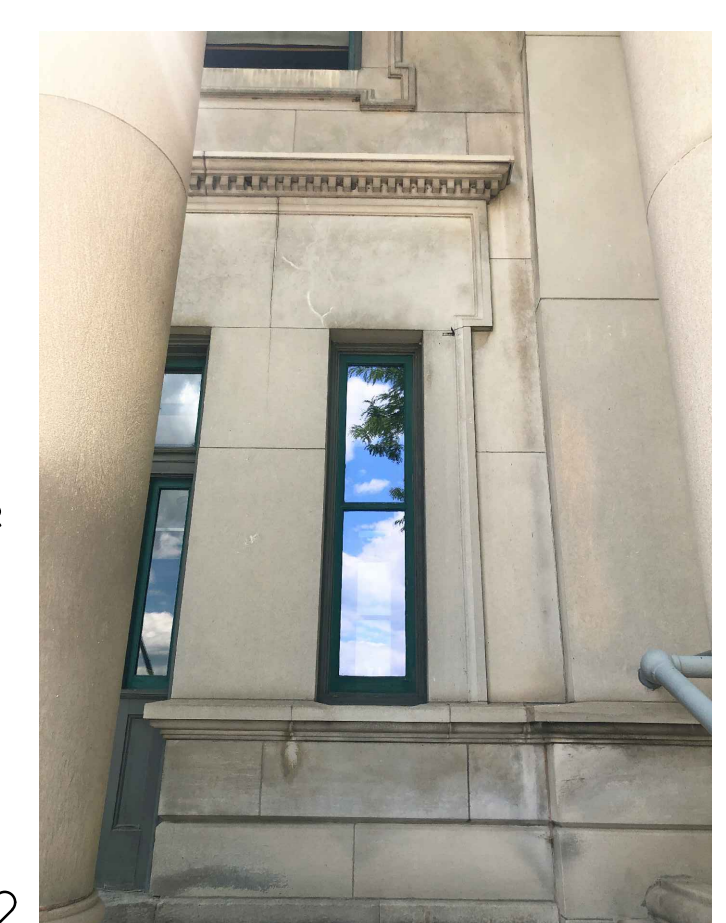
57

OBSERVATION: BOTH GREEN & GRAY WINDOW PAINT ARE PEELING & FADING
RECOMMENDATION: SURFACE PREPARATION FOR MPI DSD 2 REMOVE & REPLACE DETERIORATED PERIMETER SEALANT

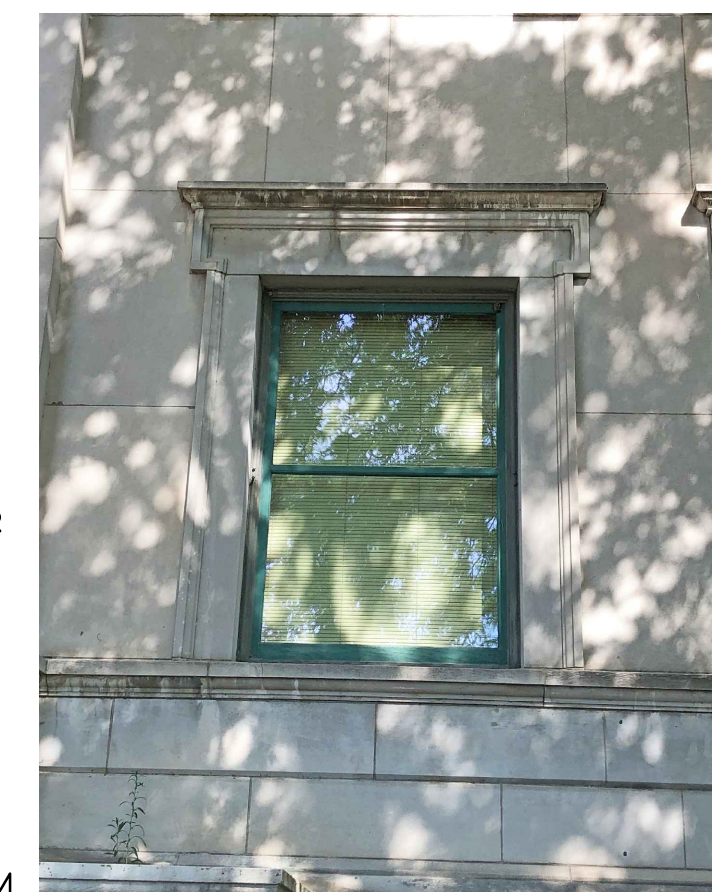
52

OBSERVATION: BOTH GREEN & GRAY WINDOW PAINT ARE PEELING & FADING
RECOMMENDATION: SURFACE PREPARATION FOR MPI DSD 2 REMOVE & REPLACE DETERIORATED PERIMETER SEALANT
