EXTERIOR MAINTENANCE REPAIR WORK FOR: VETERANS MEMORIAL HALL

WINNEBAGO COUNTY

BID # 21B-2226

ISSUED FOR: BIDDING

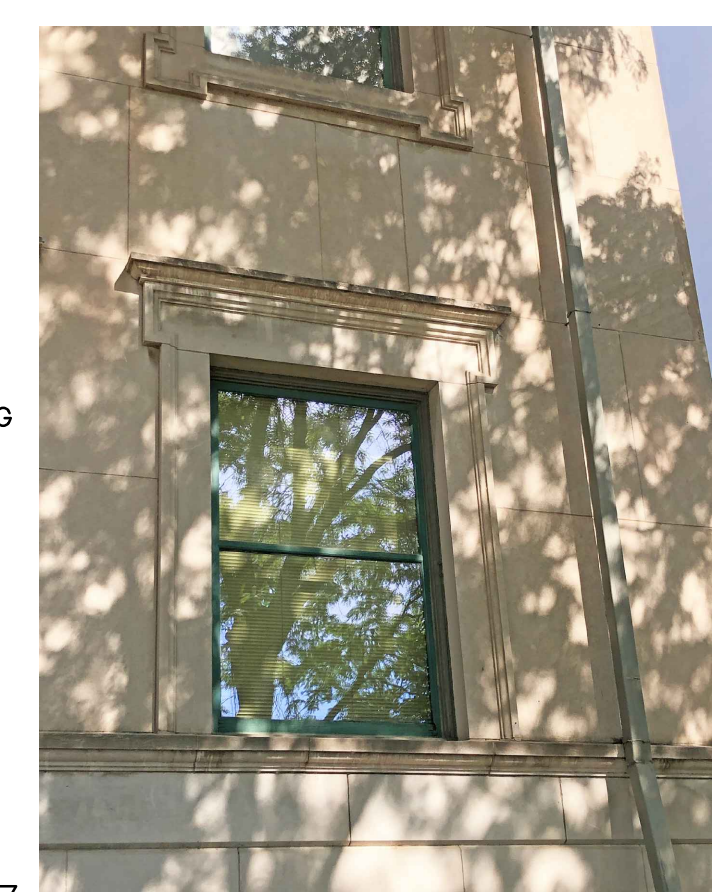
54

OBSERVATION: BOTH GREEN & GRAY WINDOW PAINT ARE PEELING & FADING
RECOMMENDATION: SURFACE PREPARATION FOR MPI DSD 2 REMOVE & REPLACE DETERIORATED PERIMETER SEALANT

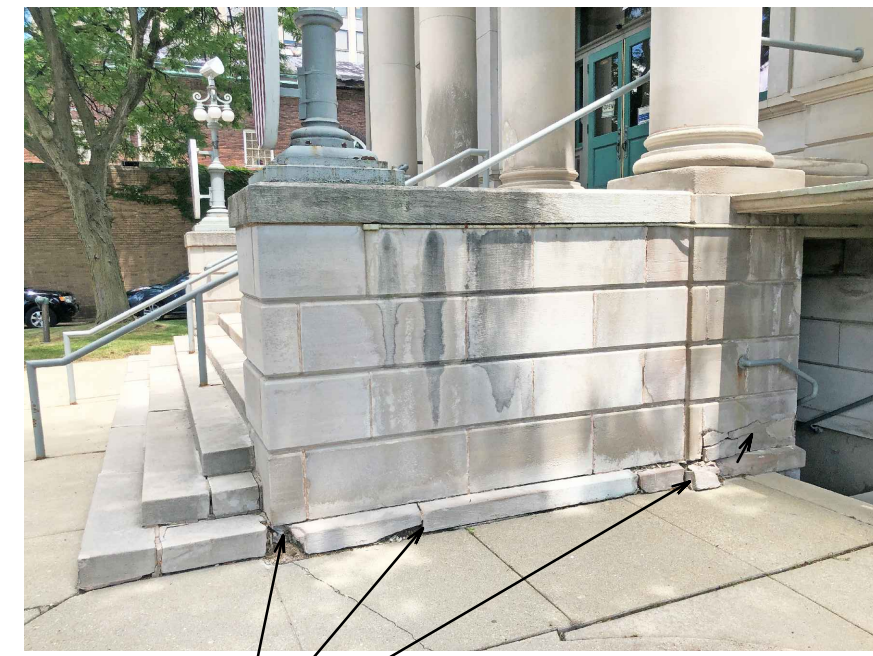
2
OBSERVATION:
STONE BASE IS SEVERELY DAMAGED AND DISPLACED
RECOMMENDATION:
SEE STAIR WORK NOTES THIS SHEET

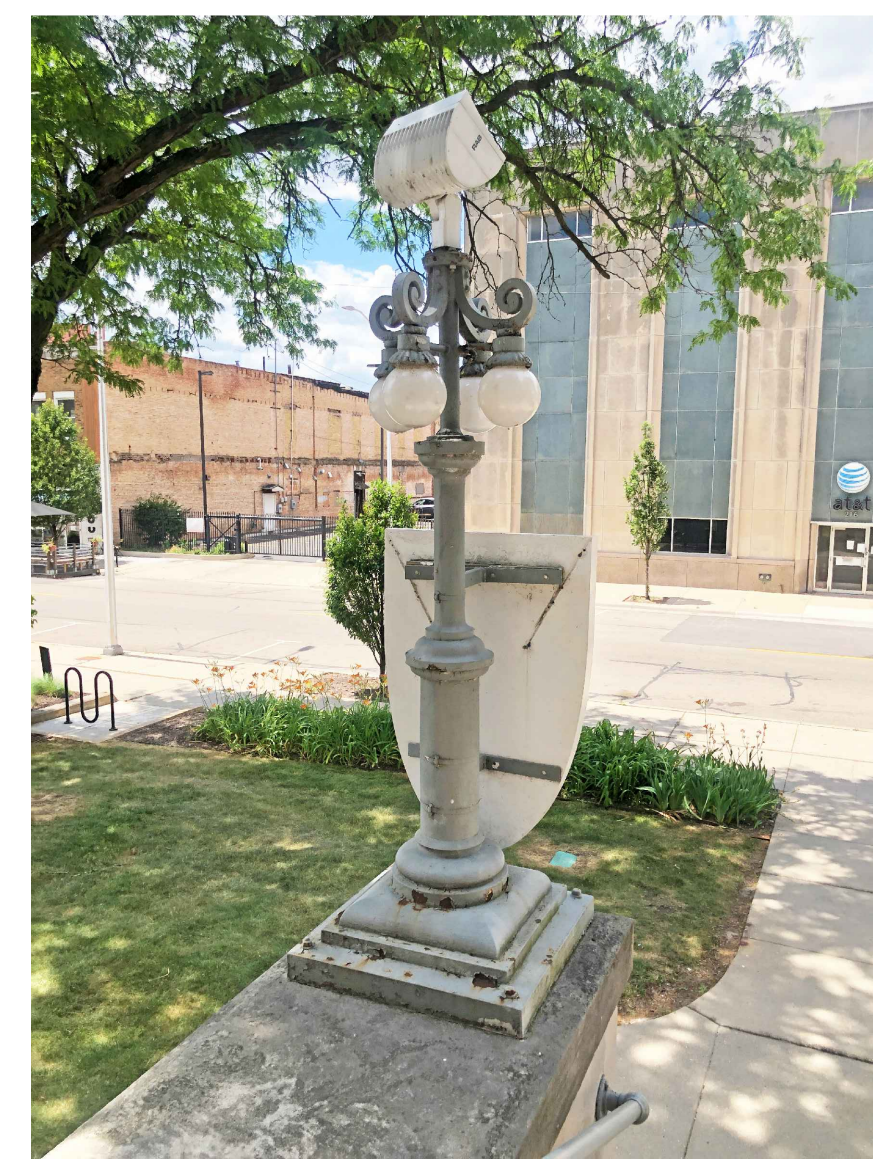
4

3
OBSERVATION:
EXTERIOR STAIR LIGHT POSTS ARE SEVERELY RUSTED
AND THE PAINT IS PEELING
RECOMMENDATION:
SURFACE PREPARATION FOR MPI DSD 3

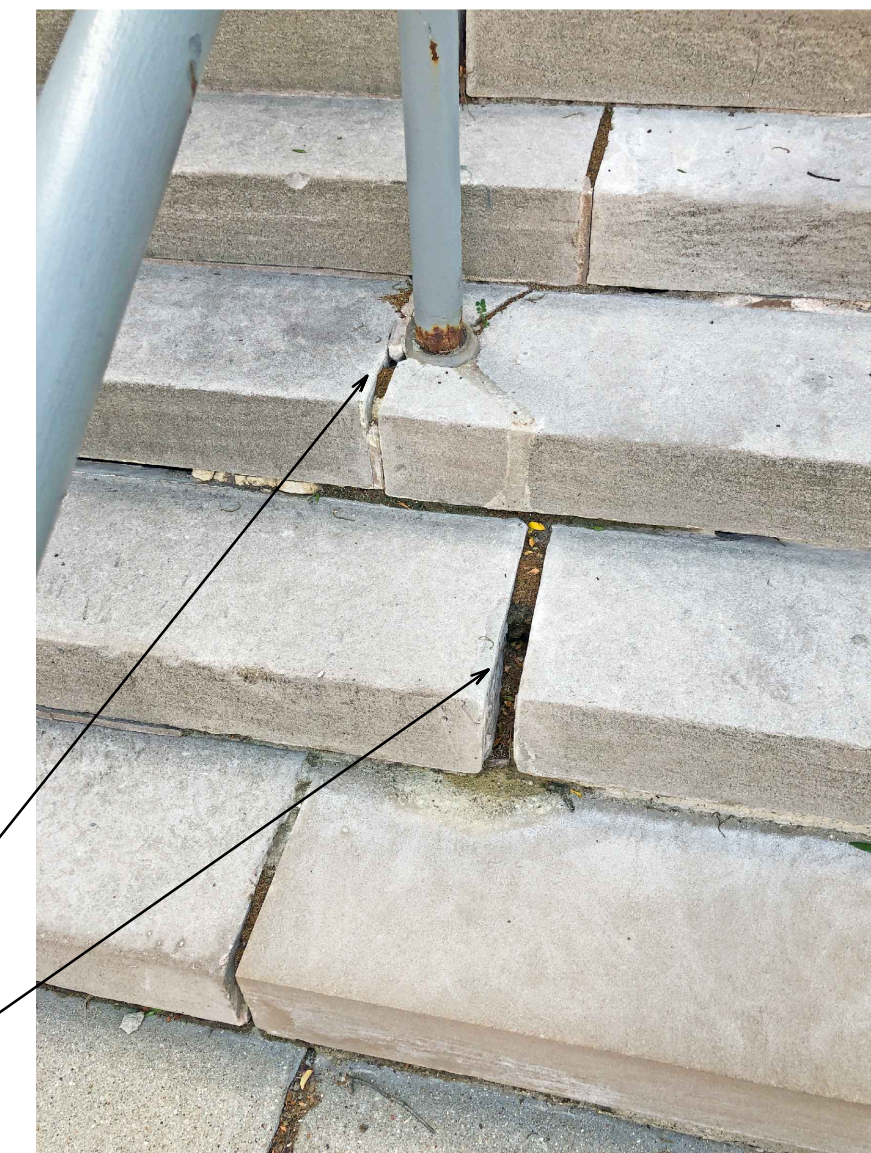
11

10
OBSERVATION:
STONE STEPS ARE CRACKED AND SEVERELY DISPLACED
RECOMMENDATION:
SEE STAIR WORK NOTES THIS SHEET

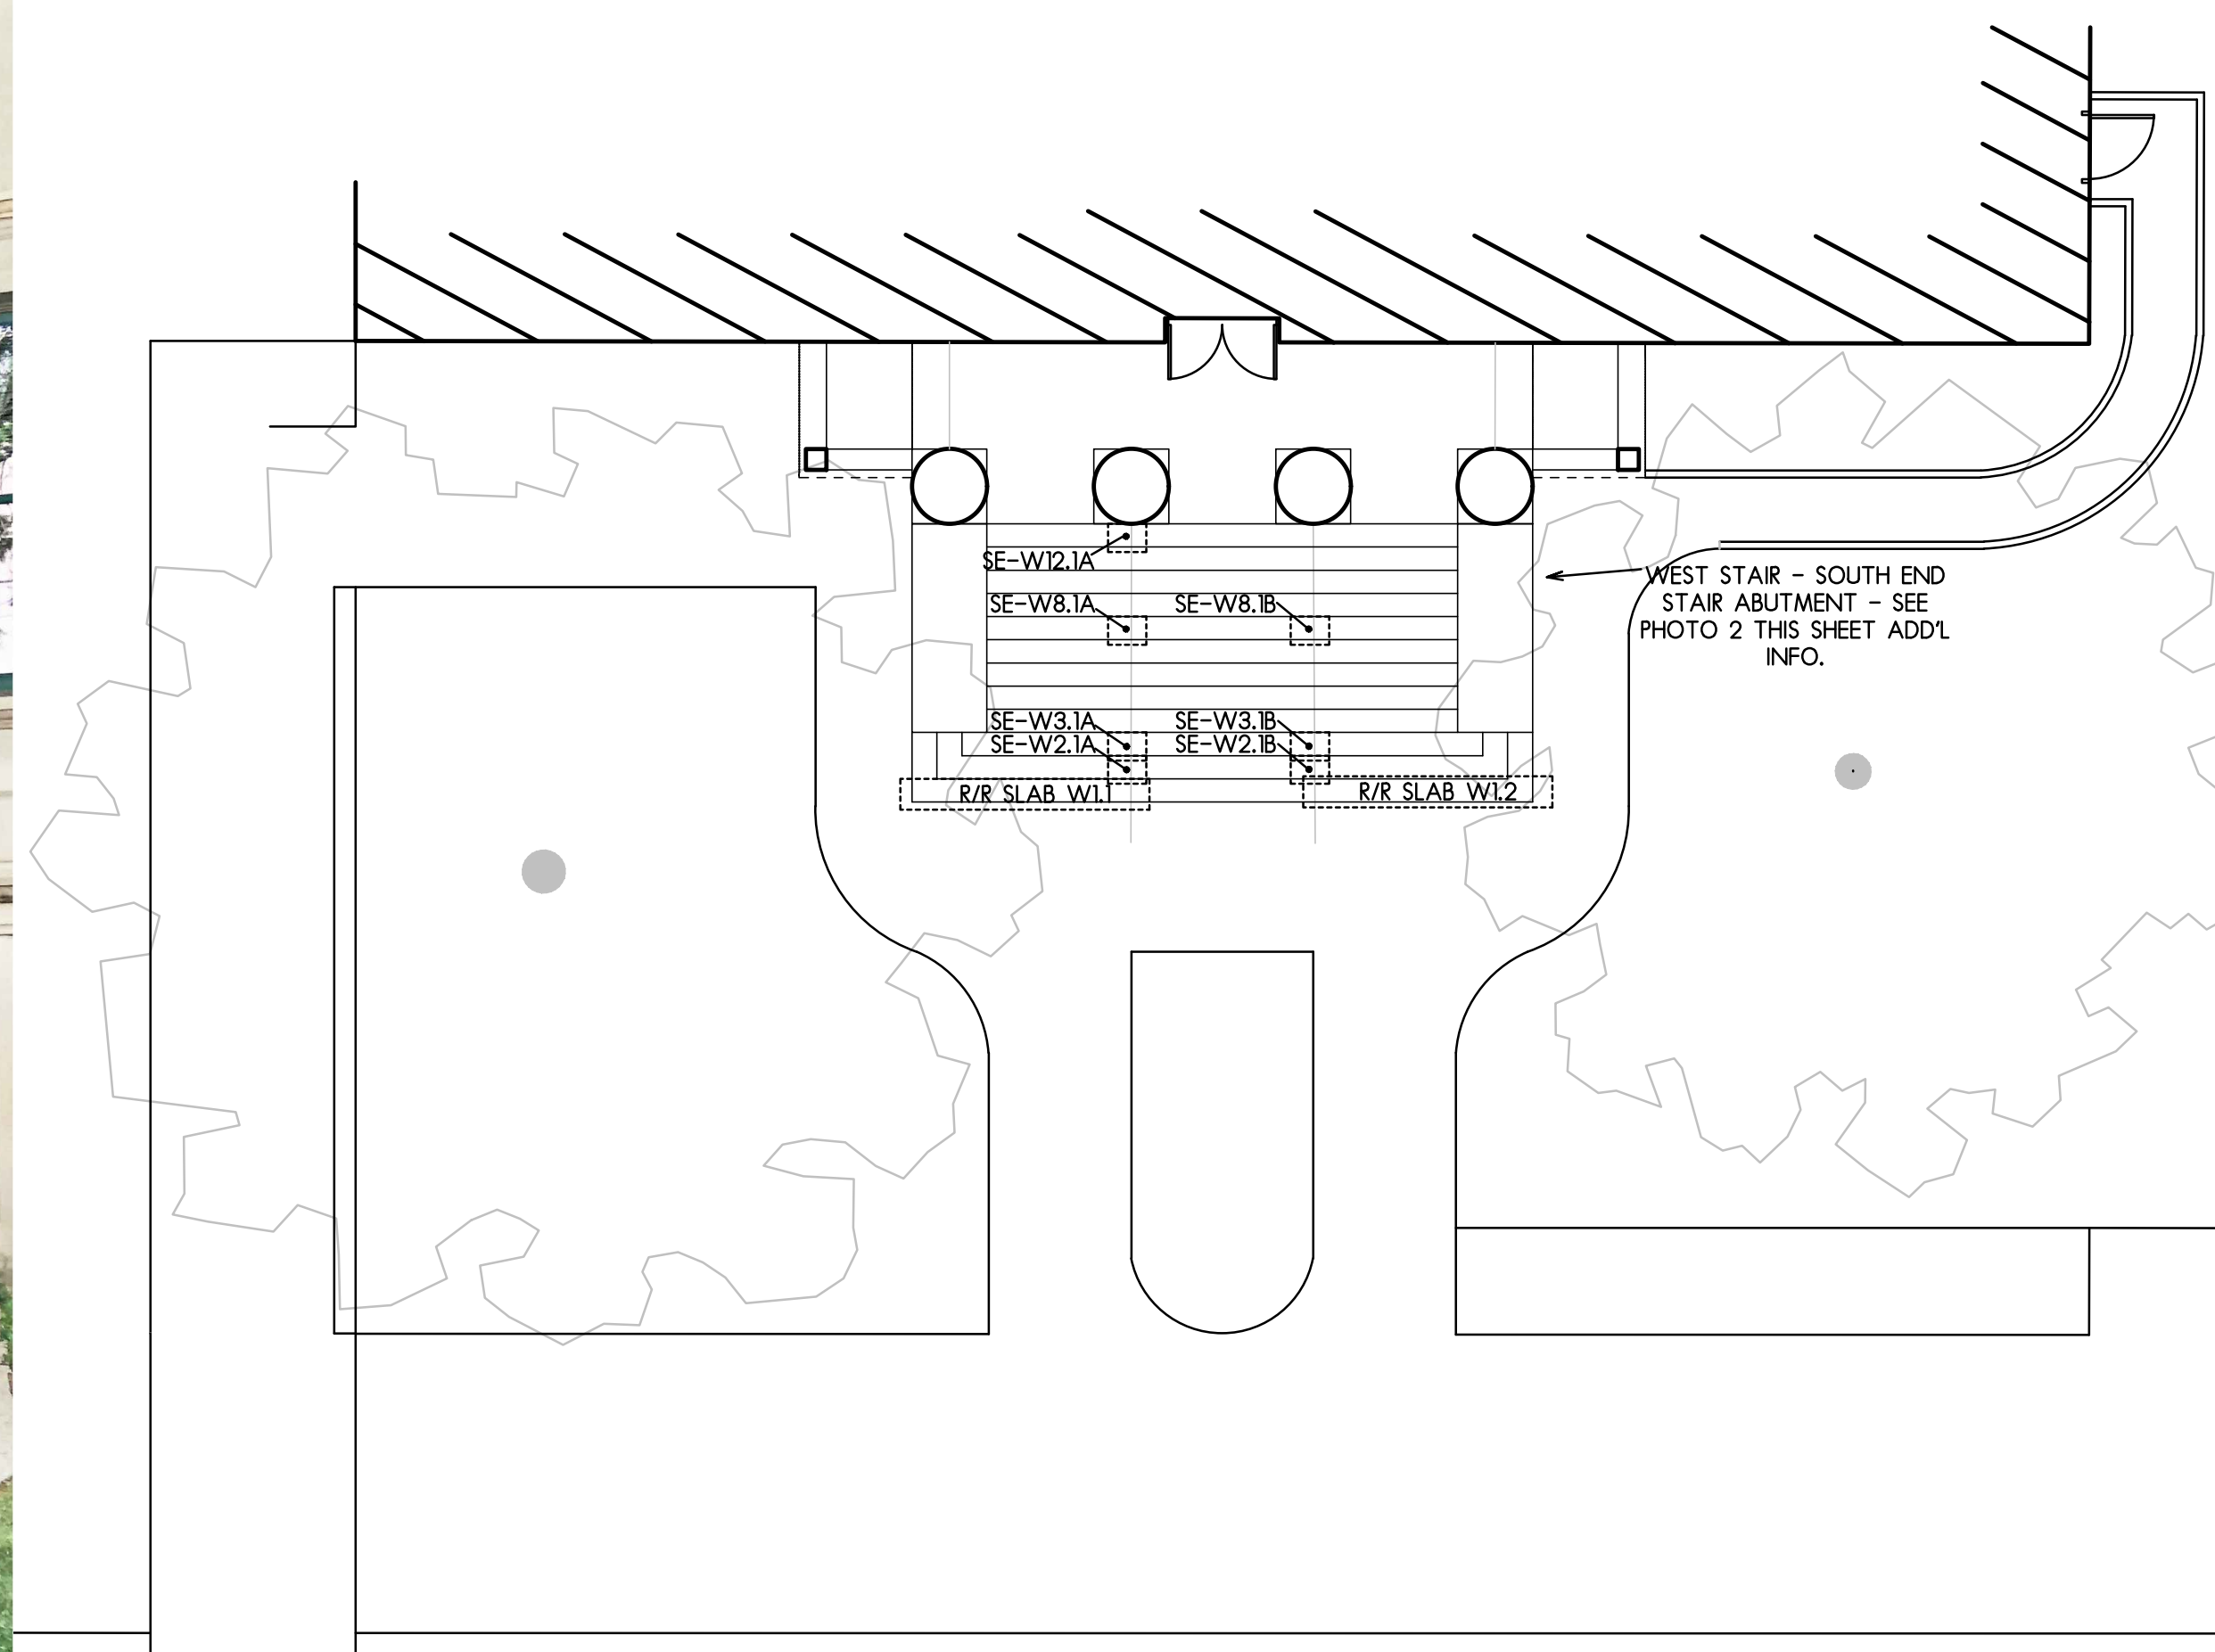
2
**DIAGRAMMATIC
WEST WALK/ MAIN STAIR PLAN**
NOT TO SCALE

WEST STAIR - SOUTH END
STAIR ABUTMENT - SEE
PHOTO 2 THIS SHEET ADD'L
INFO.

- THE NOTED STONE STAIR SLABS SHALL BE COMPLETELY REMOVED AND REPLACED WITH NEW STONE TO MATCH EXISTING:
 - STONE SLABS W11 & W12 (FULL-SIZE SLAB-REPLACEMENT)

- THE NOTED SECTIONS OF BROKEN STONE STAIR SLAB ENDS SHALL HAVE BROKEN END/ LOOSE PIECES REMOVED AND CLEANED; DRILL-IN AND EPOXY ANCHOR NEW DOWEL PINS INTO ADJACENT EXISTING SOLID STONE AND INSTALL NEW SYNTHETIC STONE REPAIR SYSTEM PER MANUFACTURER'S REQUIREMENTS; STAIN TO APPROX. BLEND-IN REPAIRS WITH ADJACENT EXISTING STONE:

- STONE SLAB ENDS SE-W2.1 A & B.
 - STONE SLAB ENDS SE-W3.1 A & B.
 - STONE SLAB ENDS SE-W8.1 A & B.
 - STONE SLAB ENDS SE-W12.1 A
- STONE STEP JOINTS SHALL BE CLEANED OF LOOSE MORTAR/ DEBRIS; GRIND MORTAR DOWN TO BE APPROX 1" BELOW SURFACE; INSTALL NEW MORTAR IN ALL STONE STAIR JOINTS UP TO APPROX 1 INCH FROM THE FINISH STONE SURFACES; INSTALL NEW BACKER ROD AND NEW WALKABLE GRADE HIGH QUALITY URETHANE JOINT SEALANT SYSTEM; CLEAN-UP ALL AREAS.

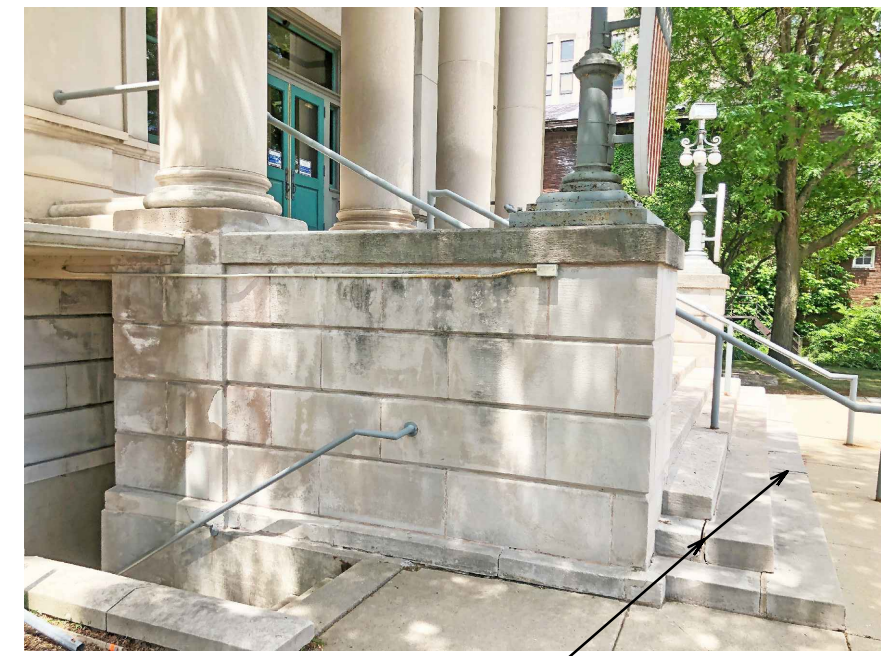
1 OBSERVATION:
STONE STEPS ARE DAMAGED AND DISPLACED

RECOMMENDATION:
SEE STAIR WORK NOTES THIS SHEET

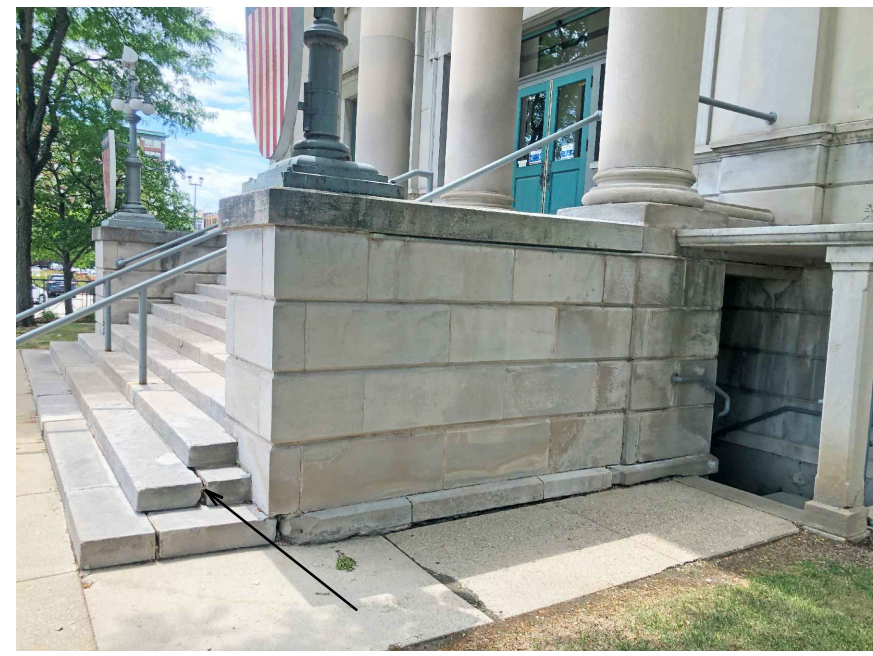
2 OBSERVATION:
STONE WALL AND BASE IS DAMAGED AND STONE
BASE IS DISPLACED

RECOMMENDATION:
SEE STAIR WORK NOTES THIS SHEET

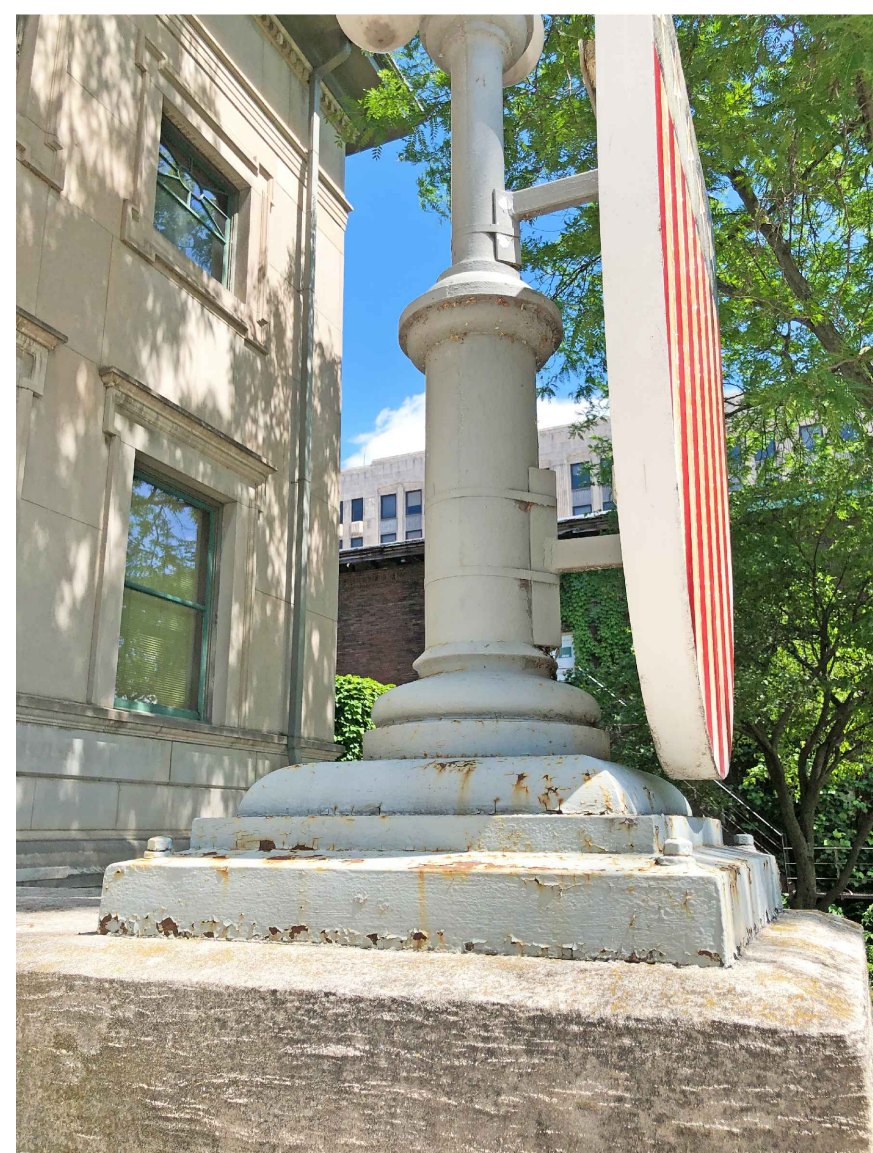
8

7 OBSERVATION:
EXTERIOR STAIR LIGHT POSTS ARE SEVERELY RUSTED
AND THE PAINT IS PEELING

RECOMMENDATION:
SURFACE PREPARATION FOR MPI DSD 3

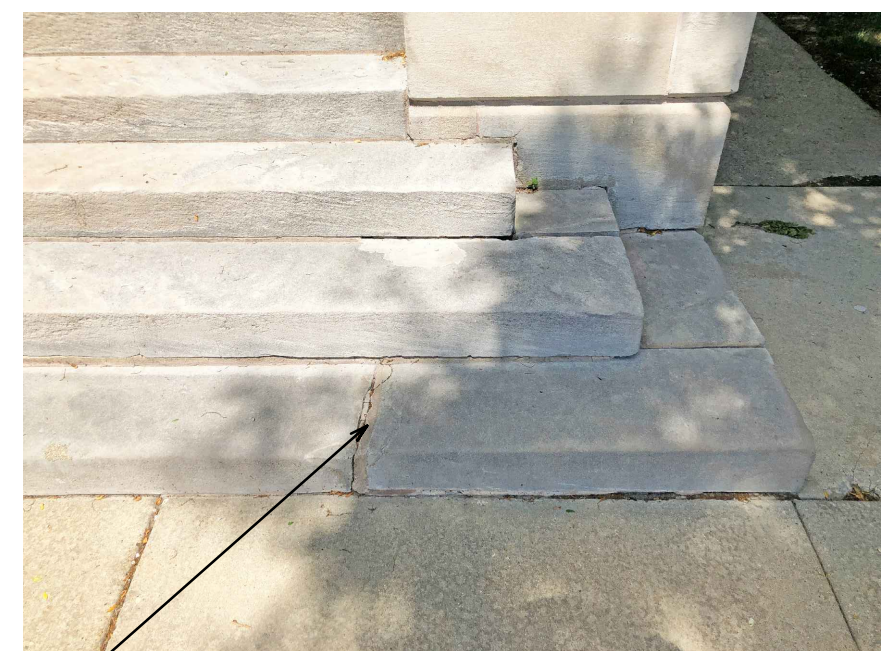
10

9 OBSERVATION:
STONE STEPS ARE DAMAGED AND DISPLACED

RECOMMENDATION:
SEE STAIR WORK NOTES THIS SHEET

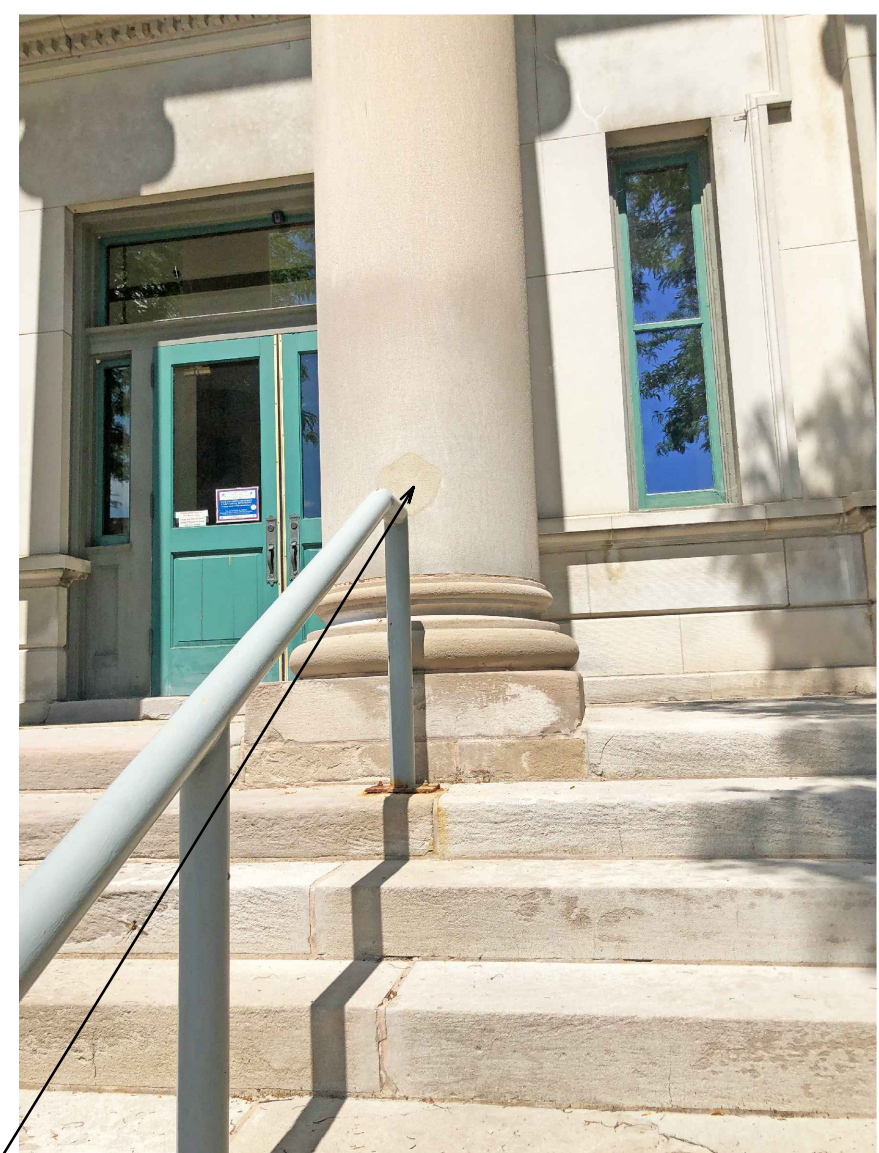
12

11 OBSERVATION:
EXISTING STONE REPAIRS ON COLUMNS DON'T
MATCH THE ORIGINAL STONE COLOR WELL

RECOMMENDATION:
CLEAN AND STAIN EXISTING REPAIR TO BETTER
BLEND WITH THE ORIGINAL STONE
